RE: Newly built class II community connector snowmobile trail to Harris Lake widely violates APA-DEC Snowmobile Trail Management Guidance, State Land Master Plan, Stormwater Pollution Prevention Plan Permit, DEC Snowmobile Bridge Construction Policy

Protect the Adirondacks recently visited the newly constructed class II community connector snowmobile trail around Harris Lake. This trail was approved by the Adirondack Park Agency (APA) and Department of Environmental Conservation (DEC) in July 2015 as part of a new Newcomb to Minerva snowmobile trail connection. The trail runs just over 1 mile through parts of Forest Preserve in the Santanoni Historic Area, Vanderwhacker Mountain Wild Forest Area, and Harris Lake Intensive Use area. PROTECT found the work on this trail to consistently violate the 2009 Management Guidance: Snowmobile Trail Siting, Construction and Maintenance in Forest Preserve Lands in the Adirondack Park (Guidance), State Land Master Plan, DEC's Stormwater Pollution Prevention Plan permit issued for this project, and the DEC guidelines for snowmobile bridge construction. There may also have been wetlands violations. It's a sad commentary on the state's management

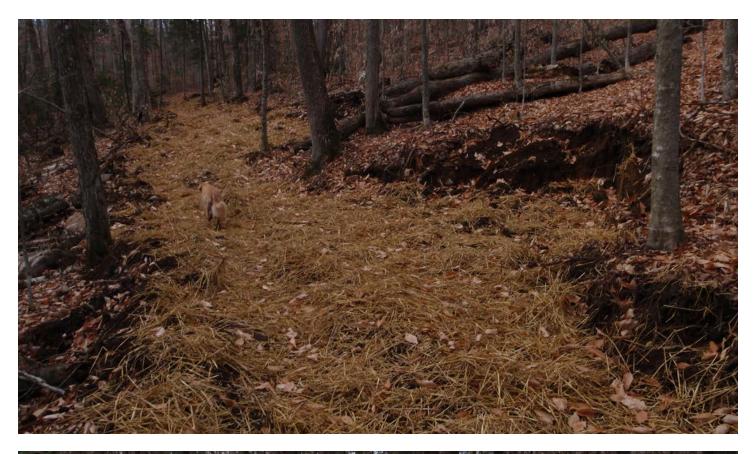
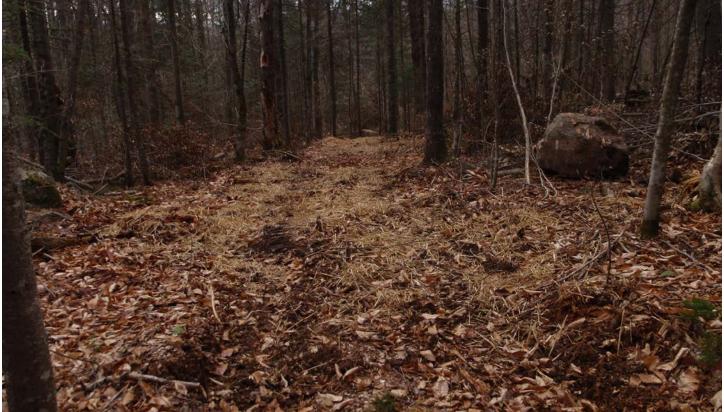
**Numerous Violations of Trail Width Standards:** The Guidance set trail width standards for class II community connector trails at 9 feet in straight areas and 12 feet on curves or slopes. In many places on the Harris Lake trail the width of the trail surface is far in excess of these standards.

Two pictures of the construction of the class II community connector snowmobile trail around Harris Lake. These pictures show areas far in excess of the 12 foot maximum width for slopes or curves and 9 feet for straight areas. This excessive widening of the trail surface causes unnecessary natural resource damage to the Forest Preserve.

The Guidance states "Class I and II trails wider that their classification allows will be actively restored to these limits." (P. 9) The pictures at the end of the letter amply show that on the Harris Lake trail these standards were not upheld. Areas of the Harris Lake trail that exceed trail width standards should be rehabilitated.

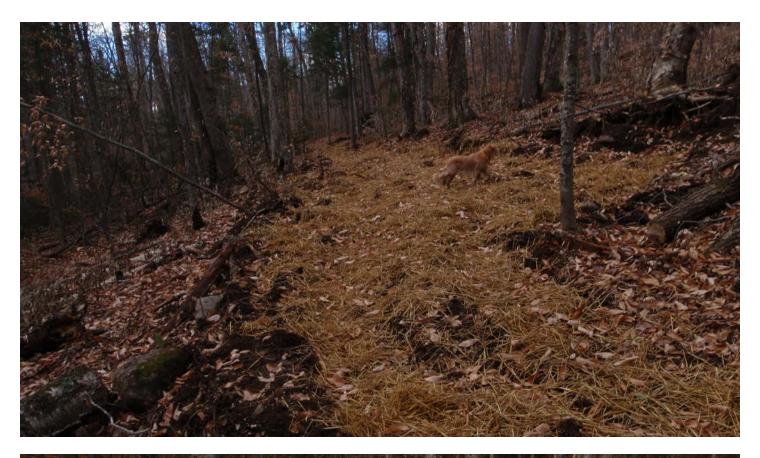
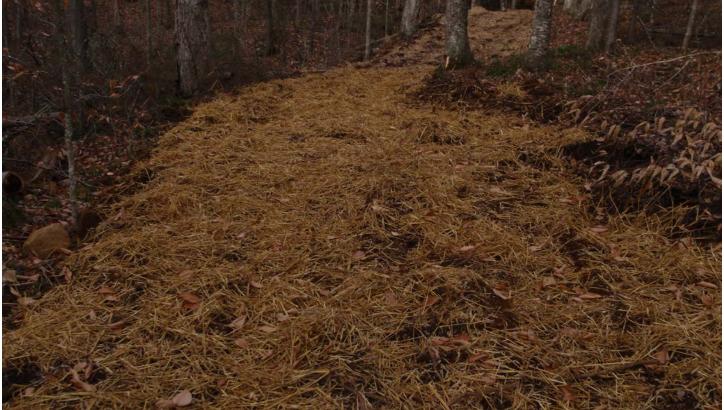
Two more pictures of the construction of the class II community connector snowmobile trail around Harris Lake. These pictures show areas far in excess of the 12 foot maximum width for slopes or curves and 9 feet for straight areas. This excessive widening of the trail surface causes unnecessary natural resource damage to the Forest Preserve.

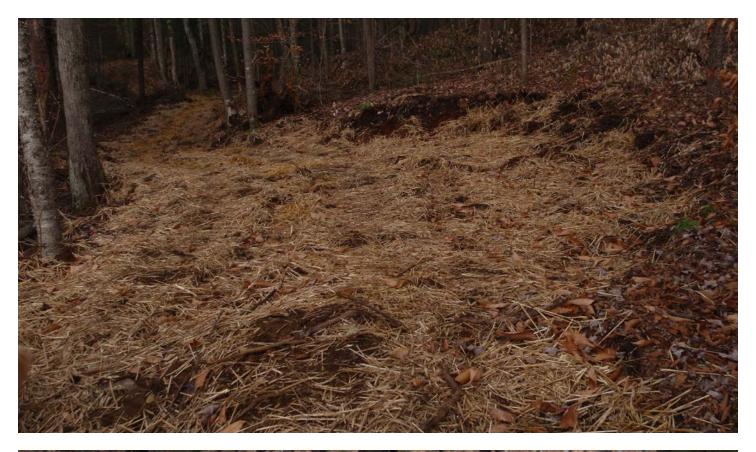
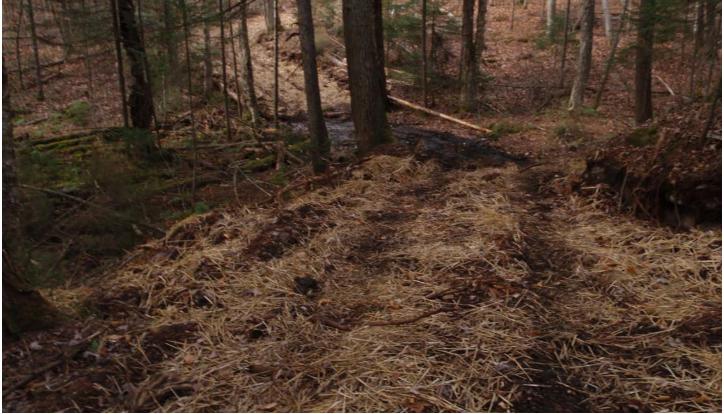
Two more pictures of the construction of the class II community connector snowmobile trail around Harris Lake. These pictures show areas far in excess of the 12 foot maximum width for slopes or curves and 9 feet for straight areas. This excessive widening of the trail surface causes unnecessary natural resource damage to the Forest Preserve.

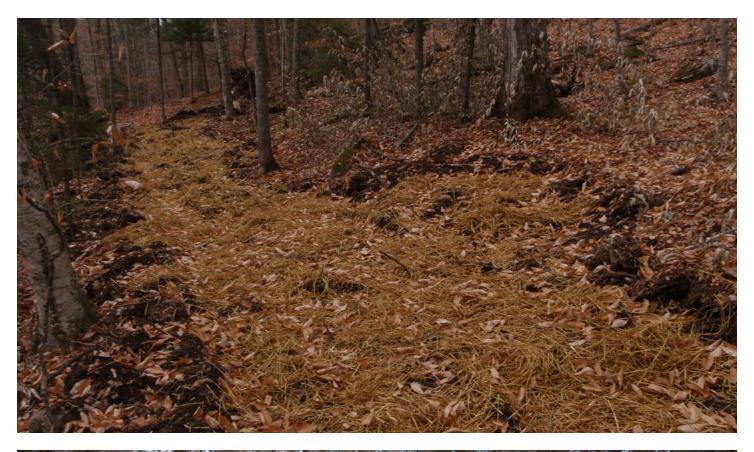
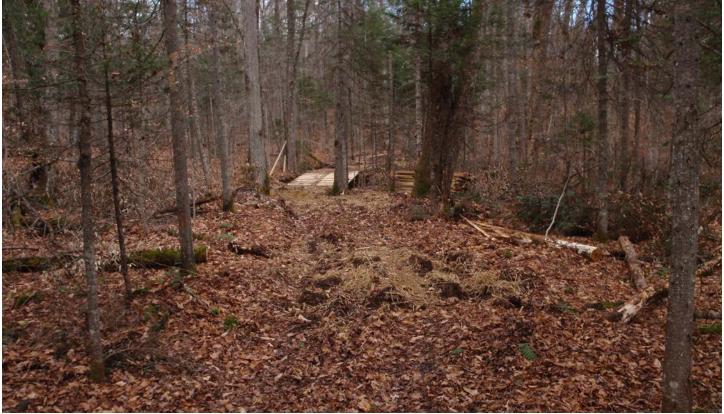
Two more pictures of the construction of the class II community connector snowmobile trail around Harris Lake. These pictures show areas far in excess of the 12 foot maximum width for slopes or curves and 9 feet for straight areas. This excessive widening of the trail surface causes unnecessary natural resource damage to the Forest Preserve. The bridge in the distance is 12.5 feet wide for reference.

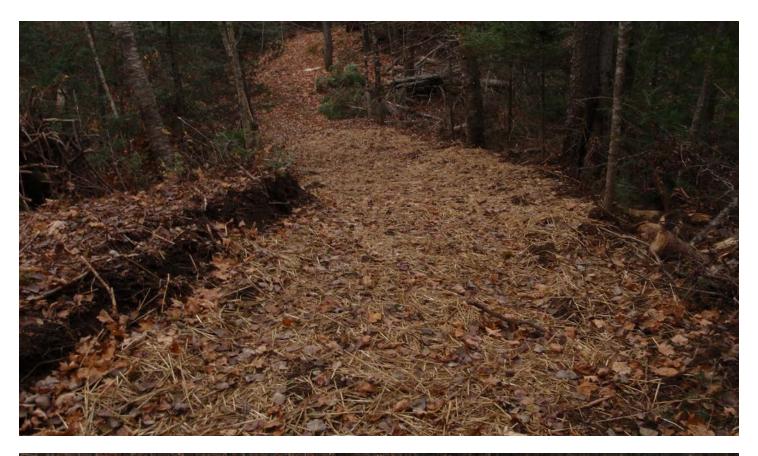
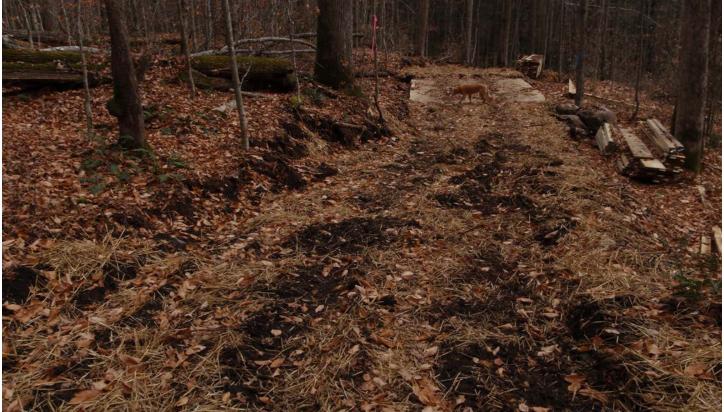
Two more pictures of the construction of the class II community connector snowmobile trail around Harris Lake. These pictures show areas far in excess of the 12 foot maximum width for slopes or curves and 9 feet for straight areas. This excessive widening of the trail surface causes unnecessary natural resource damage to the Forest Preserve. The bridge in the bottom picture is 12.5 feet wide for reference.

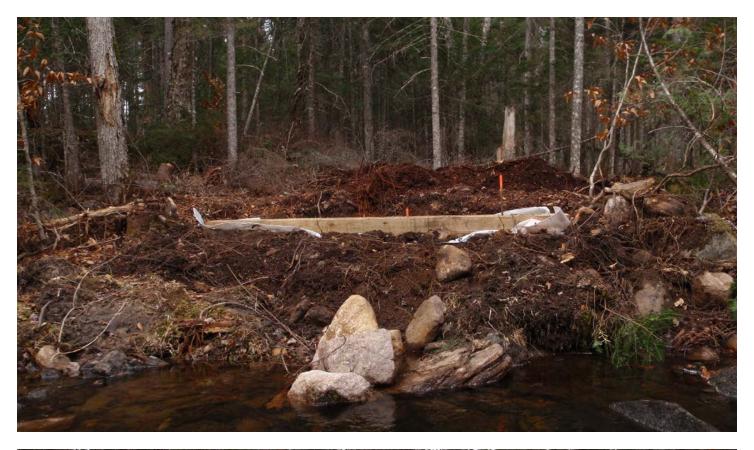
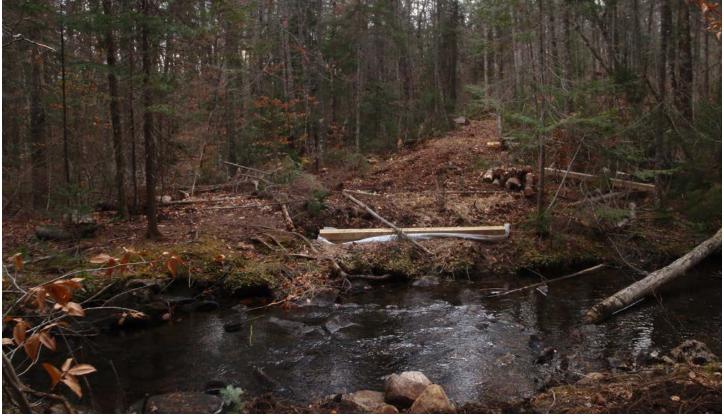
Prevention Plan (SWPPP) permit nailed to a tree at the Camp Santanoni end of the Harris Lake trail. Unfortunately, we encountered snowmobile bridges being constructed over permanent streams with heavy flows where there was disturbed and exposed soils along the stream banks with no silt fencing whatsoever. We found instances where ATVs and heavy tracked machinery were repeatedly driven through a wetland with no mats or protection for the wetland. We found snowmobile bridges being constructed within intermittent streams, with active flow, where there was disturbed and exposed soils within the stream corridor with no silt fencing.

Two pictures that show bridge construction on the Harris Lake trail over a permanent stream. Though the DEC issued itself a Stormwater Management Permit for this project it failed to use any type of silt fencing and has exposed earth that runs right to the stream. This is not acceptable natural resource protection.

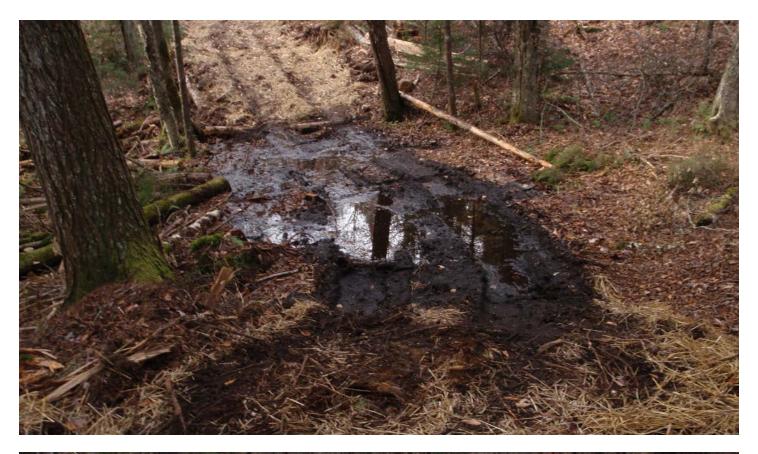
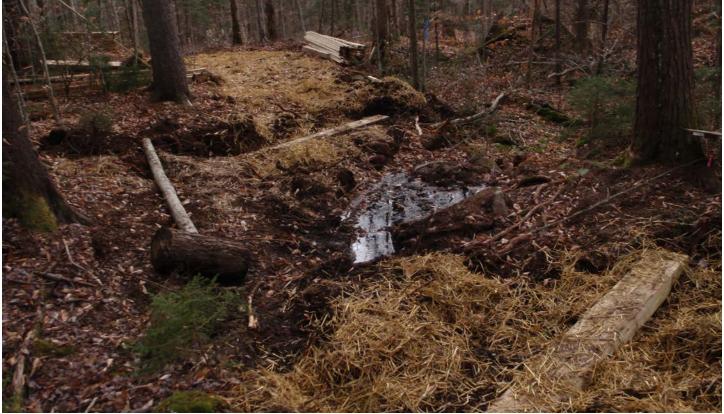
The Guidance states that "Any activity in a wetland or that may impact a wetland will be undertaken with prior consultation with the APA and with recognition of Army Corp on Engineers' permit requirements." (P. 12) If "prior consultation" was undertaken between the DEC and APA, did the APA approve construction activities that involved no use of silt fencing in stream corridors and repeated driving of various motor vehicles through a wetland? It appears that there were stormwater and wetlands violations during the construction of the Harris Lake trail.

The top pictures shows where motor vehicles repeatedly drove through a wetland during construction on the Harris Lake trail. The bottom picture shows bridge construction over an intermittent stream corridor with no silt fencing despite stream flow. This is not acceptable natural resource protection.

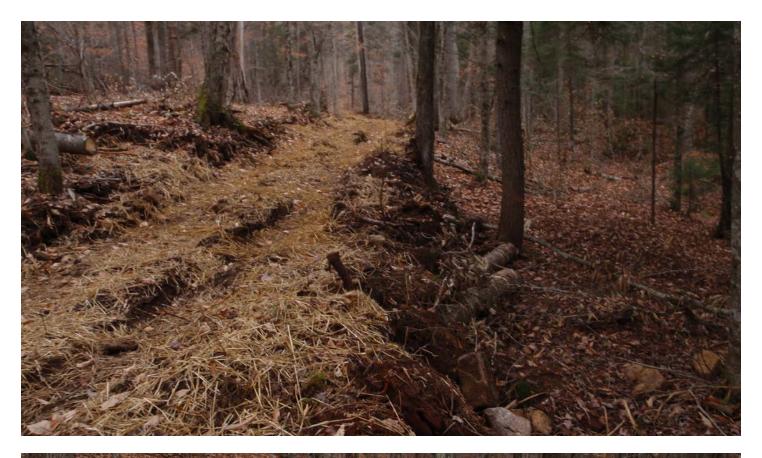
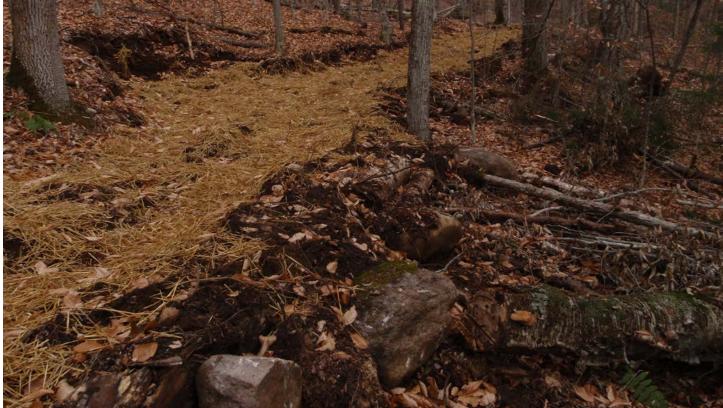
**Debris Clutters Trail Corridor:** The Guidance states "When removed boulders and rocks are not buried, but instead set to the side of the trail, they will be dispersed with care and not left in windrows or pile next to the trial." (P. 10) The Harris Lake trail is rife with debris piles alongside the trail as shown in the attached pictures.

These pictures show parts of the Harris Lake trail where rocks, boulders, cut trees, and other debris have been piled alongside the trail and used as fill or to stabilize the trail. These debris piles are expressly prohibited by the APA-DEC Snowmobile Trail Management Guidance.

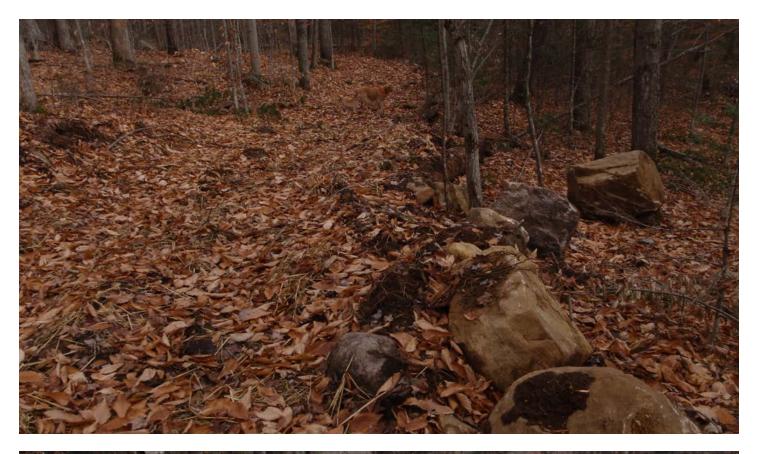
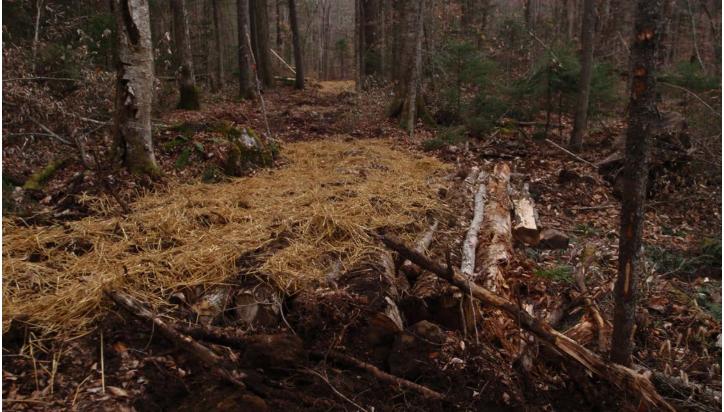
More pictures that show parts of the Harris Lake trail where rocks, boulders, cut trees, and other debris have been piled alongside the trail and used as fill or to stabilize the trail. These debris piles are expressly prohibited by the APA-DEC Snowmobile Trail Management Guidance.

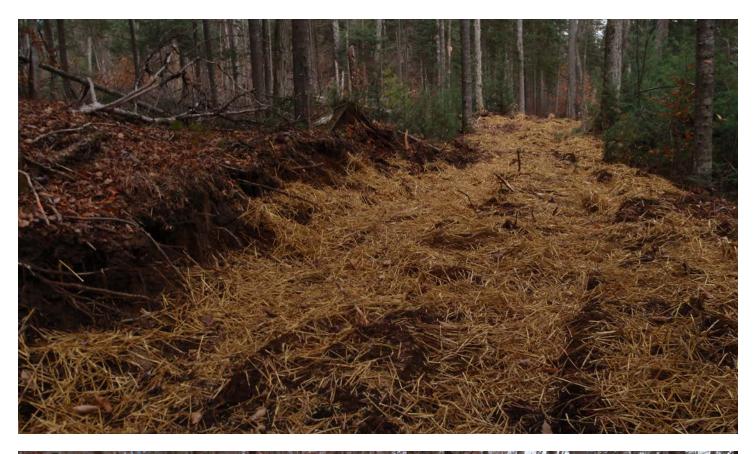
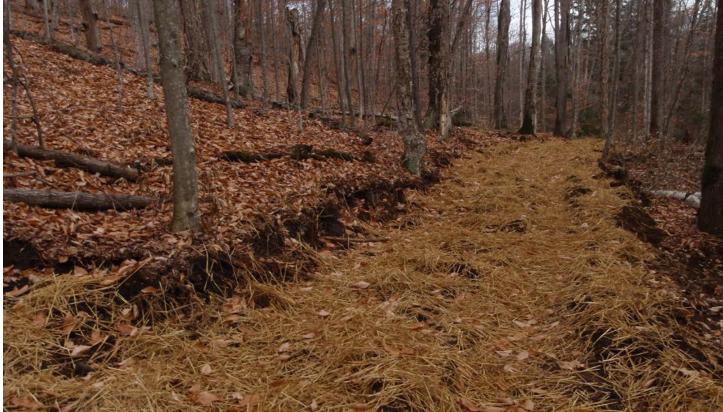
On the Harris Lake trail, bench cutting was used on a very high percentage of the total trail, upwards of one-third or more. This high use of bench cuts hardly meets the Guidance requirement for "proper trail layout" and points to a part of the Forest Preserve unsuitable to provide a motorized recreational trail experience.

These pictures show extensive grading and "bench cutting" on the Harris Lake trail. After extensive tree cutting, rock removal, filling in of hummocks, and complete destruction of the forest understory, grading and bench cutting dramatically change a trail.

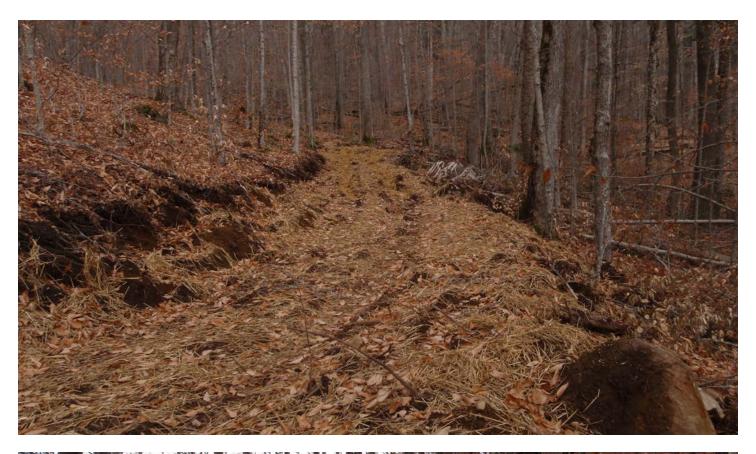
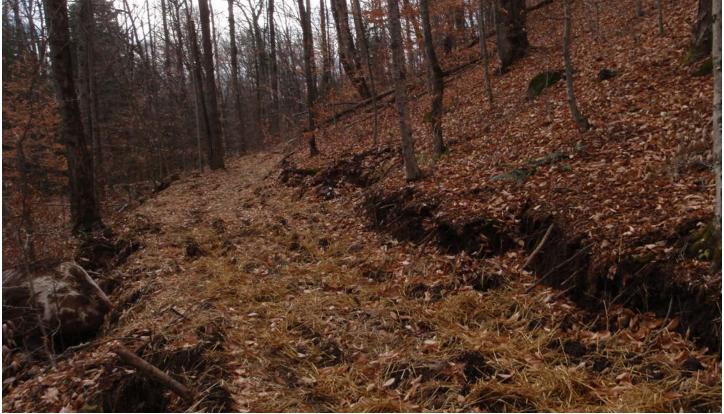
More pictures showing extensive grading and "bench cutting" on the Harris Lake trail. After extensive tree cutting, rock removal, filling in of hummocks, and complete destruction of the forest understory, grading and bench cutting dramatically change a trail. Areas where the walls of the bench cut collapse widen the trail and lead to erosion.

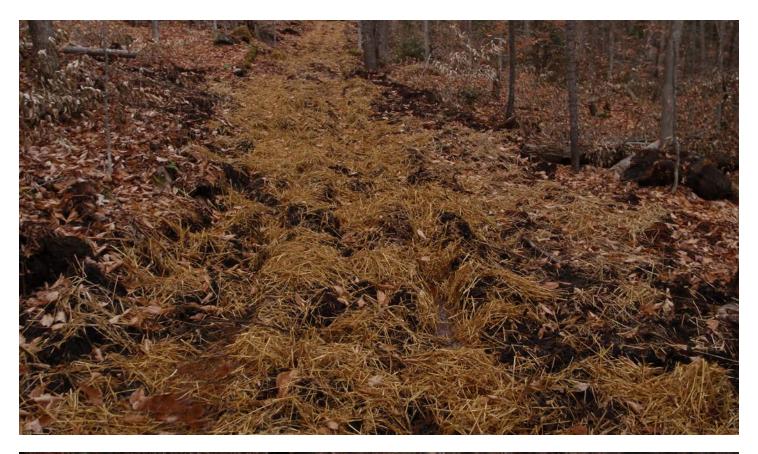
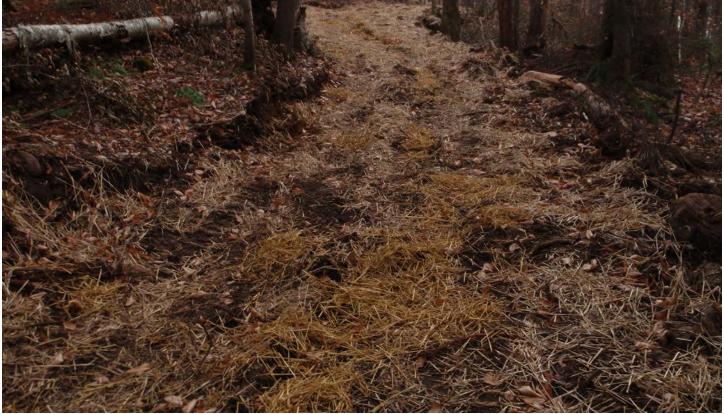
The Guidance states "Limited leveling and grading may be undertaken using appropriate low-impact landscaping equipment as specified in a Work Plan." (P 10) More than half of the Harris Lake trail corridor was substantially graded. If such a high proportion of a trail requires grading to make it safe for snowmobile riding, then it would seem that that area is unsuitable for a snowmobile trail. The Guidance talks of "limited leveling and grading." What we found on the Harris Lake trail was nearly continuous major leveling and grading." The sheer extent of leveling and grading on the Harris Lake trail violated the spirit and letter of the Guidance.

The Guidance also states that on Class II trails "Trail surfaces should generally follow the existing contours of the natural forest floor and not be graded flat." (P. 10) The Harris Lake trail was almost continuously graded flat.

These pictures show extensive grading and levelling work on the Harris Lake trail. After extensive tree cutting, rock removal, filling in of hummocks, and complete destruction of the forest understory, grading and levelling dramatically change a trail.

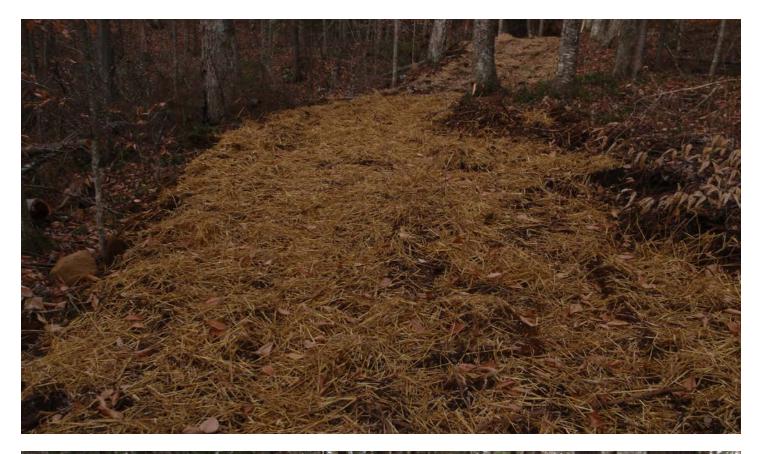
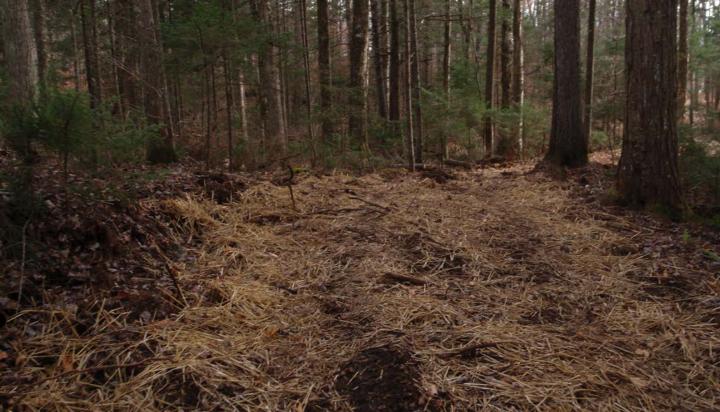
More pictures showing extensive grading and levelling work on the Harris Lake trail. After extensive tree cutting, rock removal, filling in of hummocks, and complete destruction of the forest understory, grading and levelling dramatically change a trail.

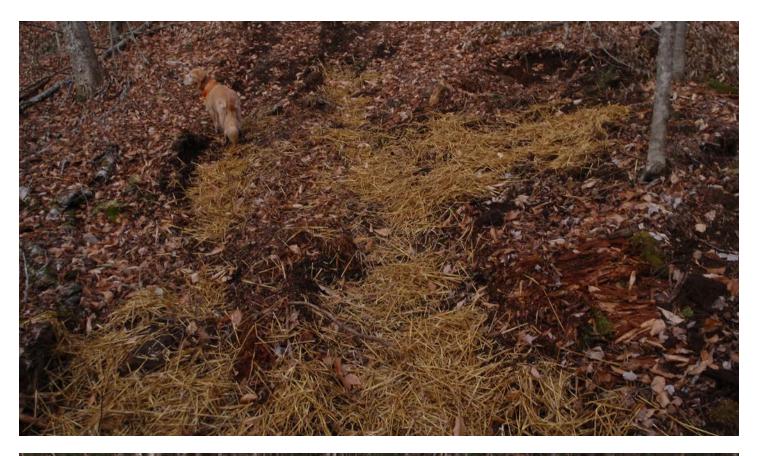
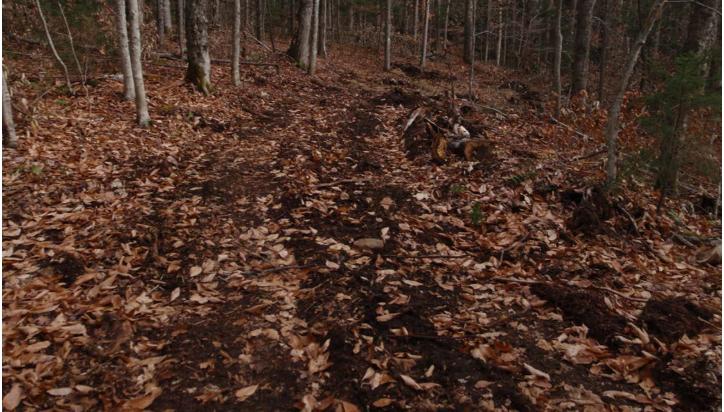
These pictures show damage to the Harris Lake trail from deep rutting due to heavy equipment used to build the trail. Note that the Guidance describes this heavy equipment as "appropriate low impact landscaping equipment." The Guidance states that deep rutting of the trail surface is prohibited and if it occurs the trail surface should be restored.

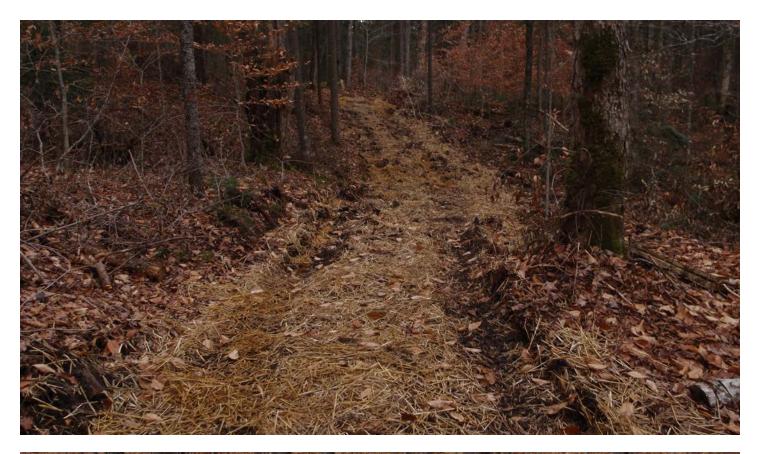
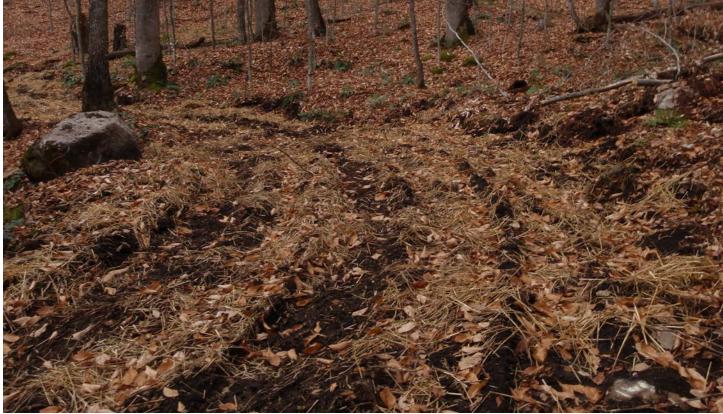
More pictures pictures showing damage to the Harris Lake trail from deep rutting due to heavy equipment used to build the trail. Note that the Guidance describes this heavy equipment as "appropriate low impact landscaping equipment." The Guidance states that deep rutting of the trail surface is prohibited and if it occurs the trail surface should be restored.

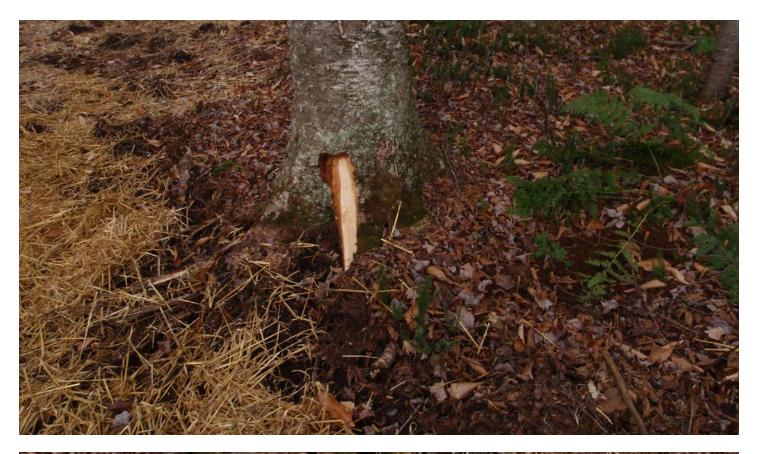
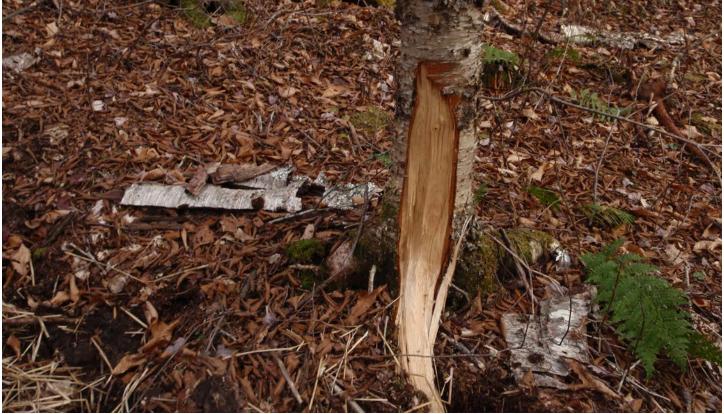
These pictures show damage to trees that were left standing within the Harris Lake trail corridor during trail construction. These trees are unlikely to survive. This type of collateral damage is particular to class II community connector snowmobile trail construction. This level of natural resource damage is unacceptable.

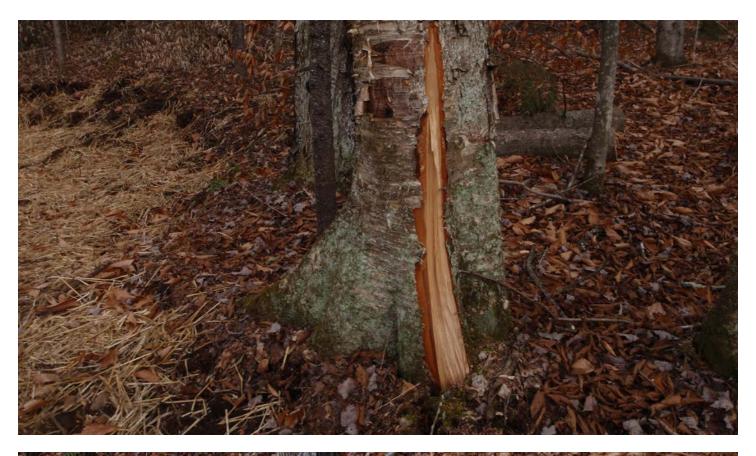
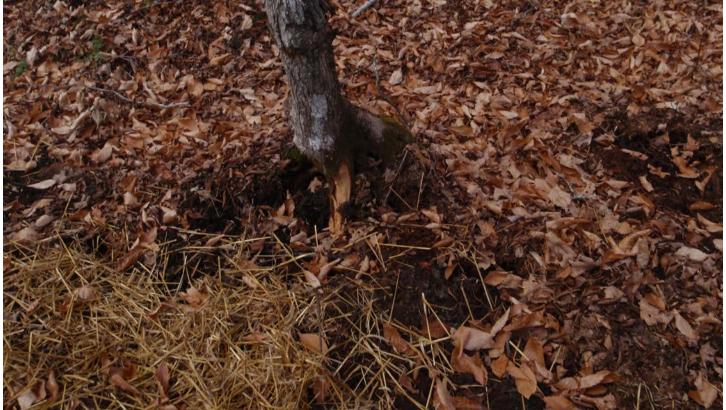
More pictures that show damage to trees that were left standing within the Harris Lake trail corridor during trail construction. These trees are unlikely to survive. This type of collateral damage is particular to class II community connector snowmobile trail construction. This level of natural resource damage is unacceptable.

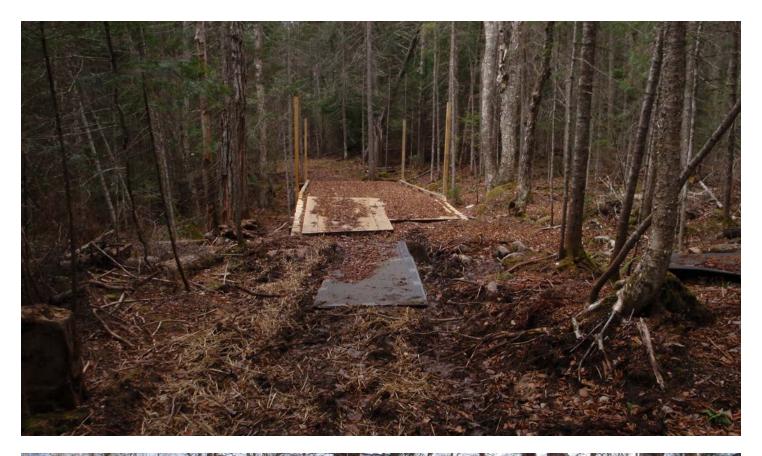
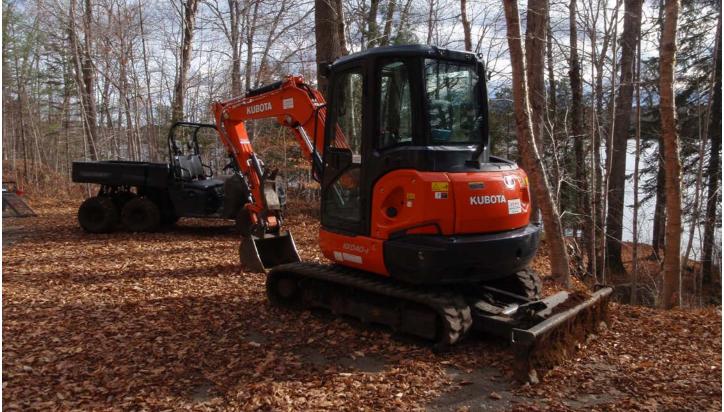
**New Style of Snowmobile Bridge:** The DEC has installed a new type of snowmobile bridge along the Harris Lake Trail. These bridges employ high 8-foot posts at all four corners of the bridge. This feature is not commonly used elsewhere and such posts are not featured in snowmobile bridge design documents.

The top picture shows a new style of snowmobile bridge being used on the Harris Lake trail with high posts at all corners. The APA-DEC snowmobile bridge policy does not allow for these types of posts, which presumably will be used to afix signs, warnings, or reflectors to manage high speed snowmobile use. The bottom picture shows what the Guidance refers to as "appropriate low impact landscaping equipment" used to build this trail.
