January 27, 2013

RE: PROTECT finds possible Wetlands Act and stormwater pollution violations along new community connector class II snowmobile trail through the Moose River Plains from 7th Lake to the Sagamore Road

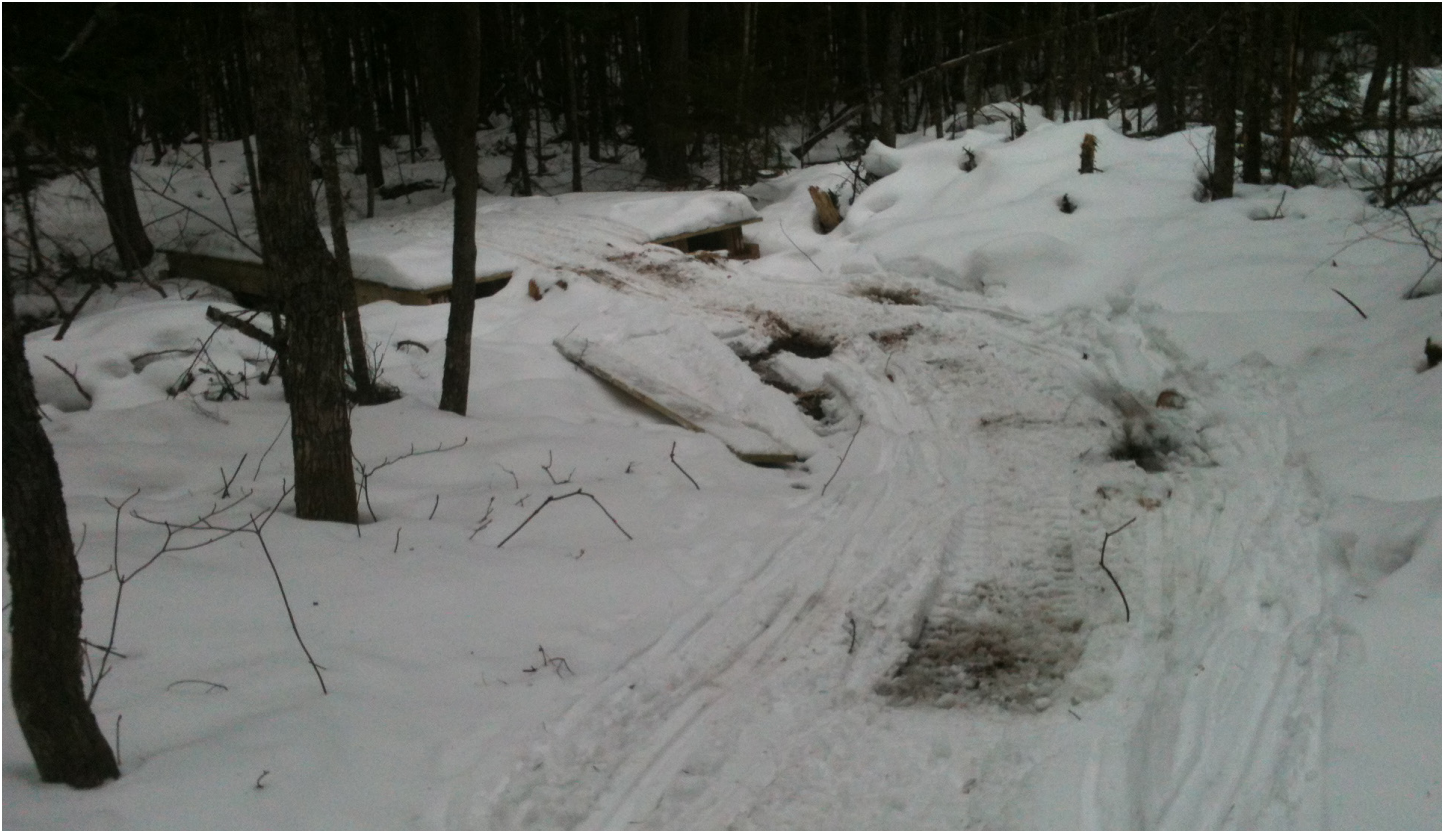
Incomplete bridge through what appears to be a class 1 wetland system. Snowmobiles are driving through the wetland, which has pooled water in places. No silt fences or mitigation was visible.

In two locations I encountered areas where the new community connector trail passes through a large wetland, likely a class 1 wetland system. In one wetland one section of bridge had been built, but clearly many more sections are needed. In another wetland no bridges had been built, but they are needed. In both sections snowmobiles have been using the trail.

In neither wetland did I see adequate bridges to protect the wetland, nor did I see silt fencing or any type of mitigation efforts. In both wetlands the fact that snowmobiles are driving through the wetland without bridges does not seem to “minimize adverse impacts.” It appears to us that this work violates the Wetlands Act. We respectfully request that your agencies kindly investigate this issue.

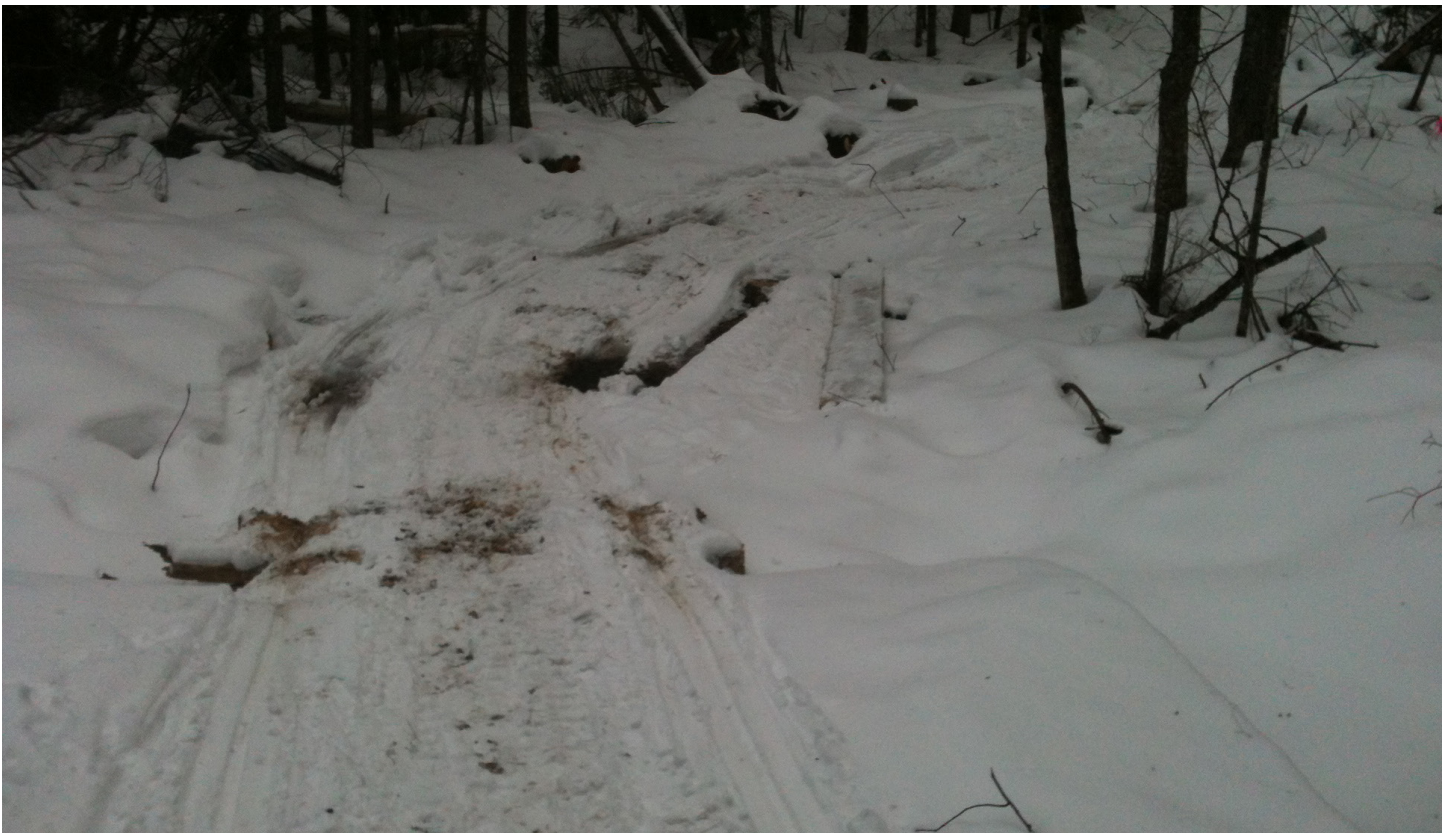
Another view of the incomplete bridge through what appears to be a class 1 wetland system. Notice debris. No silt fences or mitigation was visible.

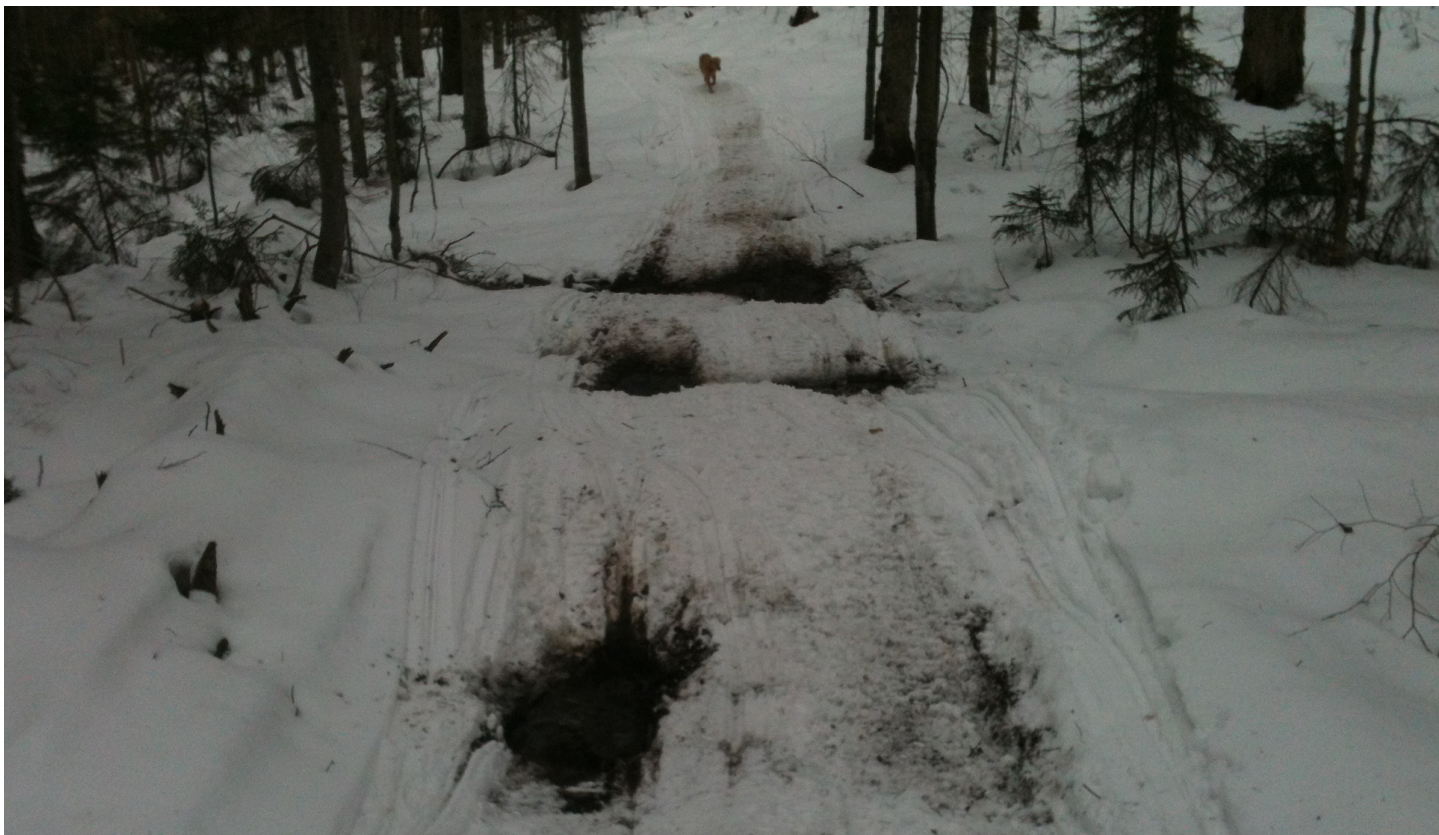
Part of trail where no bridge was built through a large wetland. Snowmobiles are driving through the wetland, which has pooled water in places.

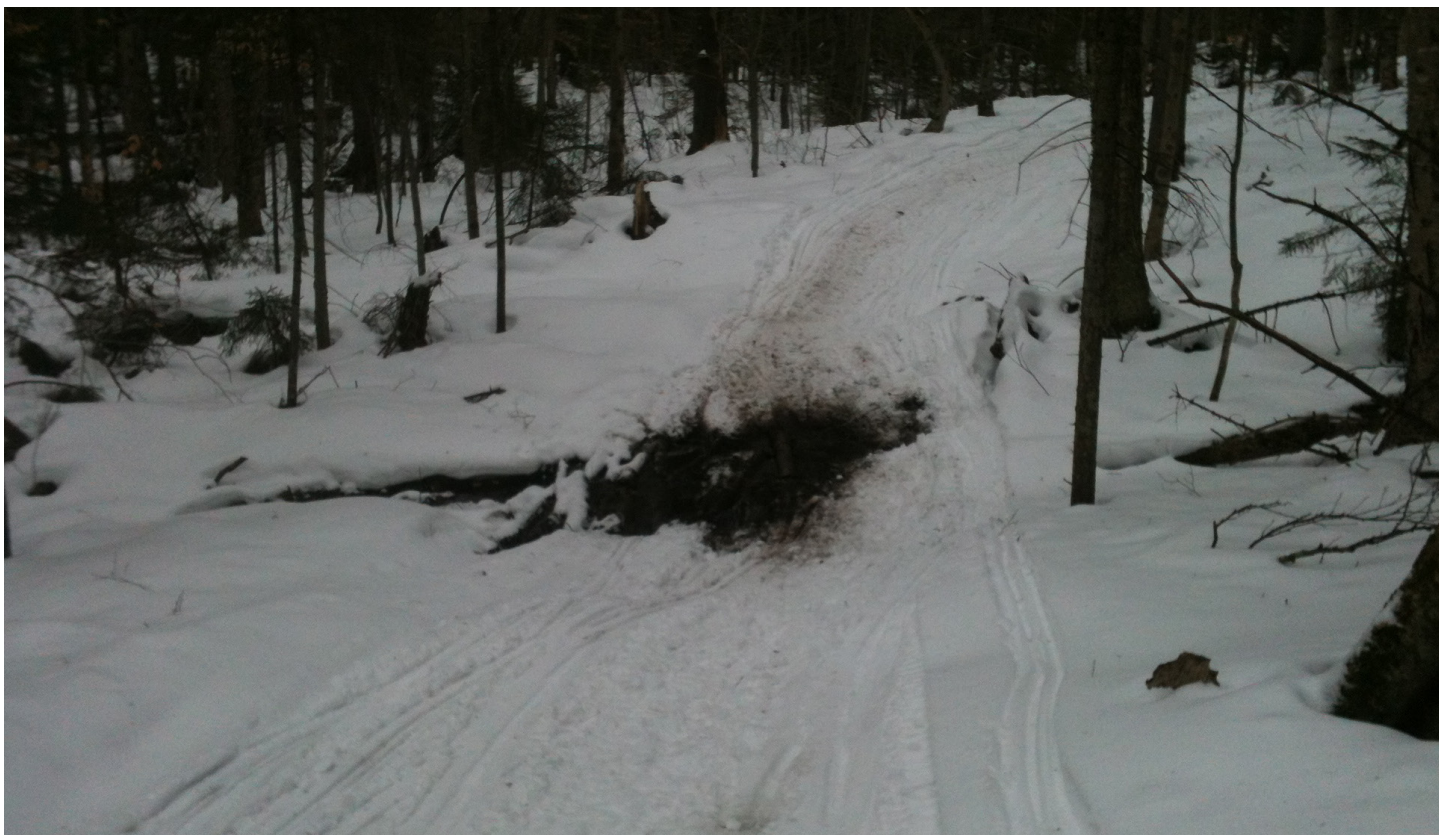
Section of trail built through a stream crossing with no bridge or protection for the stream. Snowmobiles are driving through the stream channel.

In several locations no bridges had been built for stream crossings. These may have been intermittent streams, but they may have also been perennial streams too. In each location snowmobiles were driving through the stream channel. It is our understanding that snowmobiles are not supposed to drive through stream channels and that snowmobiles should have bridges built over streams to protect them.

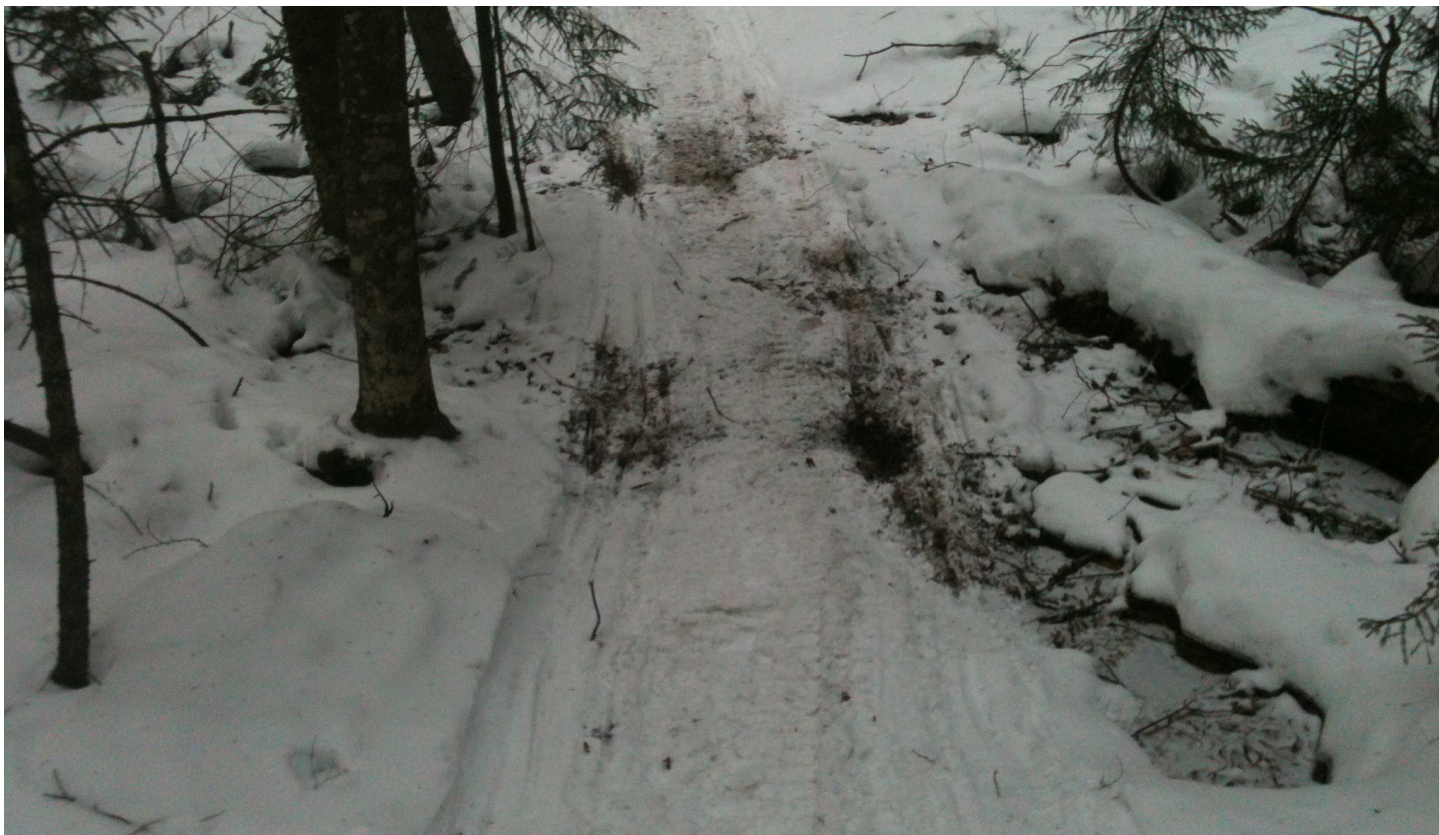
Another section of trail built through a wetland or stream crossing with no bridge or protection for the stream. Snowmobiles are driving through the stream channel.

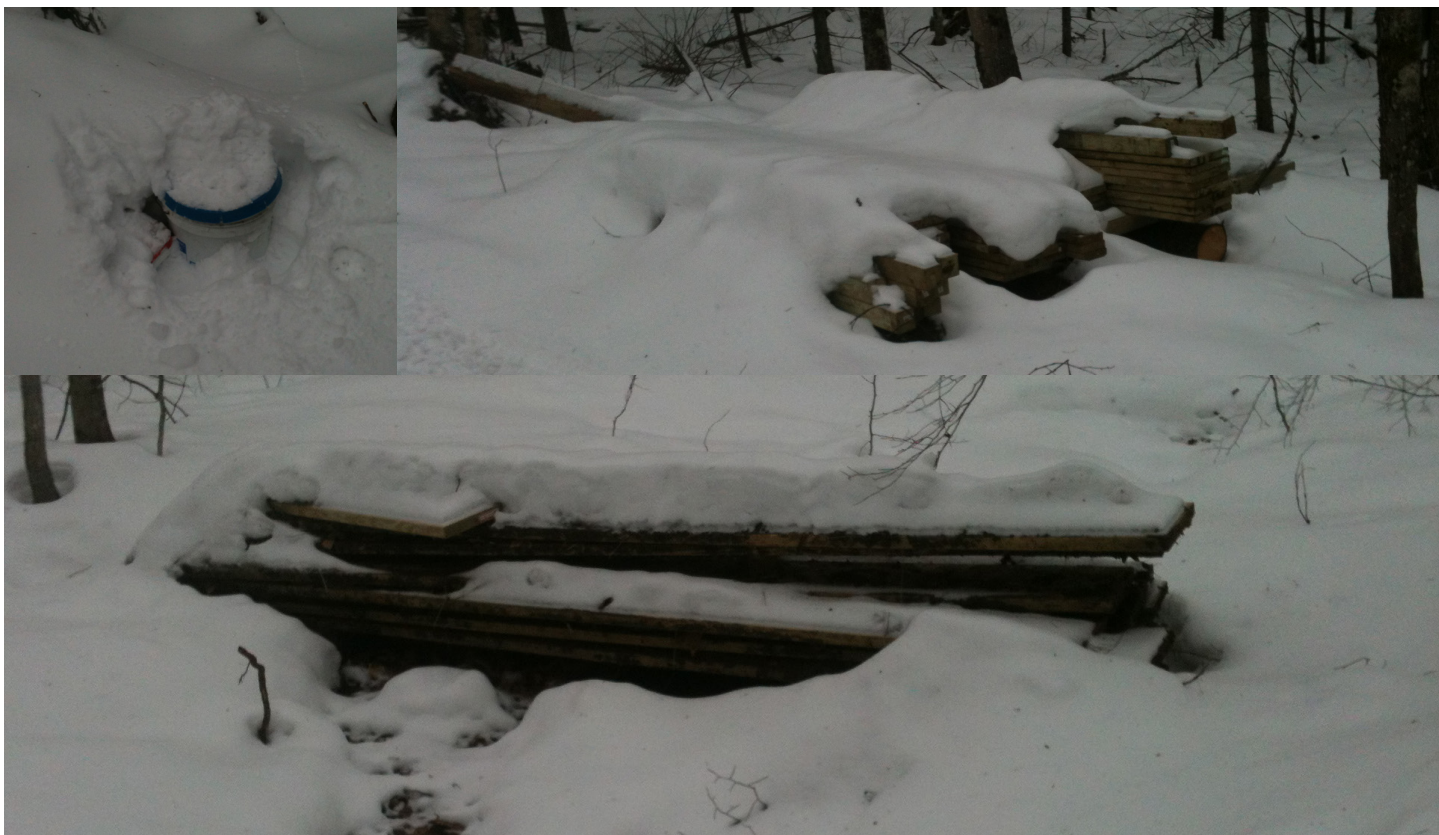
Construction materials and debris remaining along the trailside.

I also encountered several instances where various debris, from half buried buckets, to piles of wood, to hay bales, stood along the trail. Please inform us as to the protocol for removing debris from this trail.

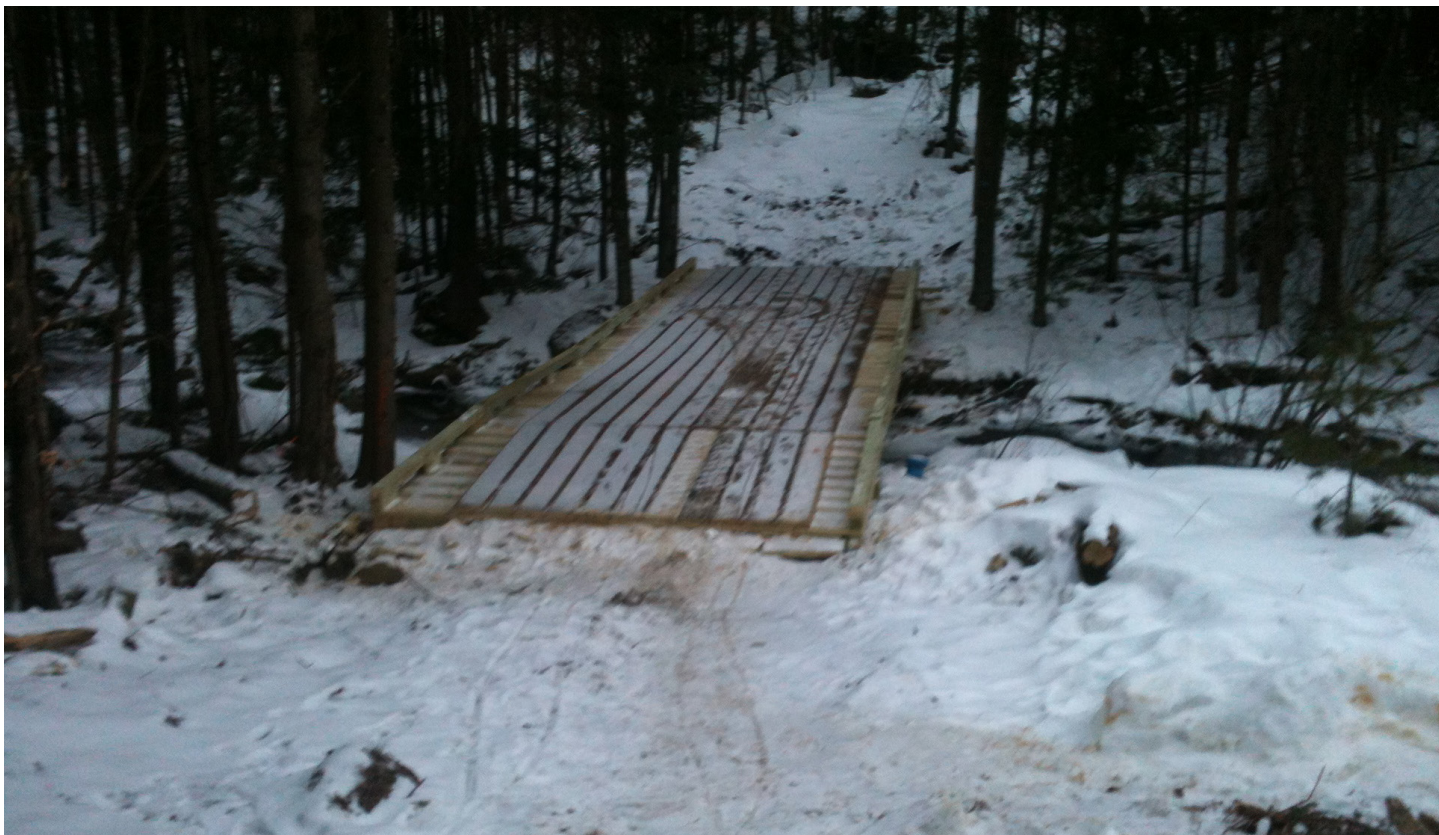
Extensive disturbed area, likely more than 1 acre, around the new bridge at the outlet of the Raquette Lake Reservoir. Lots of debris. No silt fences or mitigation was visible.

Also attached, see pictures of the new bridge over the outlet of the Raquette Lake Reservoir. It appeared that more than 1 acre total had been disturbed while this bridge was under construction. There were no signs of silt fencing or any type of stormwater pollution prevention or mitigation efforts.

Please also consider this letter a request under the Freedom of Information Act for all Stormwater Pollution Prevention Plan (SWPPs) requested and approved for this trail. It appears to us that this work necessitated a SWPP in certain areas, or perhaps its entire length, but the lack of standard measures deployed in a SWPP project

raises concerns that no SWPP was obtained. We respectfully request that your agencies kindly investigate this issue.

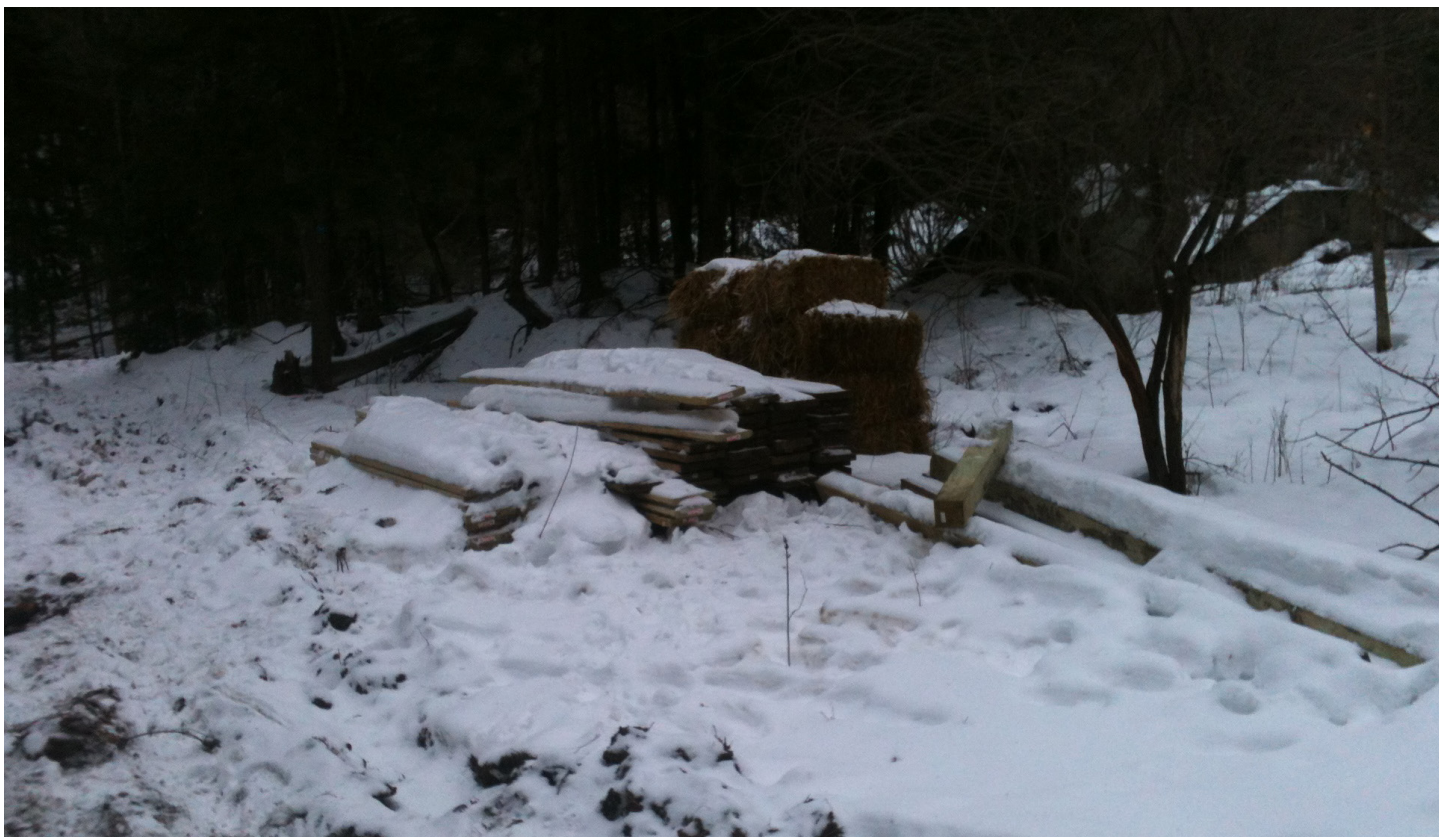
Another view of the extensive disturbed area, likely more than 1 acre, around the new bridge at the outlet of the Raquette Lake Reservoir. Lots of debris. No silt fences or mitigation was visible.
