**RE: Reconstruction of the Bear Creek Road in Black River Wild Forest work is creating a highway through the Forest Preserve**

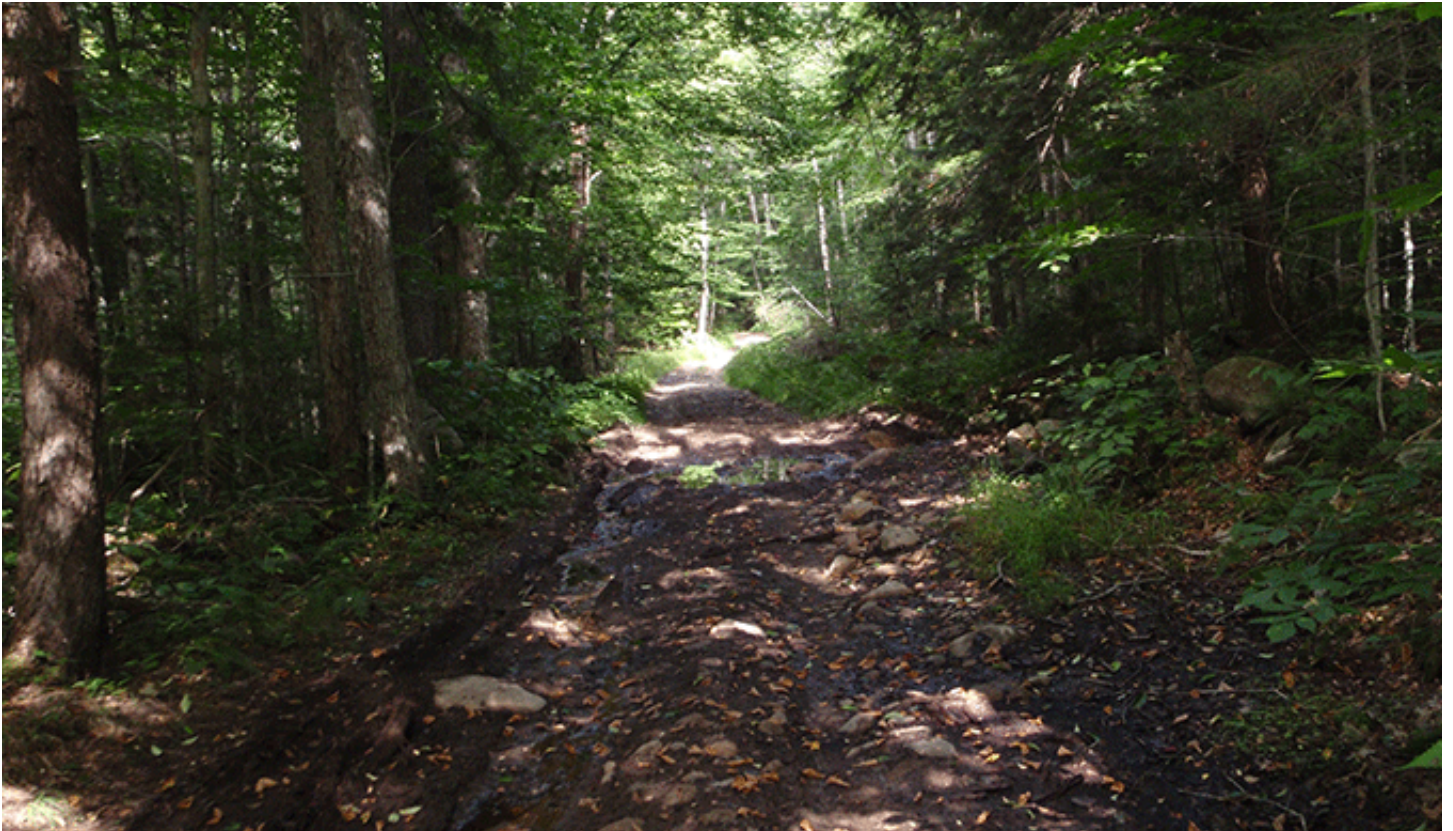
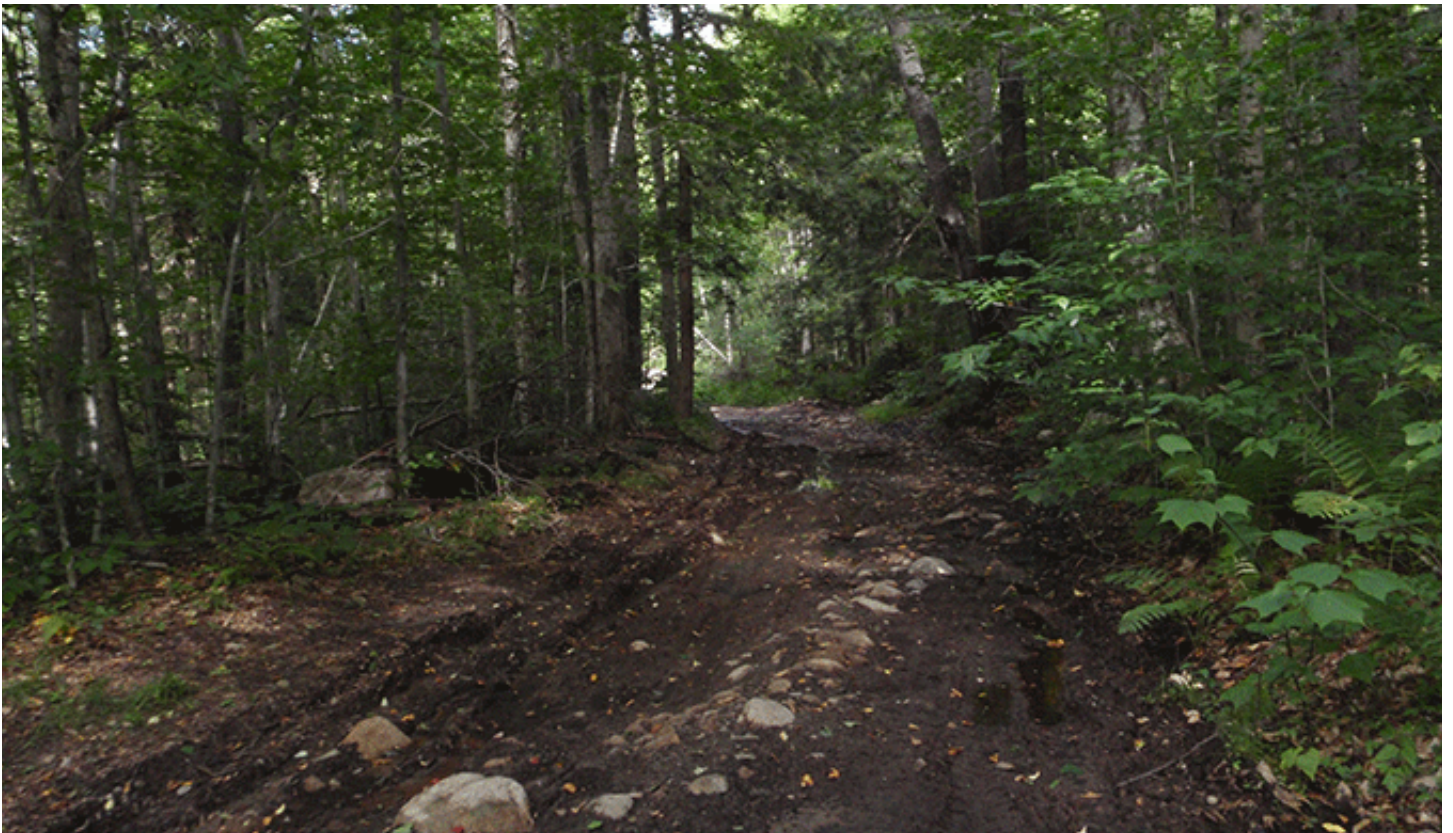
*Two pictures of the current condition of the Bear Creek Road in the Black River Wild Forest area. Though heavily rutted by legal and illegal motor vehicle use, especially by ATVs, the road corridor is narrow in most places and is 9-11 feet in width.*

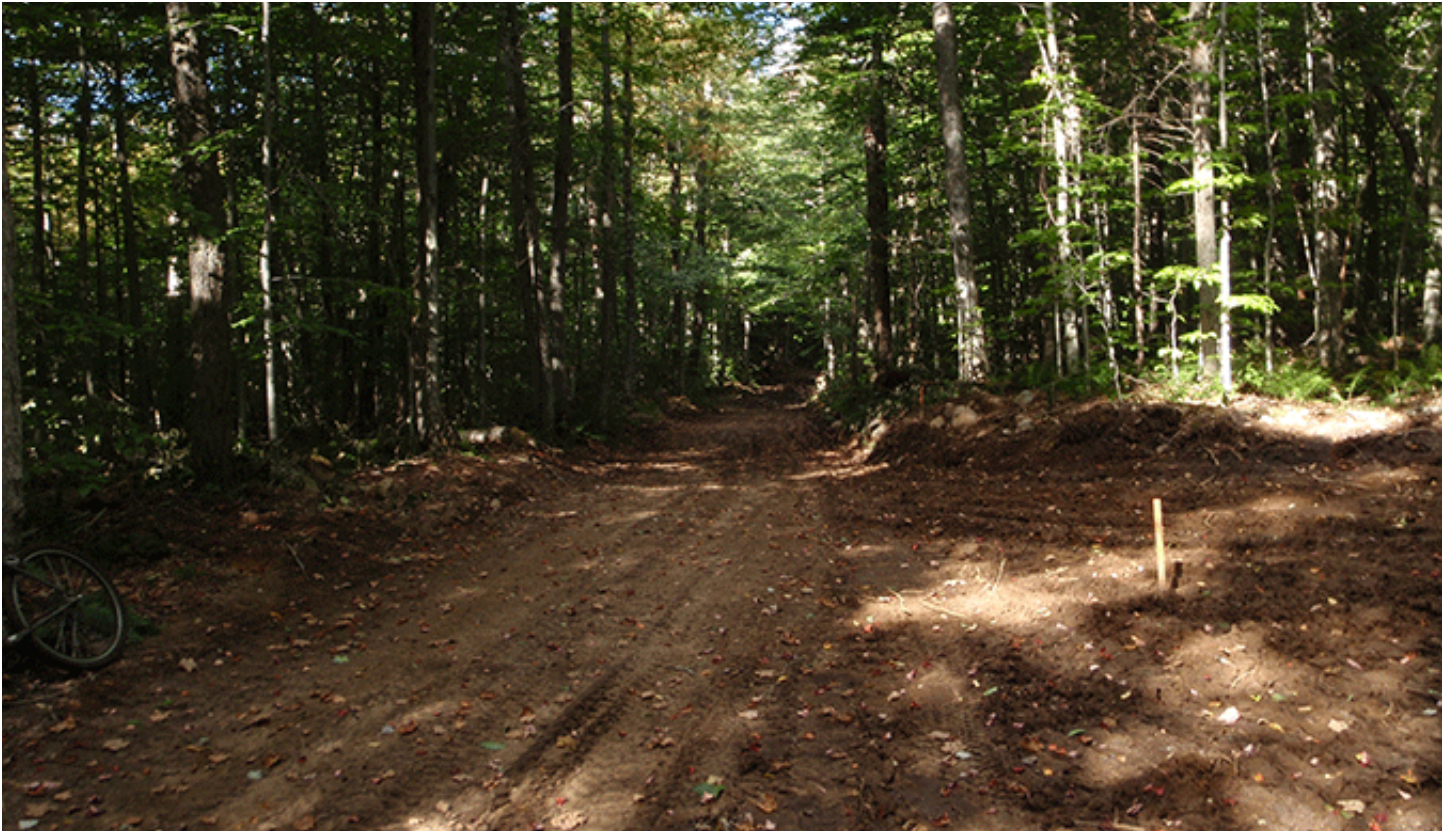
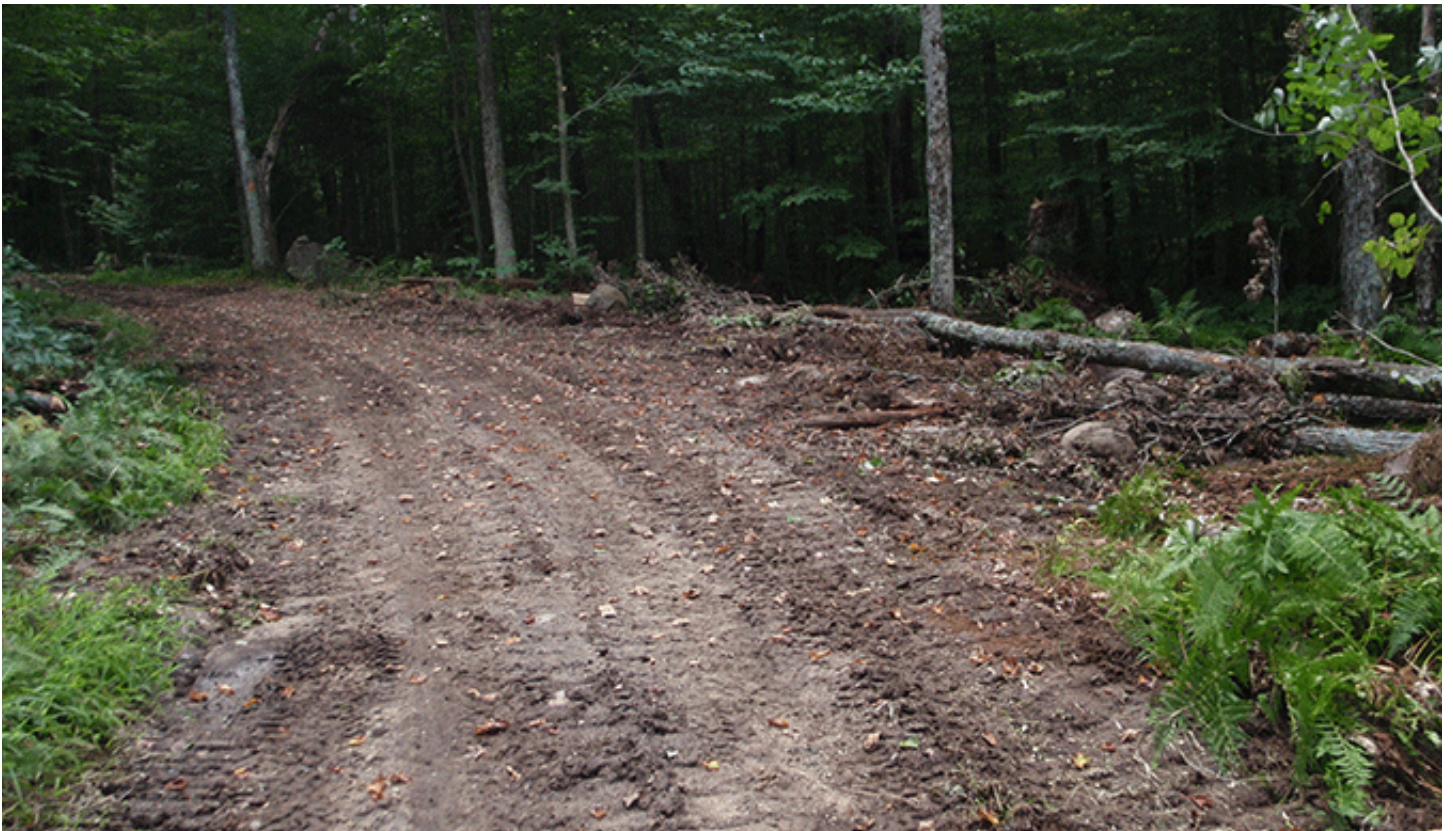
**Bear Creek Road Surface Width:** The reconstruction of the Bear Creek Road has resulted in significant widening of this road. In many places the existing road corridor was 8-10 feet in width. The new road is regularly 12-14 feet wide and in many places in upwards of 20 feet. Pictures on page 4 show the current state of the Bear Creek Road and pages 5-6 show new clearing work by the DEC, which in many places has widened the road by 50%.

*The pictures above show areas of the Bear Creek Road where DEC has undertaken work to clear the roadside and expand the width of the road. In many places the width of the Bear Creek Road corridor has been expanded 50% or more to consistent widths of 12-15 feet with many areas 20 feet wide.*

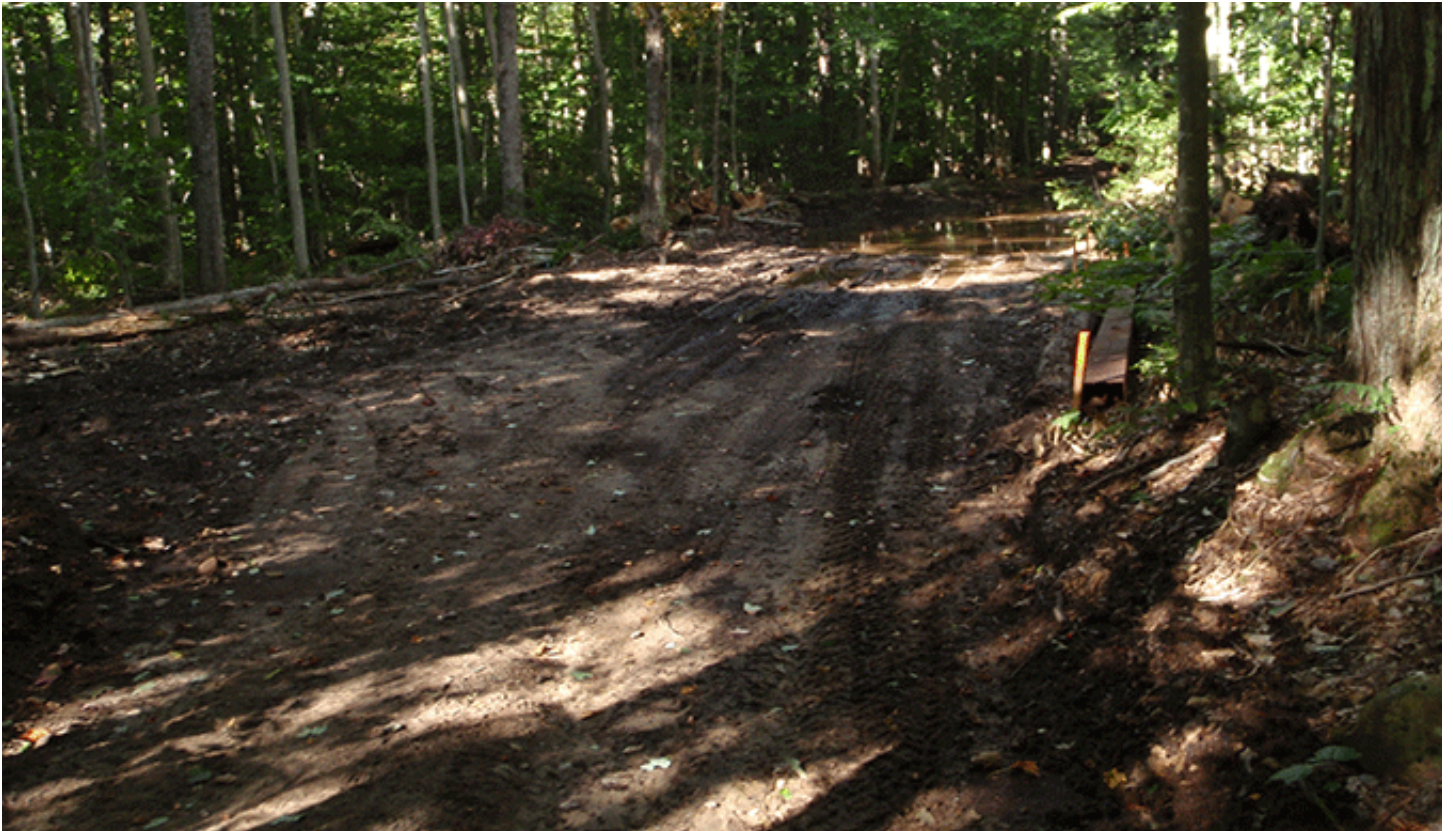
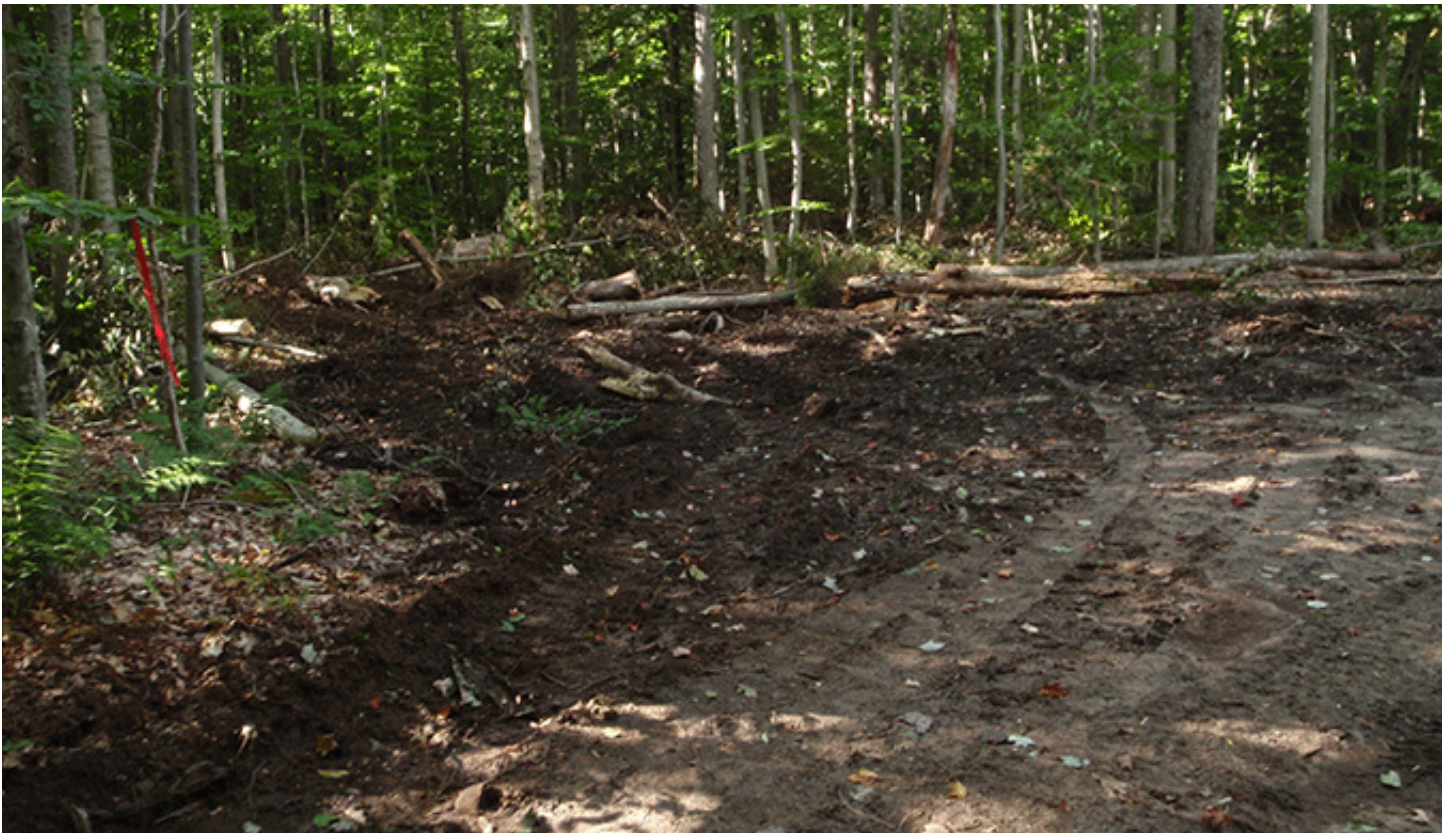
*Two more pictures that show areas of the Bear Creek Road where DEC has undertaken work to clear the roadside and expand the width of the road. In many places the width of the Bear Creek Road corridor has been expanded 50% or more.*

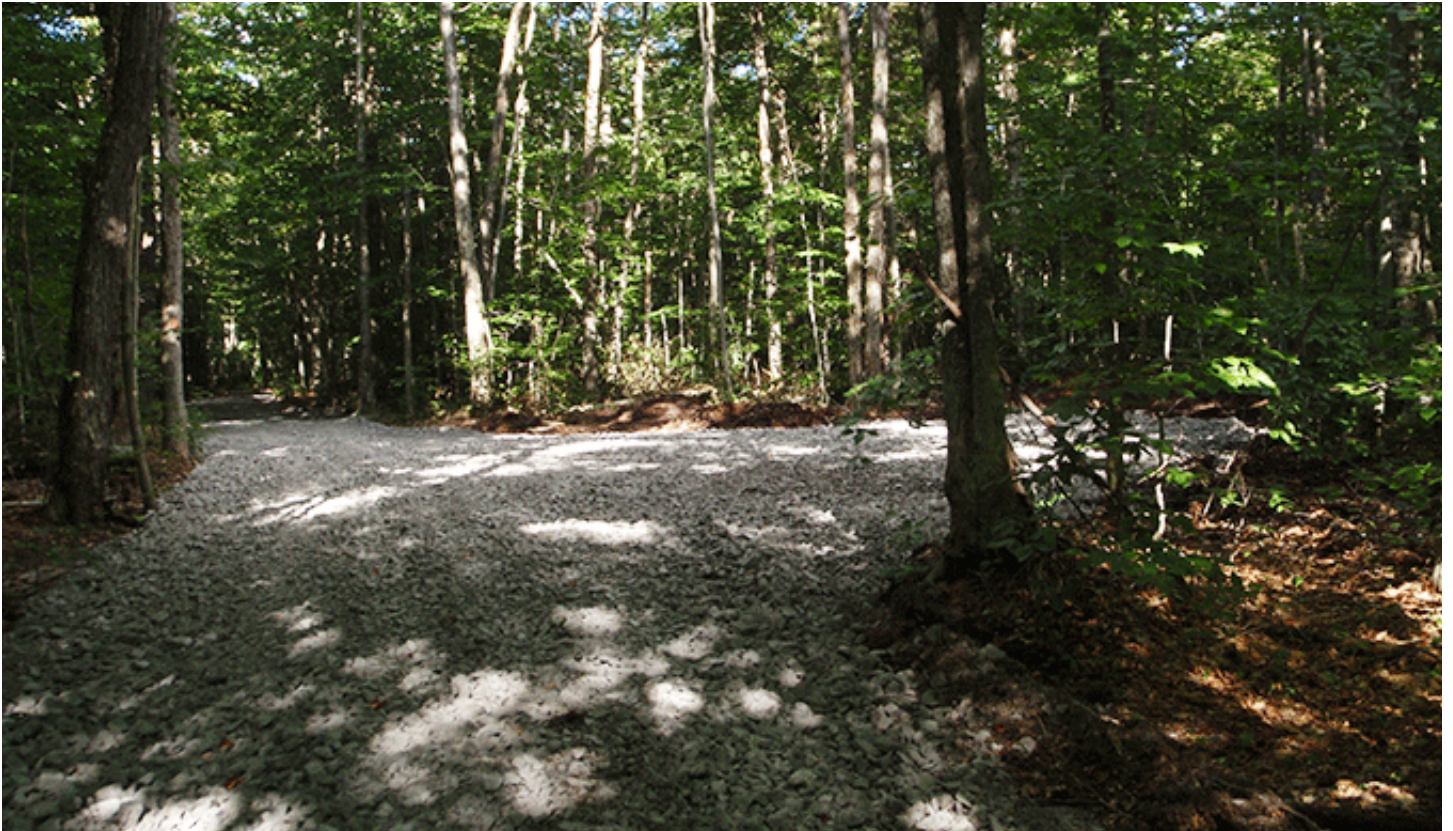
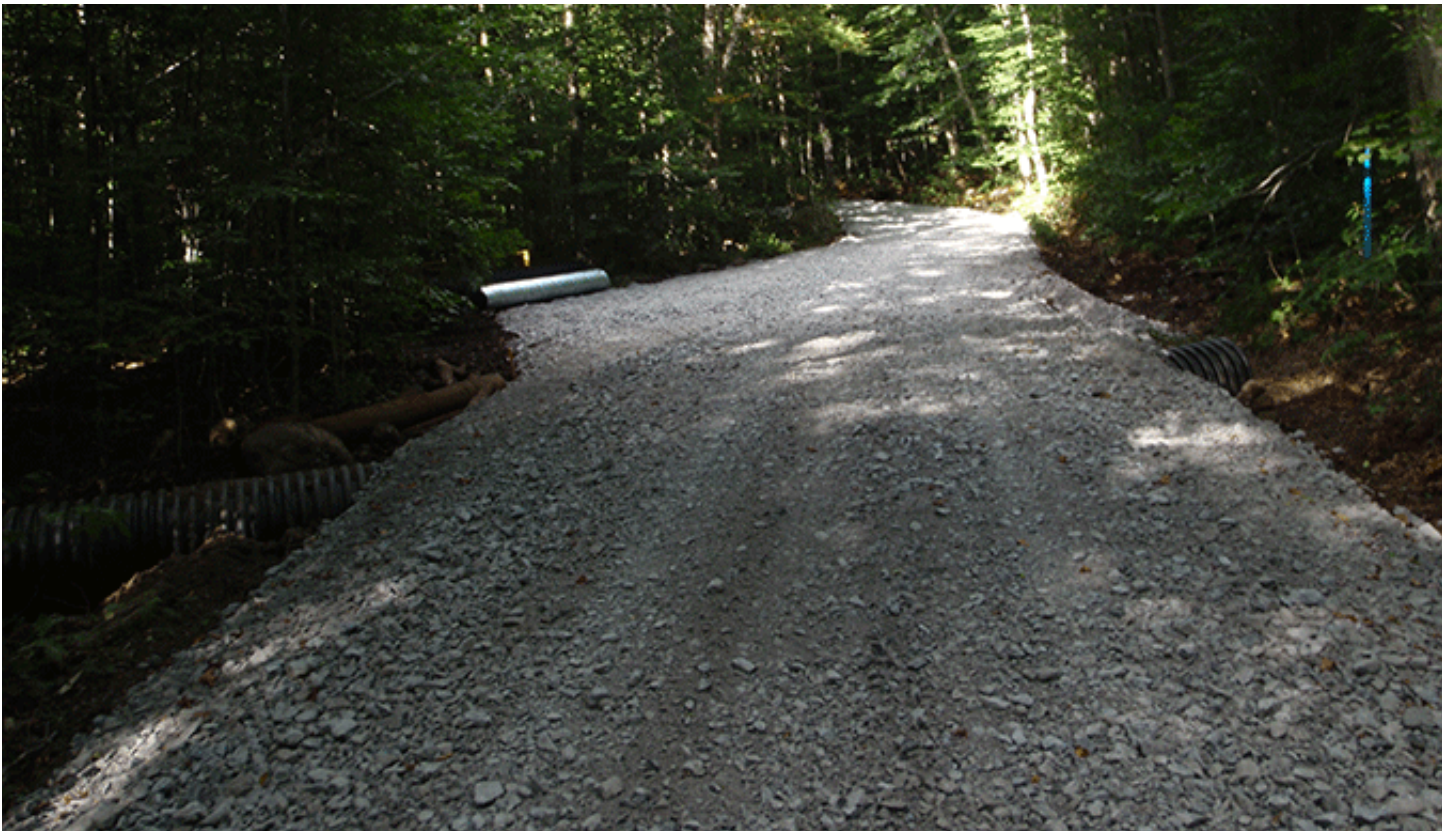
**Excessive Gravel Surfacing:** In addition to expanding the width of the Bear Creek Road, the DEC has placed many tons of gravel on the road surface. The changes to the Wild Forest “character,” “setting” and “atmosphere” through this hardening of the road surface and deployment of many tons of gravel is stunning. See pictures on page 7.

*Two areas of the Bear Creek Road that have been reconstructed. The road has been widened with a deep gravel surface. Two small pull-offs are pictured on these stretches. Small and large pull-offs are a regular feature on this road.*

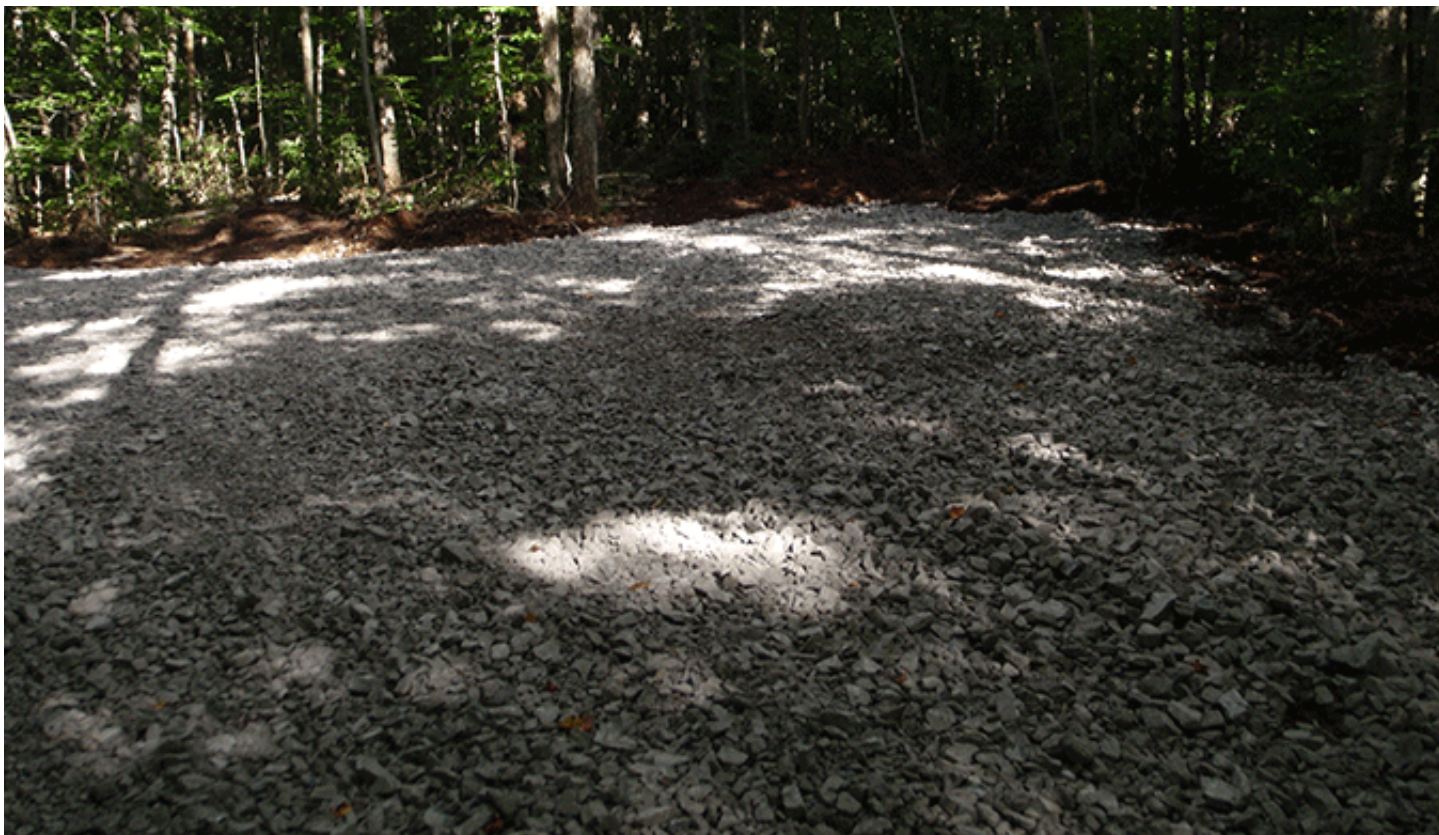
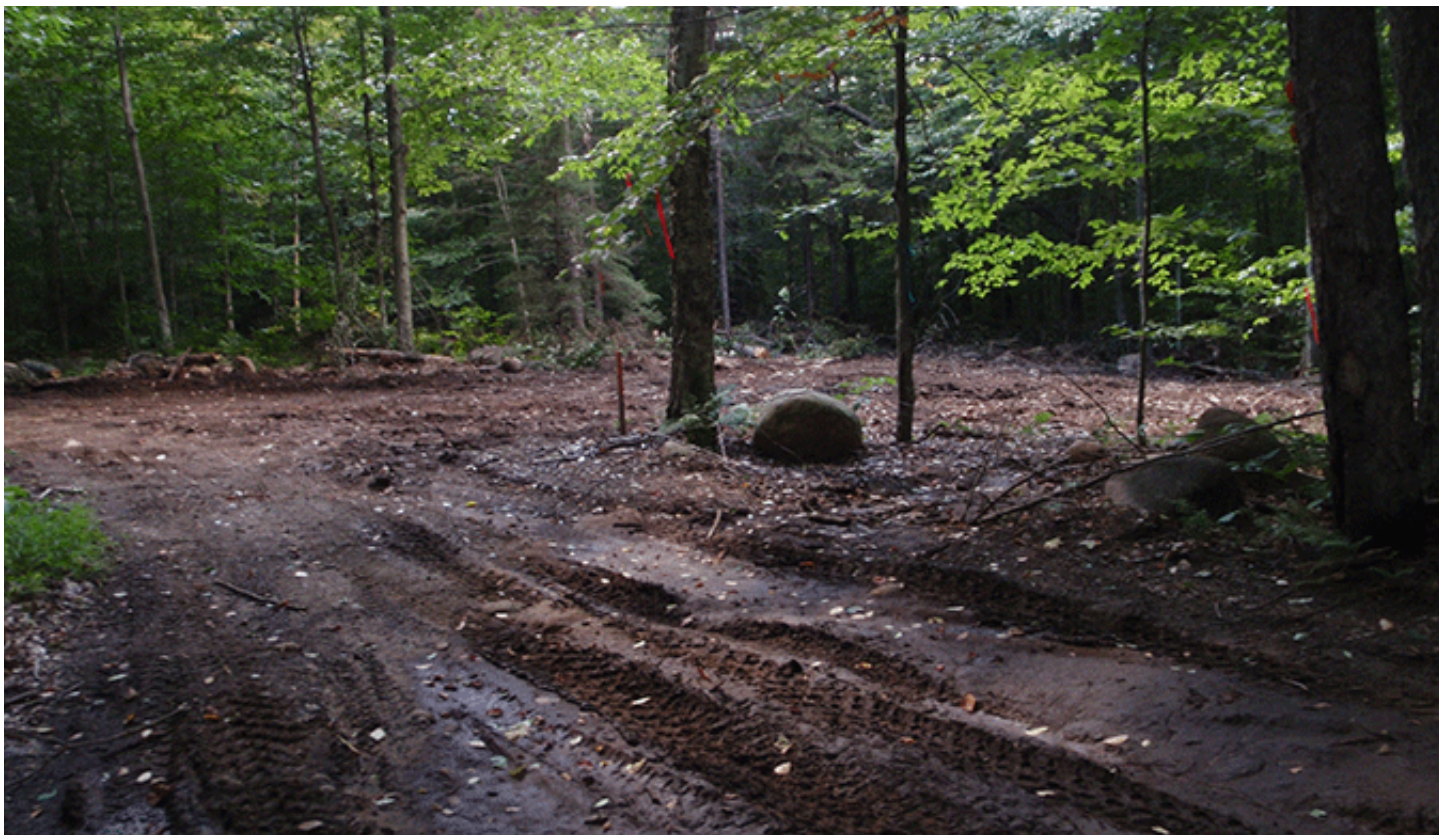
**Excessive Clearing for Road “Pull-offs”:** Another feature that sets the Bear Creek Road apart from other Wild Forest area roads is the prominent use of “pull-offs.” These areas are cleared to the size of a basketball court and are hardened and covered with gravel. Pull-offs on roads are not common features in other Wild Forest areas, but have been built, or cleared, in a dozen areas on the portion of the Bear Creek Road where work has been completed. The use of these pull-offs seems excessive and out of character with a Wild Forest area. See pictures on pages 8-9.

*Pictures above show pull-offs along the Bear Creek Road. The top picture shows a pull-off that has been cleared, excavated and a gravel surface applied. The lower picture shows a pull-off that has been recently cleared. These are large clearings.*

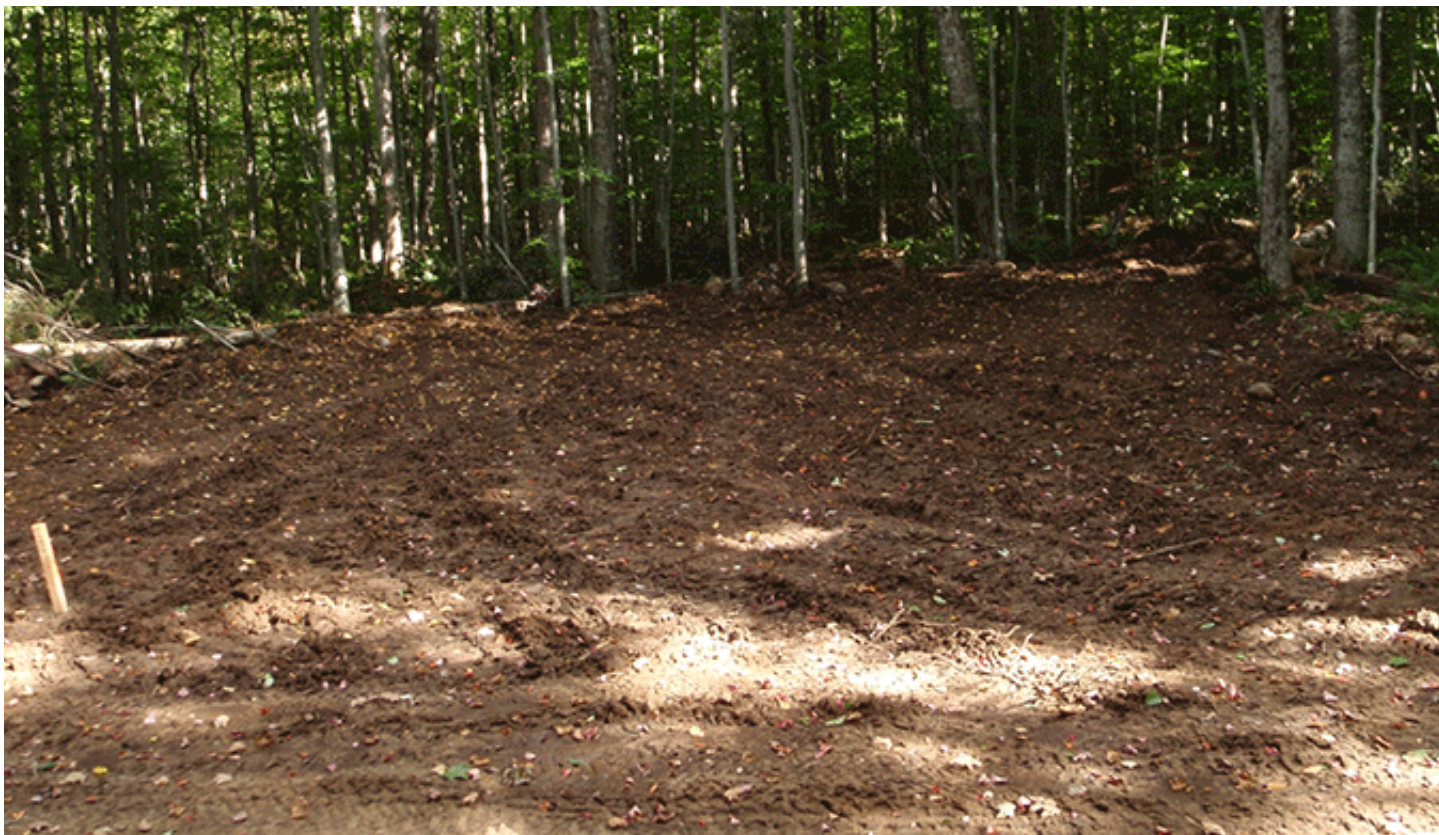
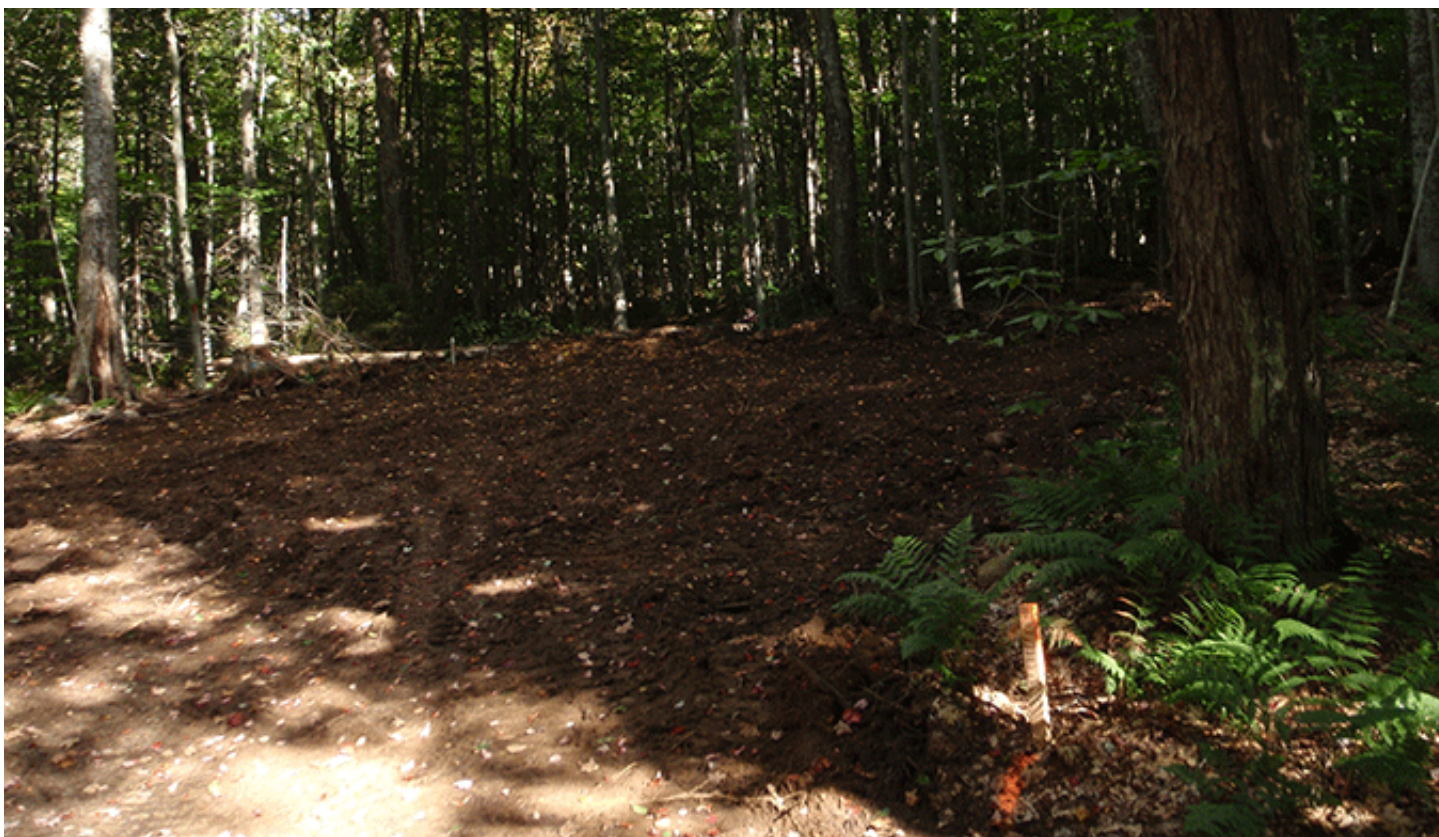
*Two more pictures of cleared areas along side the Bear Creek Road.*

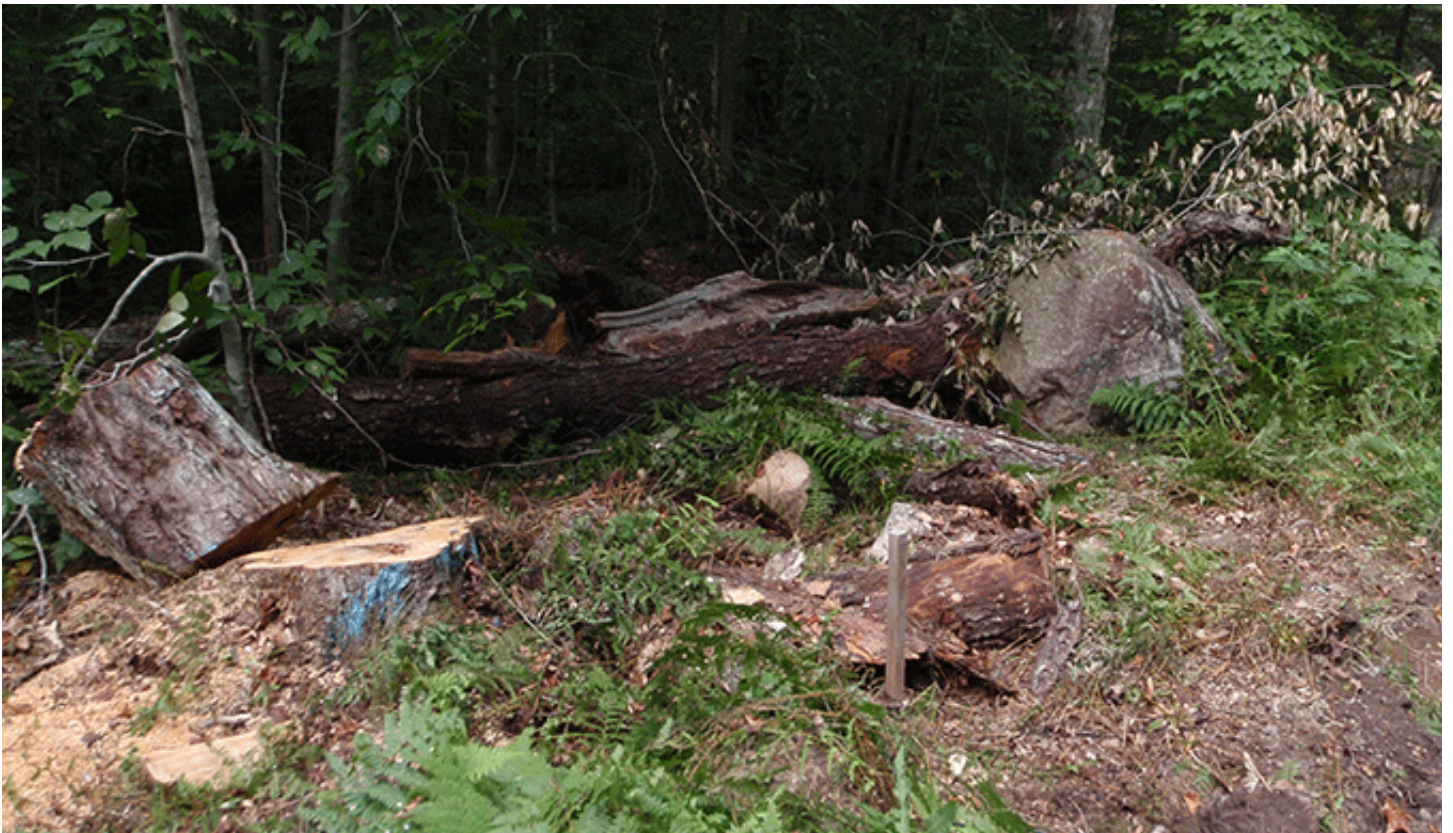
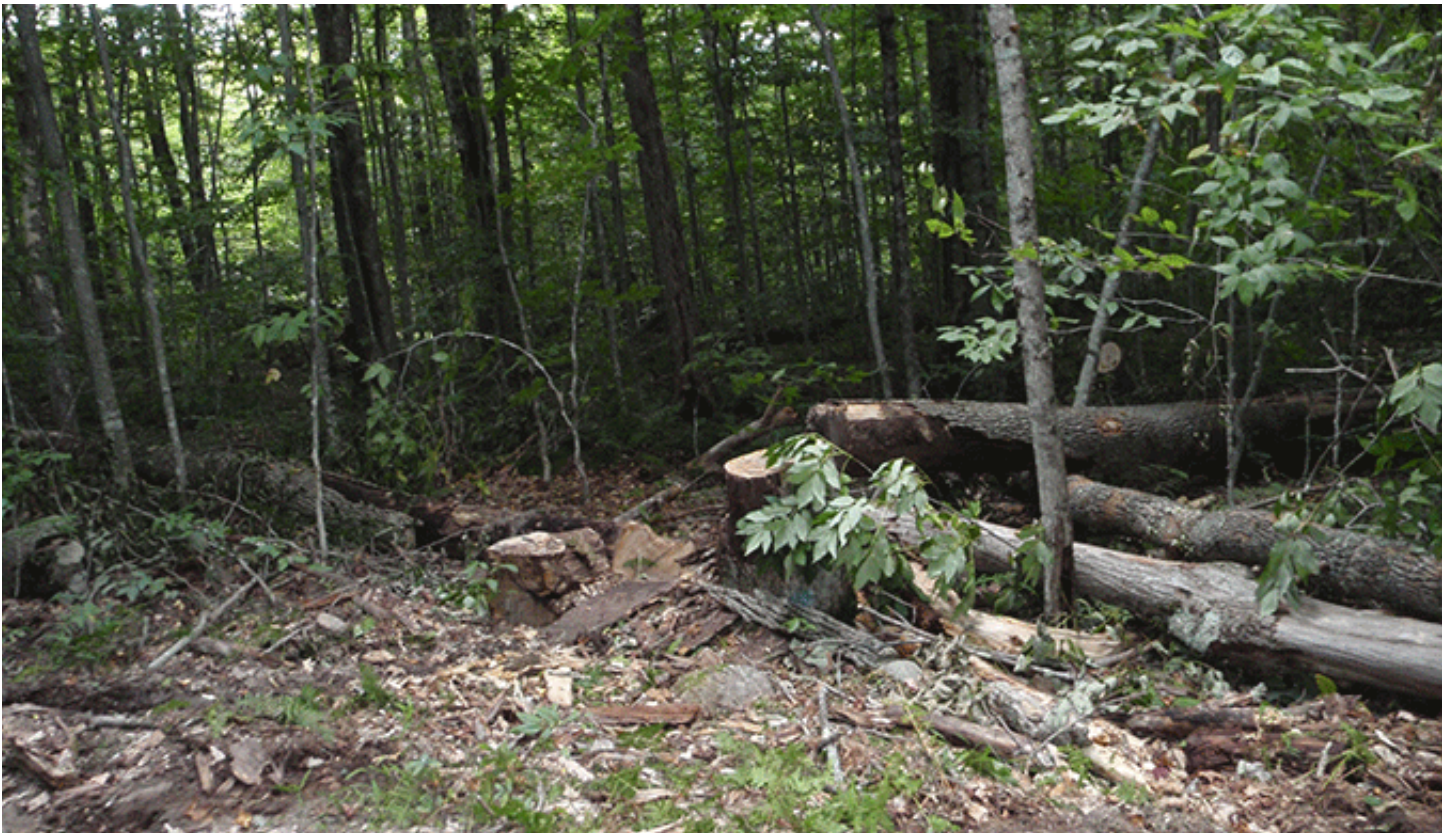
**Many Mature Trees Taken Down:** Another feature of the Bear Creek Road reconstruction project is that number of mature trees that have been removed. The widening and excavation of the road has required that many trees were cut down. The clearing of the many large pull-offs also required many trees to be taken down. See pictures on page 10.

*Pictures above show some of the extensive tree cutting along the Bear Creek Road as part of a major reconstruction of this road.*

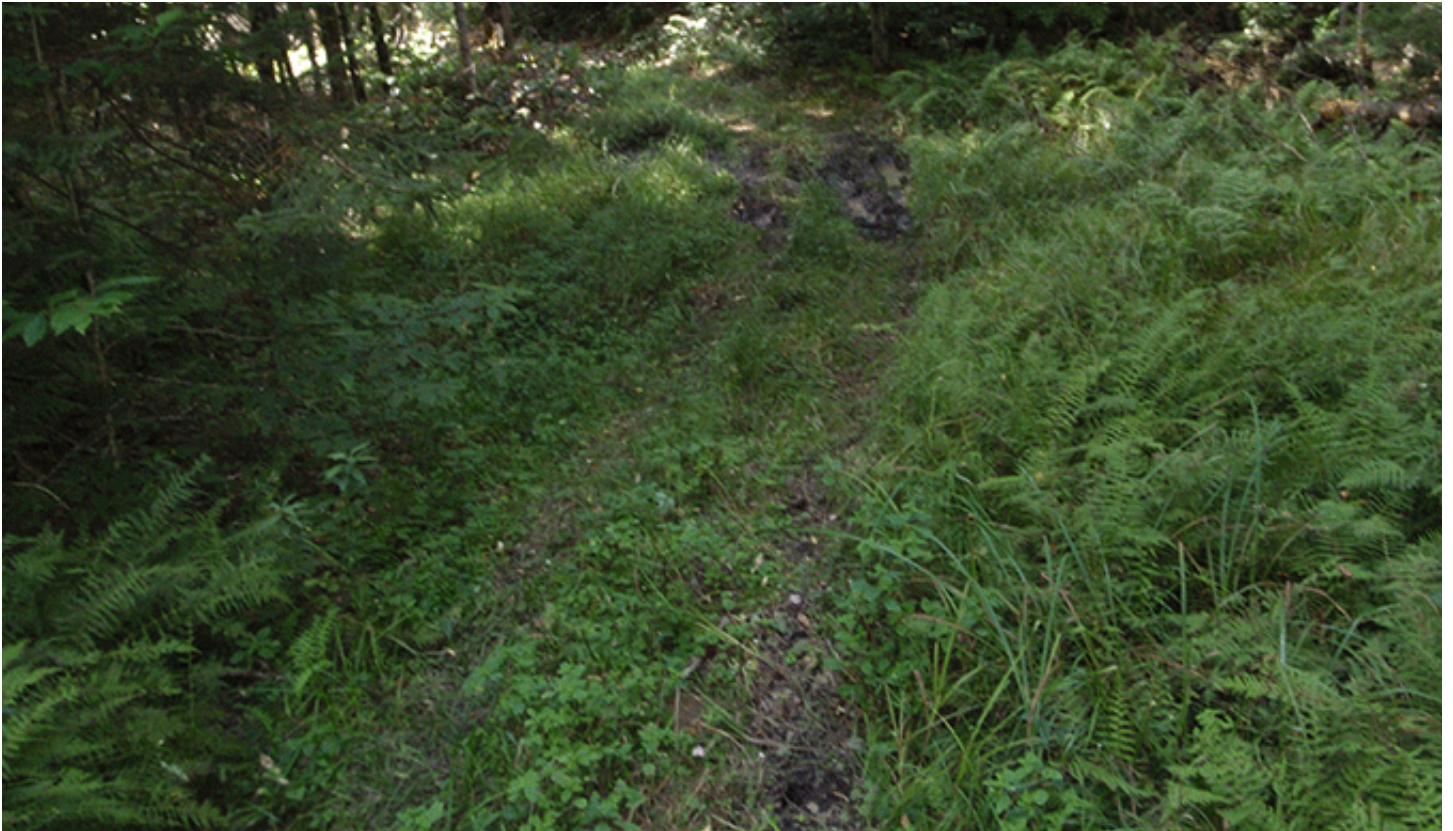
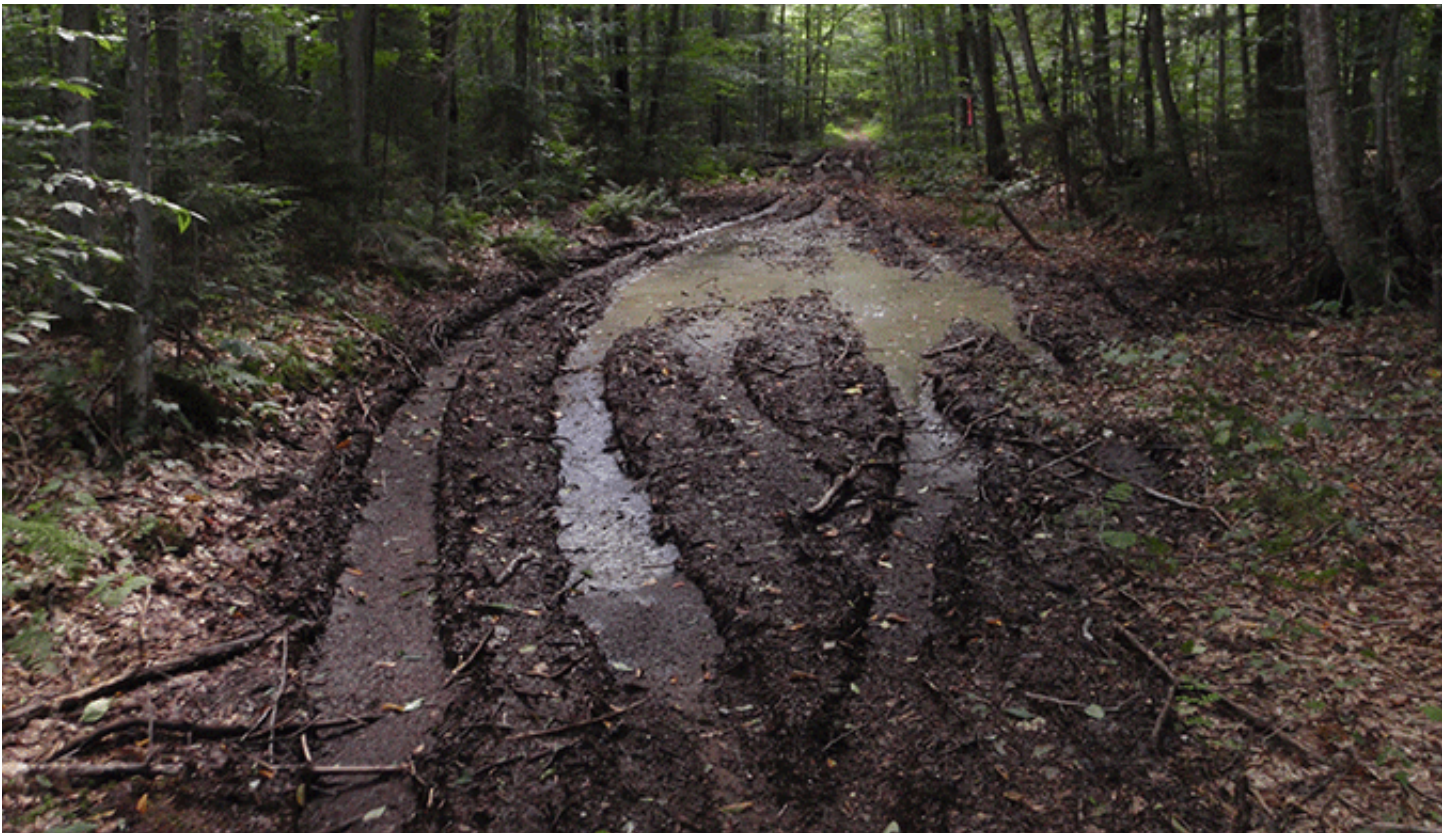
**Additional Issues:** The Bear Creek Road is noteworthy for the failure to control illegal ATV trespass. From Bear Creek Road illegal ATV riding has caused extensive damage around Gull Lake, Chubb Pond, the west shore area of Woodhull Lake and Sand Lake. This road is a major point of entry to and extensive area throughout the Black River Wild Forest. See pictures on page 11.

*These pictures show ATV damage to trails in the Black River Wild Forest area accessed from the Bear Creek Road. The top picture is an unnamed trail where ATVs have bushwhacked. The bottom picture is some of the extensive damage on the Chubb Pond trail.*
