Shaker Mountain Wild Forest and Northville Boat Launch

Unit Management Plan Environmental Impact Statement

Examples of Erosion on Seventh Lake Mountain Trail in 2016

The pictures above were taken in the summer of 2016 on the Seventh Lake Mountain Trail, a newly constructed class II community connector snowmobile trail located in the Moose River Plains Wild Forest area, part of the Adirondack Forest Preserve. These pictures show visible trail erosion.

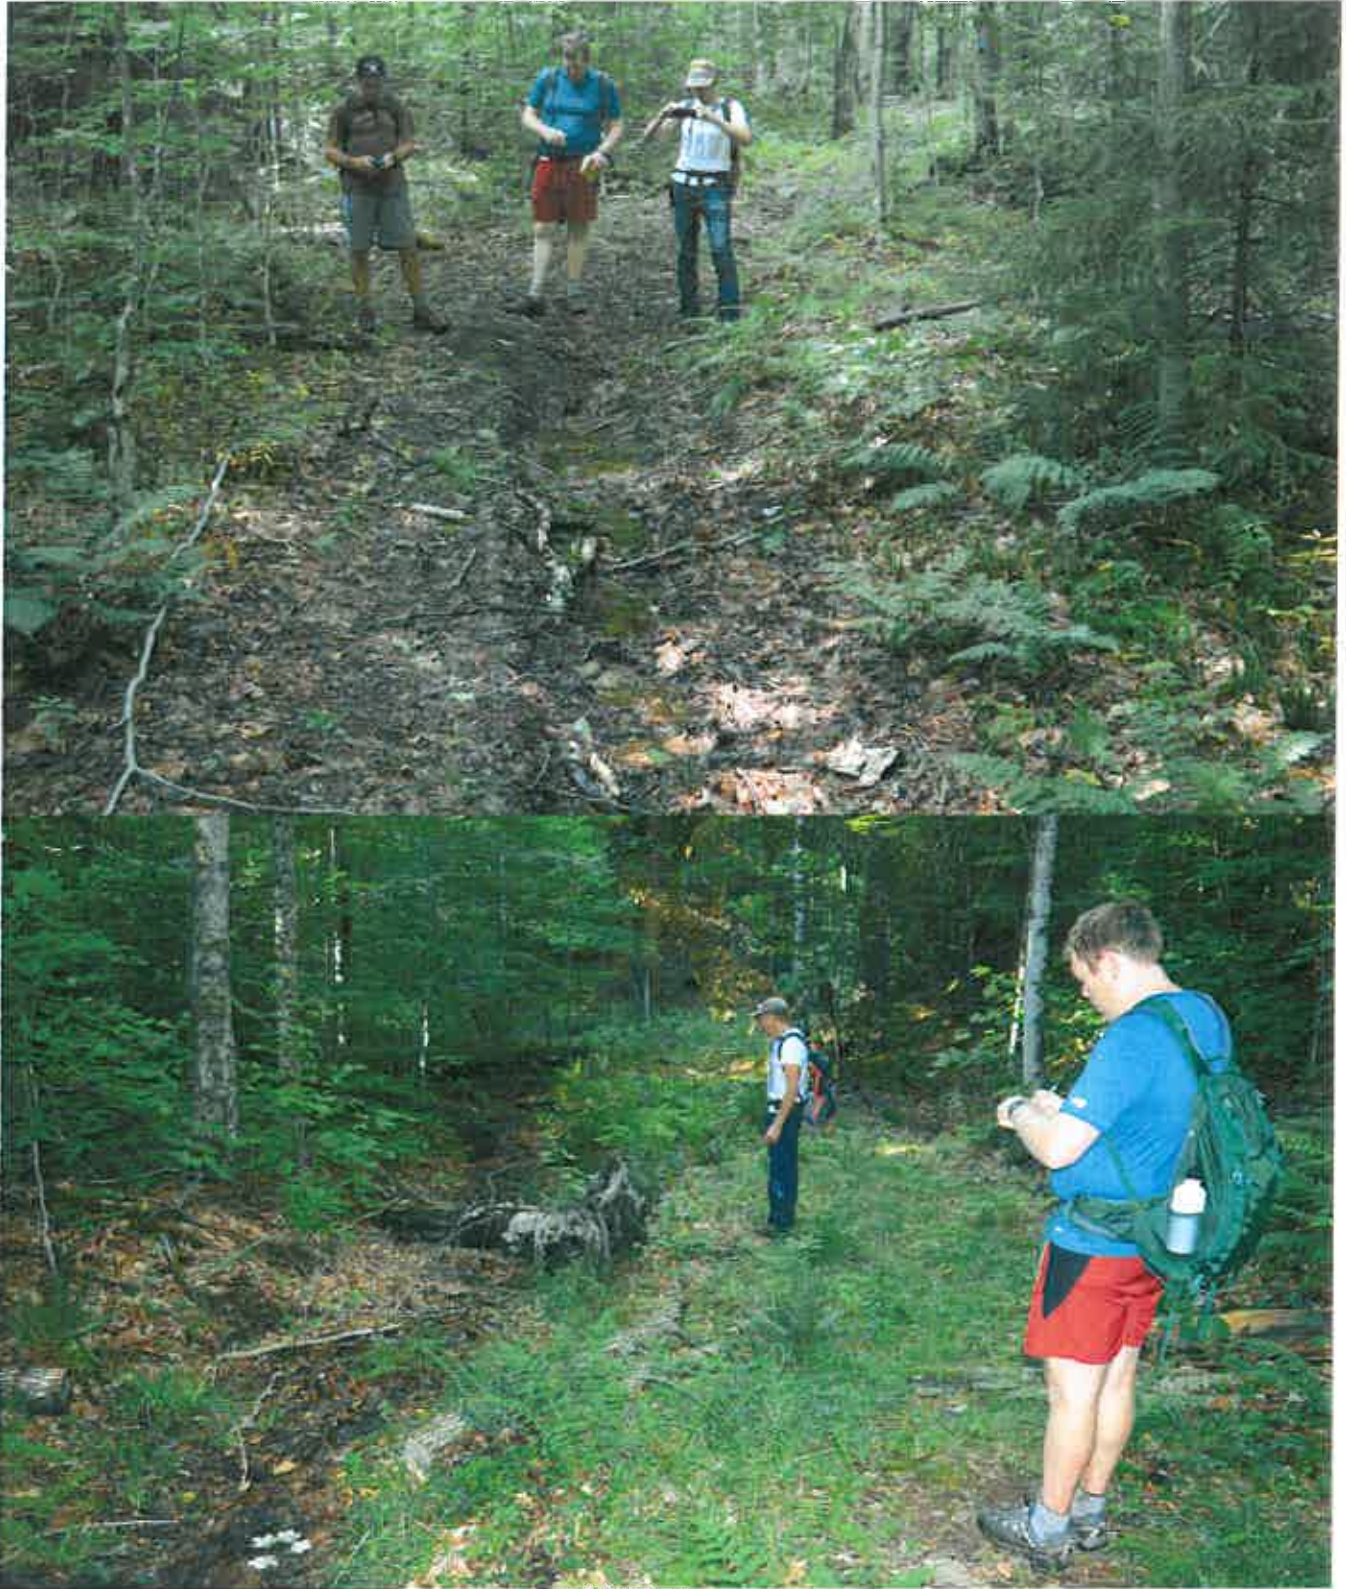
Examples of Erosion on Seventh Lake Mountain Trail in 2016

The pictures above were taken in the summer of 2016 on the Seventh Lake Mountain Trail, a newly constructed class II community connector snowmobile trail located in the Moose River Plains Wild Forest area, part of the Adirondack Forest Preserve. These pictures show visible trail erosion.

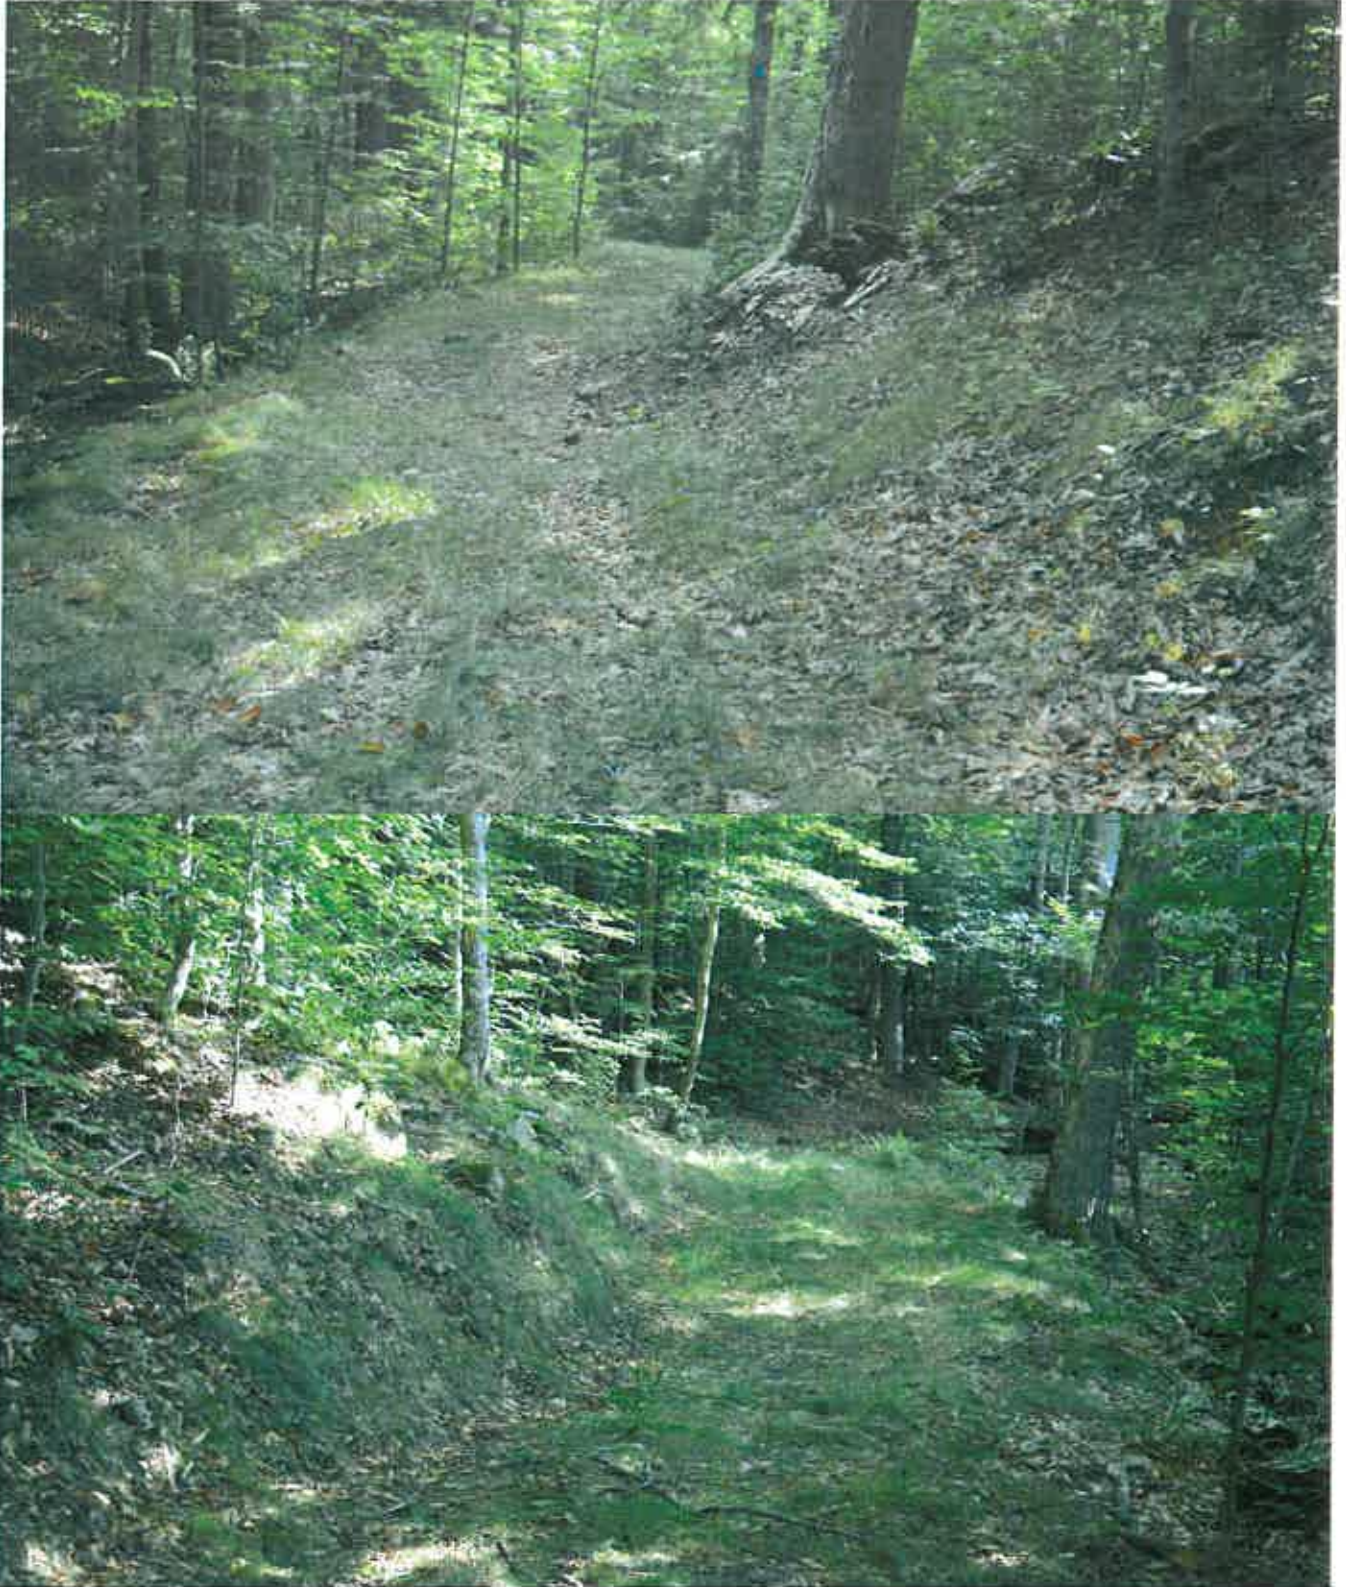
Examples of Large and Highly Visible Manmade Bench Cuts on Seventh Lake Mountain Trail in 2016

The pictures above were taken in the summer of 2016 on the Seventh Lake Mountain Trail, a newly constructed class II community connector snowmobile trail located in the Moose River Plains Wild Forest area, part of the Adirondack Forest Preserve. These pictures show visible man-made bench cuts widely used on this trail.

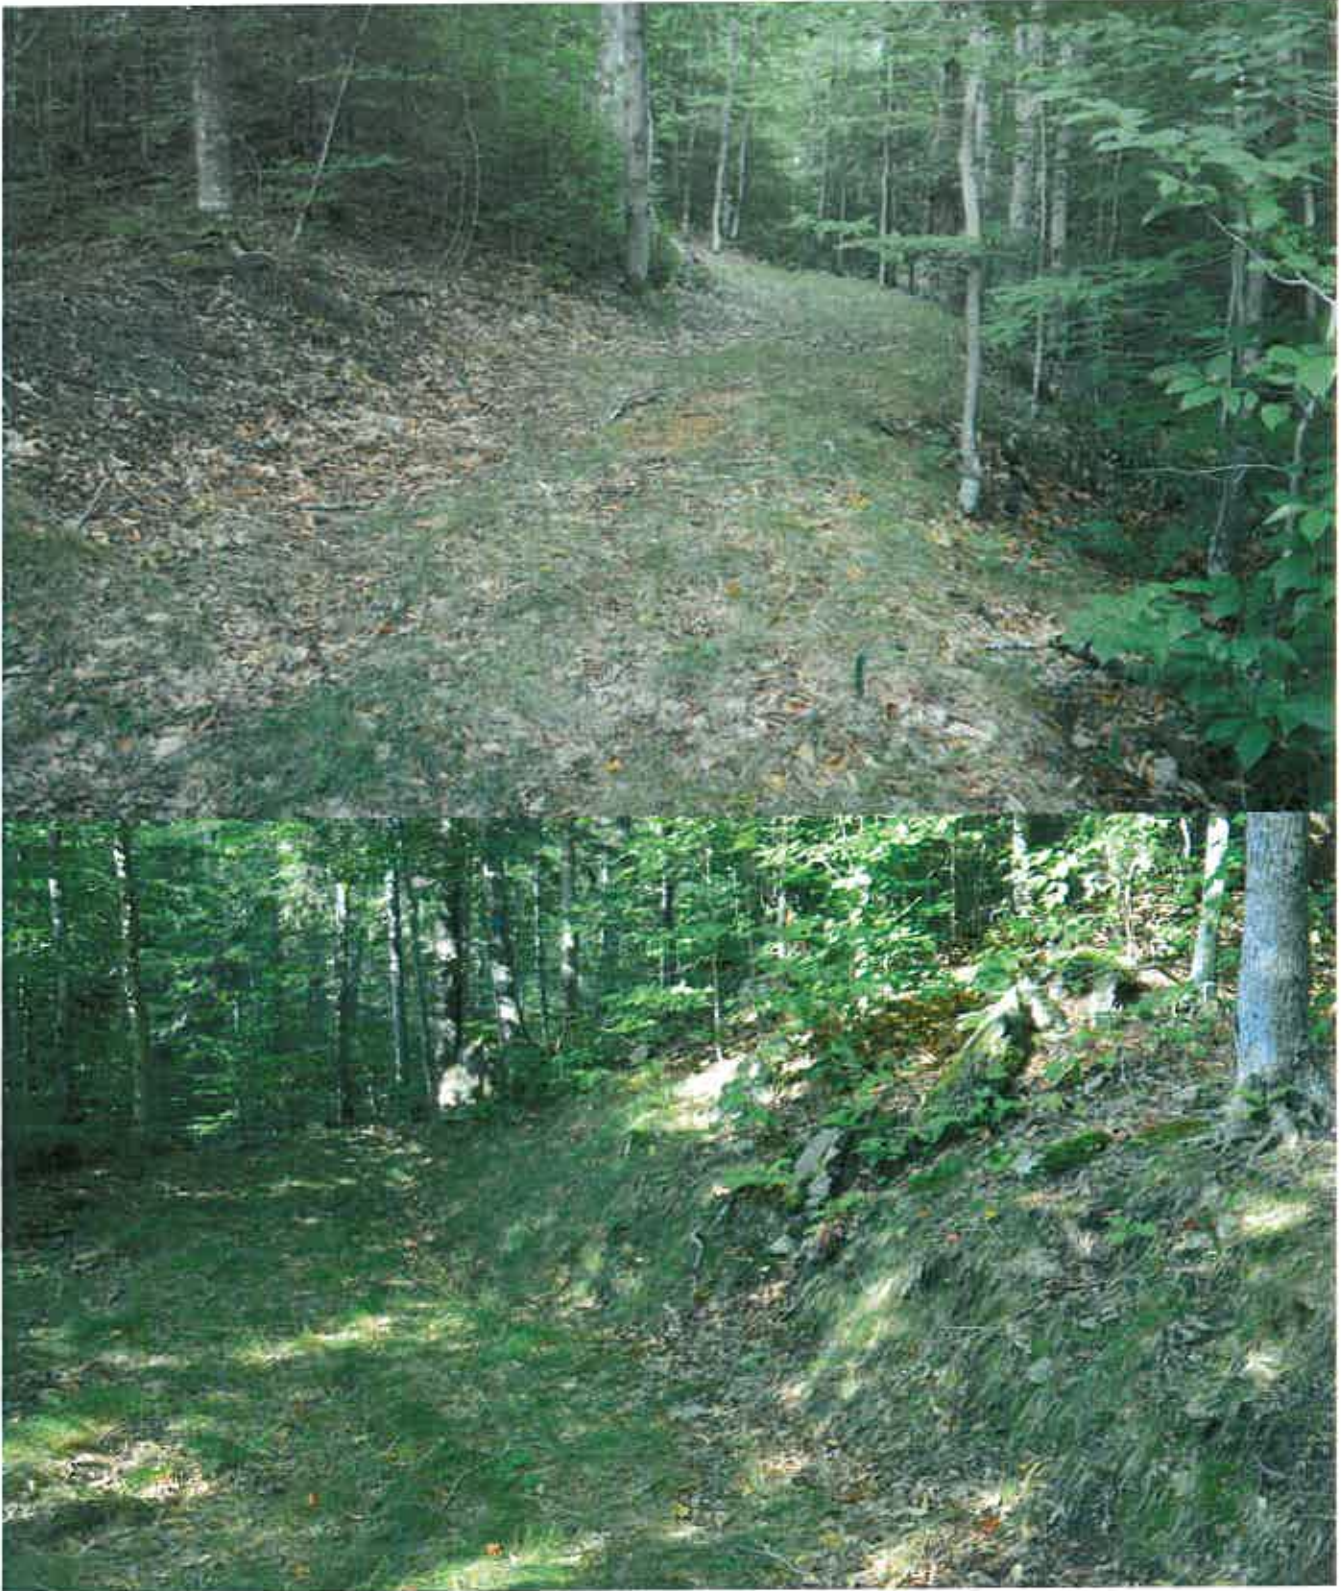
Examples of Large and Highly Visible Manmade Bench Cuts on Seventh Lake Mountain Trail in 2016

The pictures above were taken in the summer of 2016 on the Seventh Lake Mountain Trail, a newly constructed class II community connector snowmobile trail located in the Moose River Plains Wild Forest area, part of the Adirondack Forest Preserve. These pictures show visible man-made bench cuts widely used on this trail.

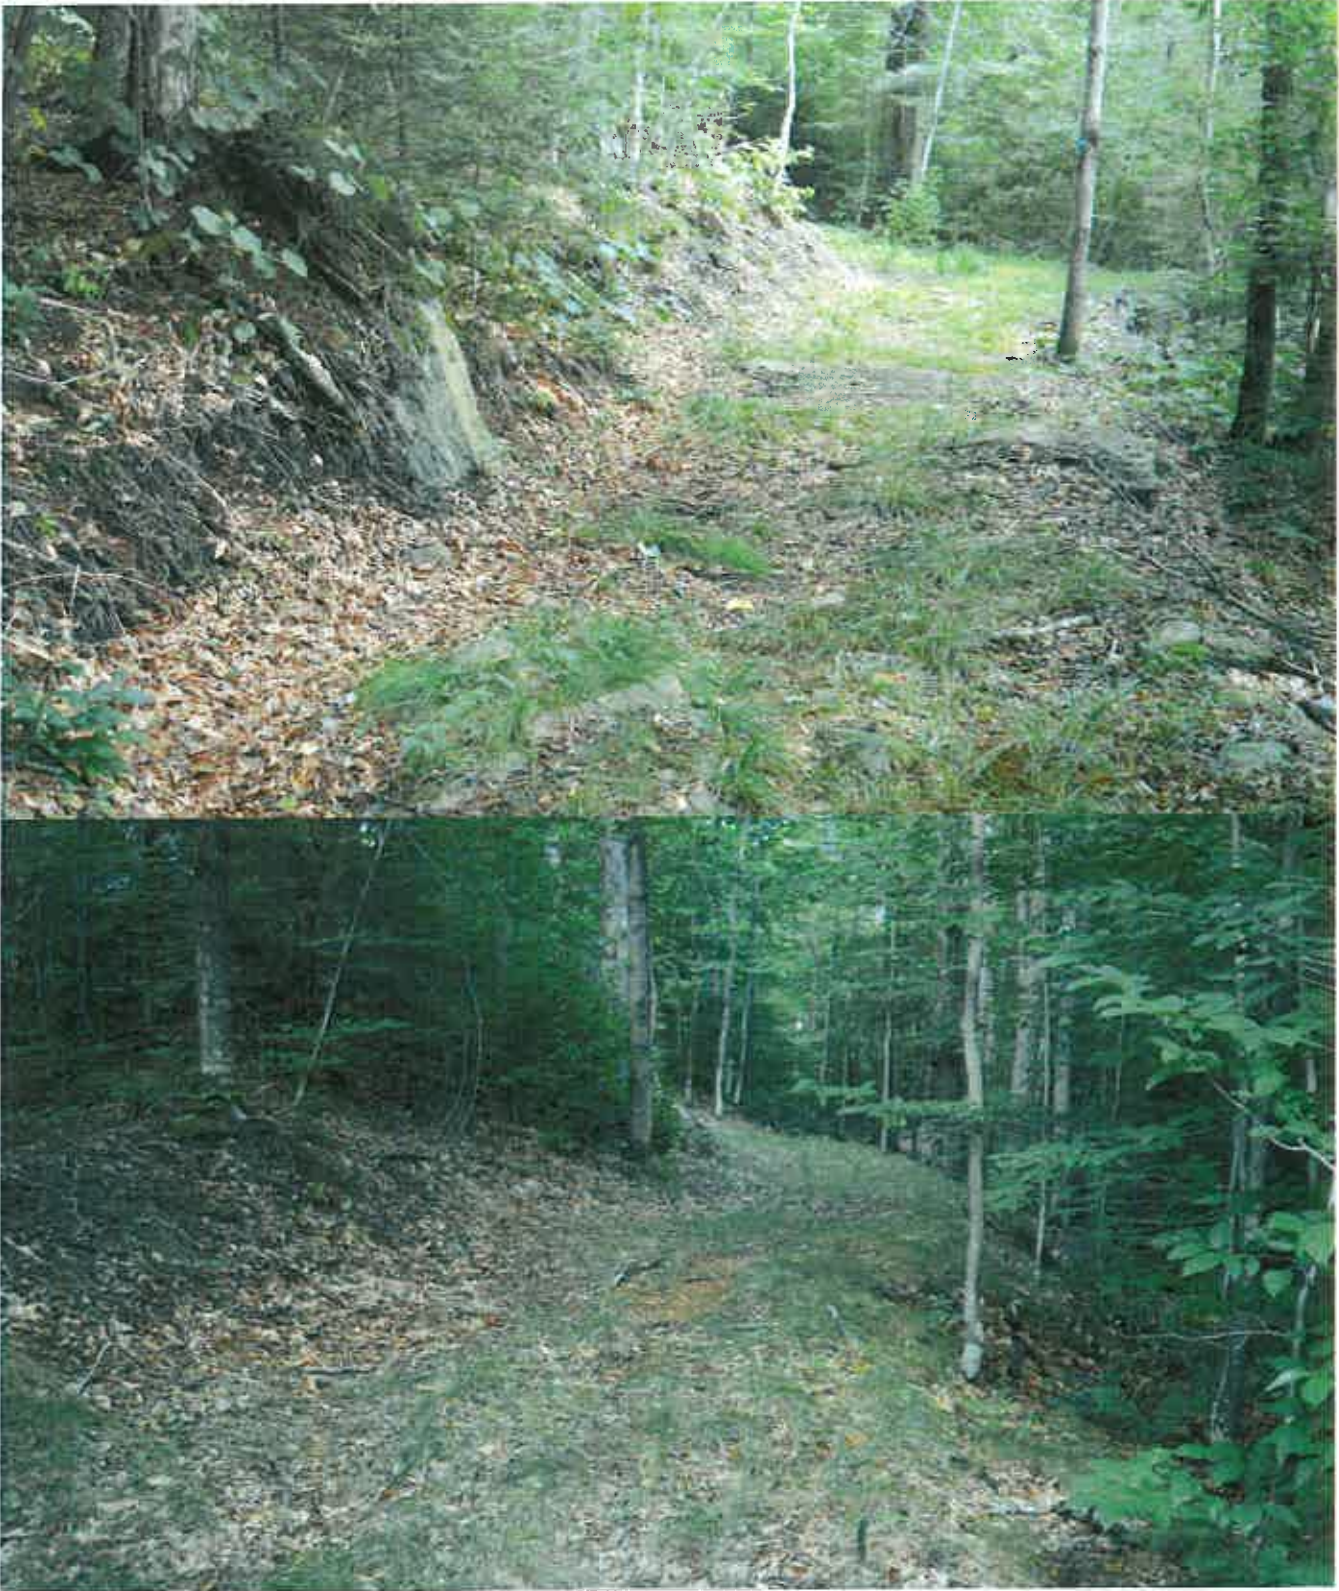
Examples of Un-Revegetated Bench Cuts on Seventh Lake Mountain Trail in 2016

The pictures above were taken in the summer of 2016 on the Seventh Lake Mountain Trail, a newly constructed class II community connector snowmobile trail located in the Moose River Plains Wild Forest area, part of the Adirondack Forest Preserve. These pictures show visible man-made bench cuts that have not revegetated.

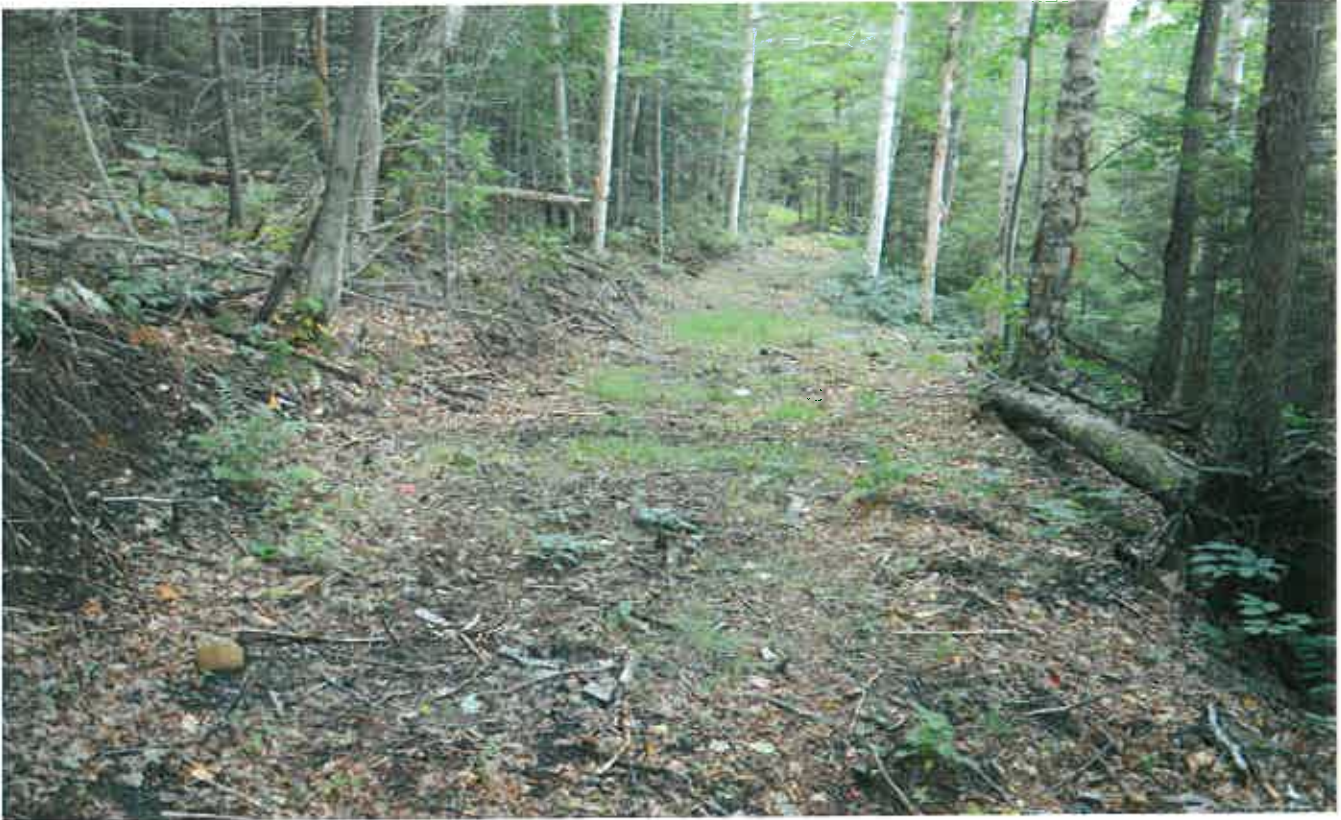
Examples of Un-Revegetated Bench Cuts on Seventh Lake Mountain Trail in 2016

The pictures above were taken in the summer of 2016 on the Seventh Lake Mountain Trail, a newly constructed class II community connector snowmobile trail located in the Moose River Plains Wild Forest area, part of the Adirondack Forest Preserve. These pictures show visible man-made bench cuts that have not revegetated.

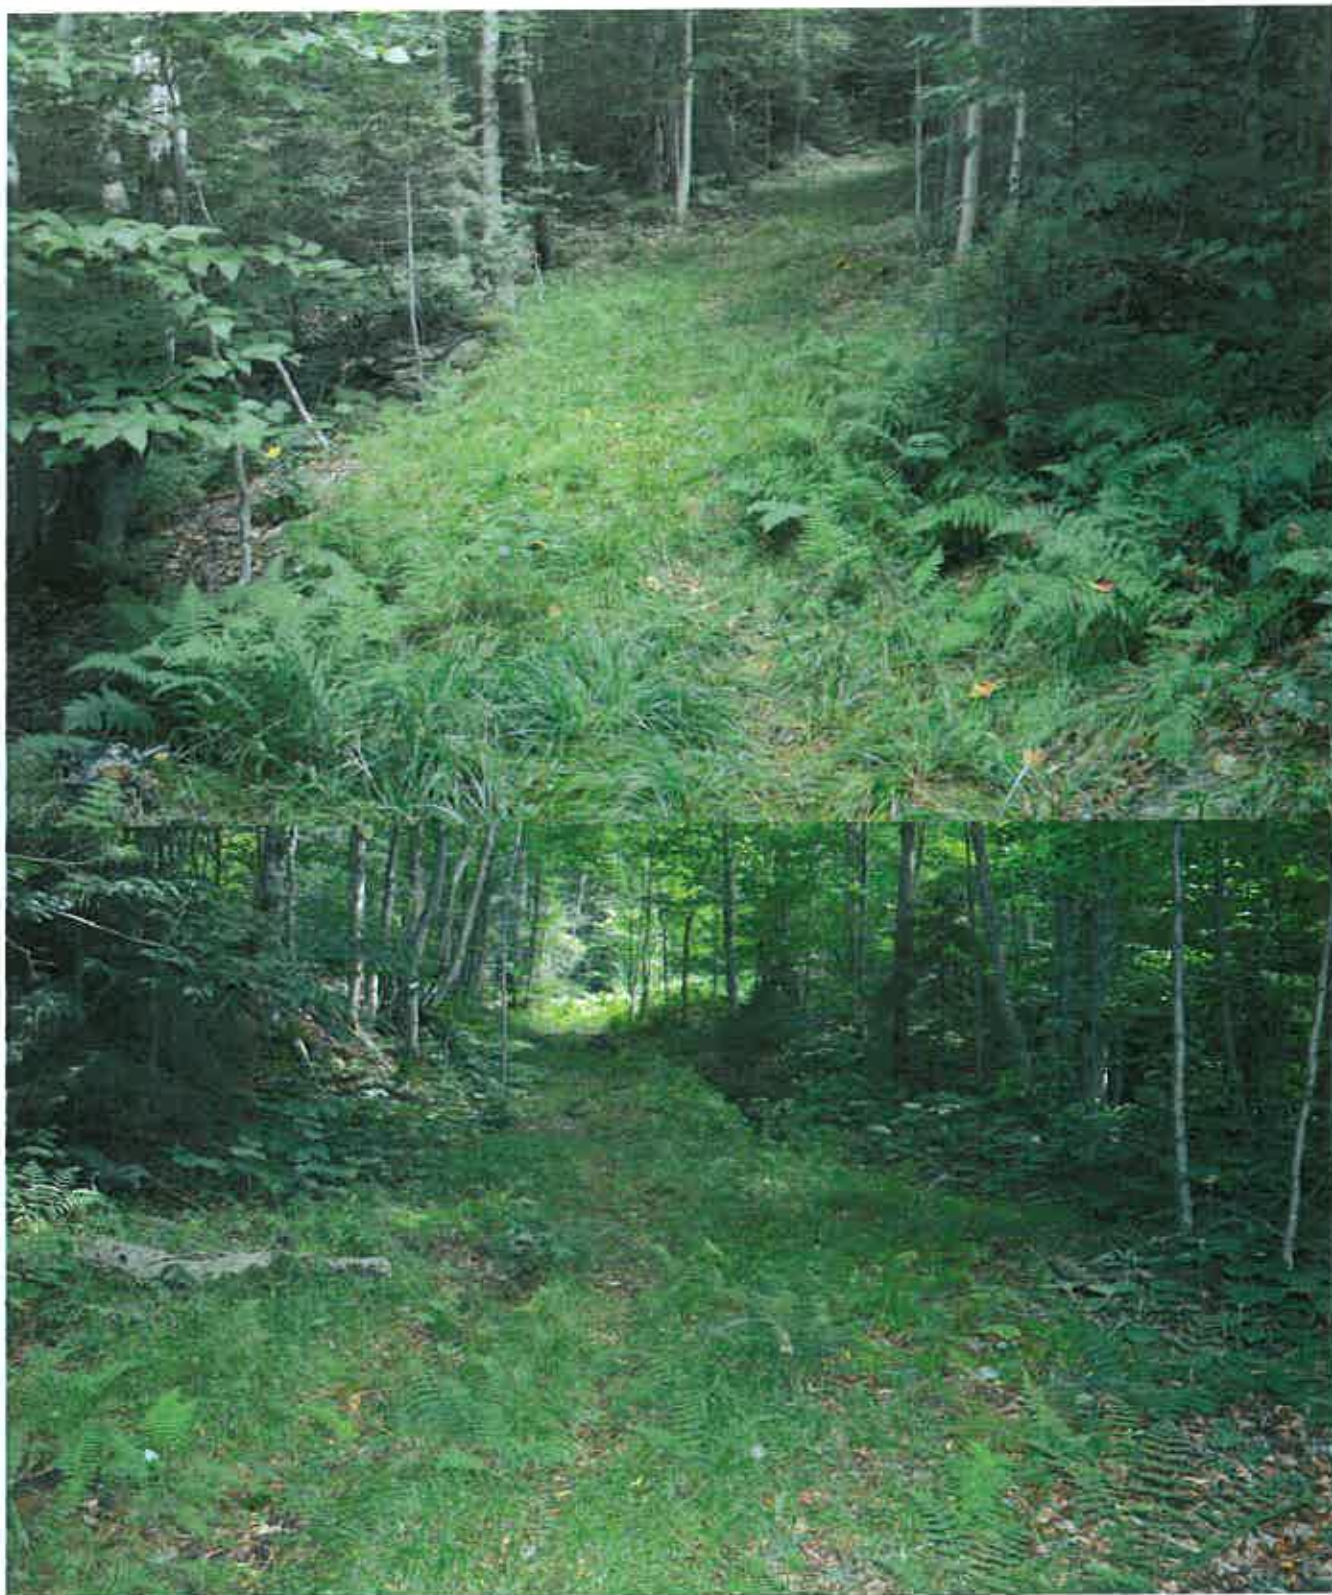
Examples of Extensive Grassy Sections on Seventh Lake Mountain Trail in 2016

The pictures above were taken in the summer of 2016 on the Seventh Lake Mountain Trail, a newly constructed class II community connector snowmobile trail located in the Moose River Plains Wild Forest area, part of the Adirondack Forest Preserve. These pictures show new grassy sections of a highly disturbed trail corridor.

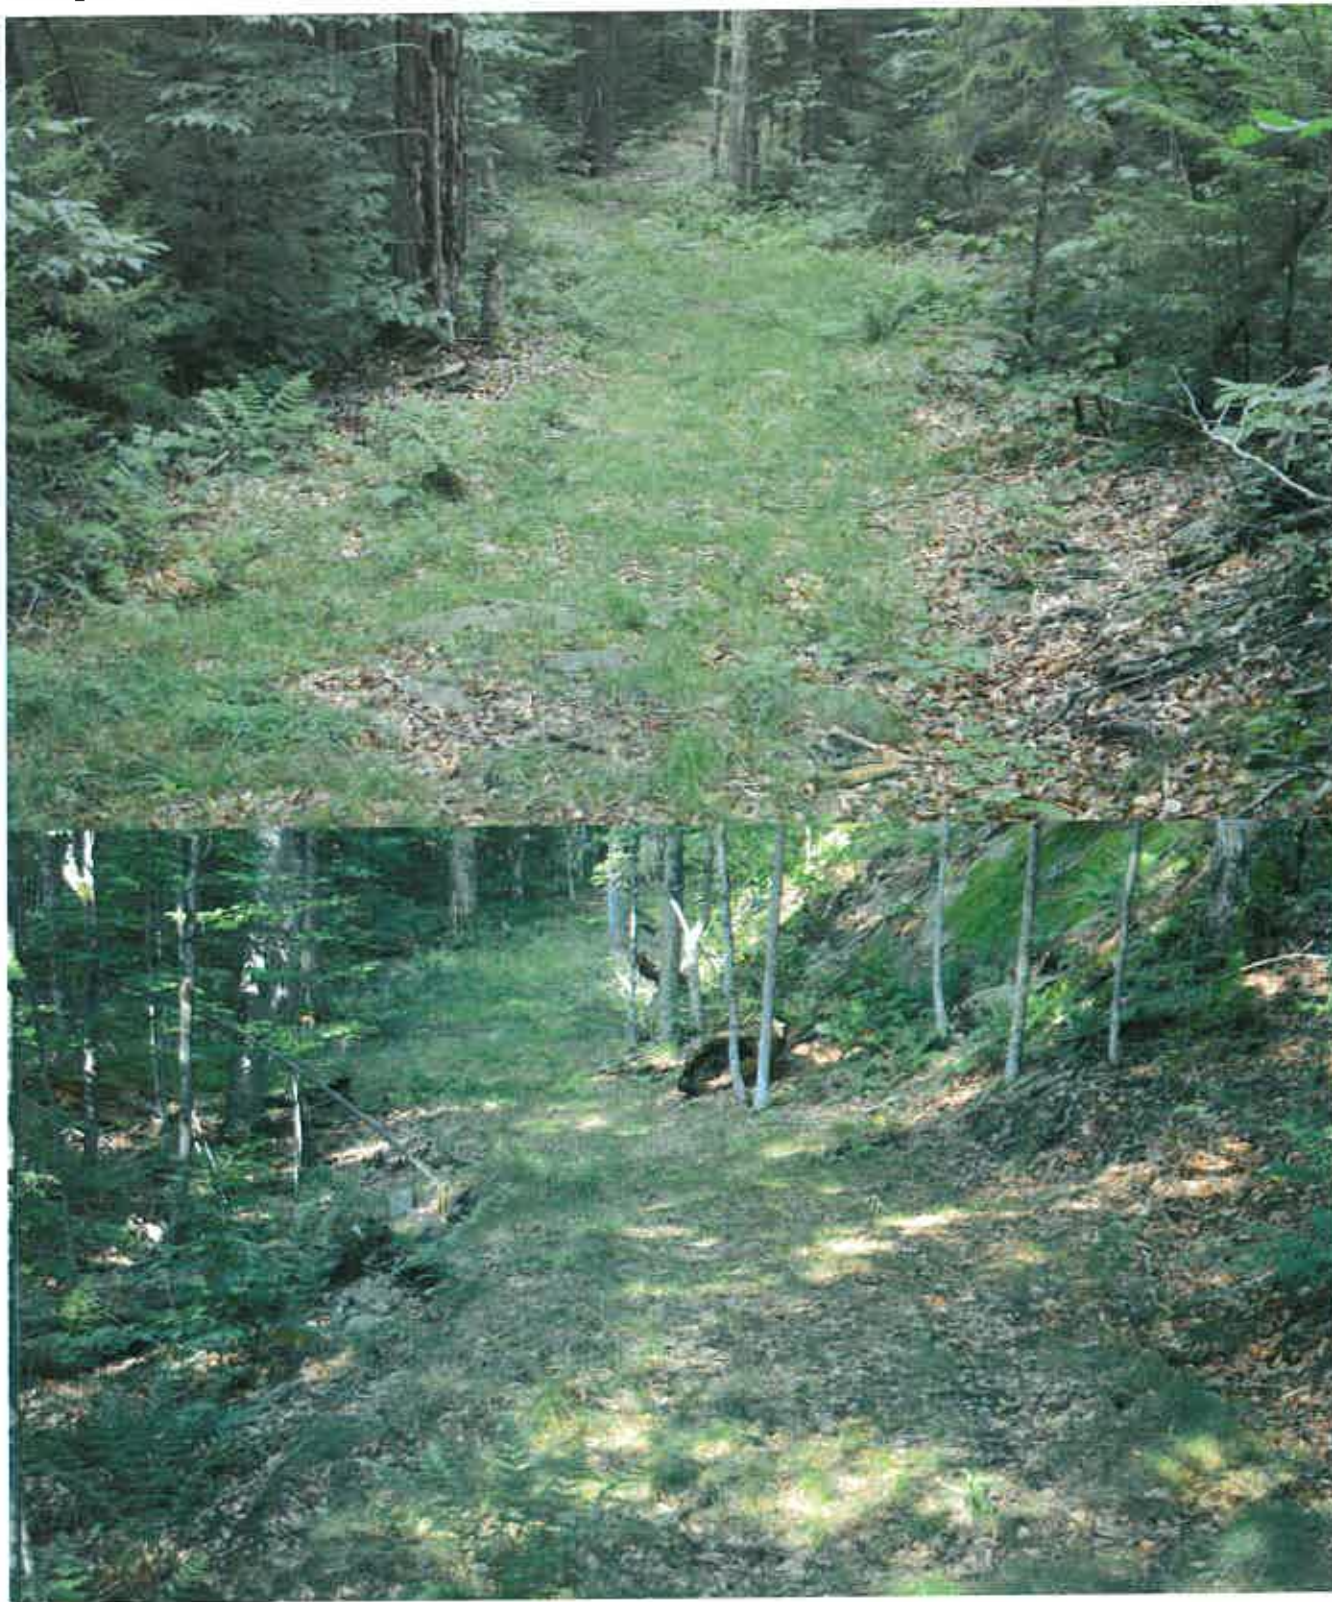
Examples of Extensive Grassy Sections on Seventh Lake Mountain Trail in 2016

The pictures above were taken in the summer of 2016 on the Seventh Lake Mountain Trail, a newly constructed class II community connector snowmobile trail located in the Moose River Plains Wild Forest area, part of the Adirondack Forest Preserve. These pictures show new grassy sections of a highly disturbed trail corridor.

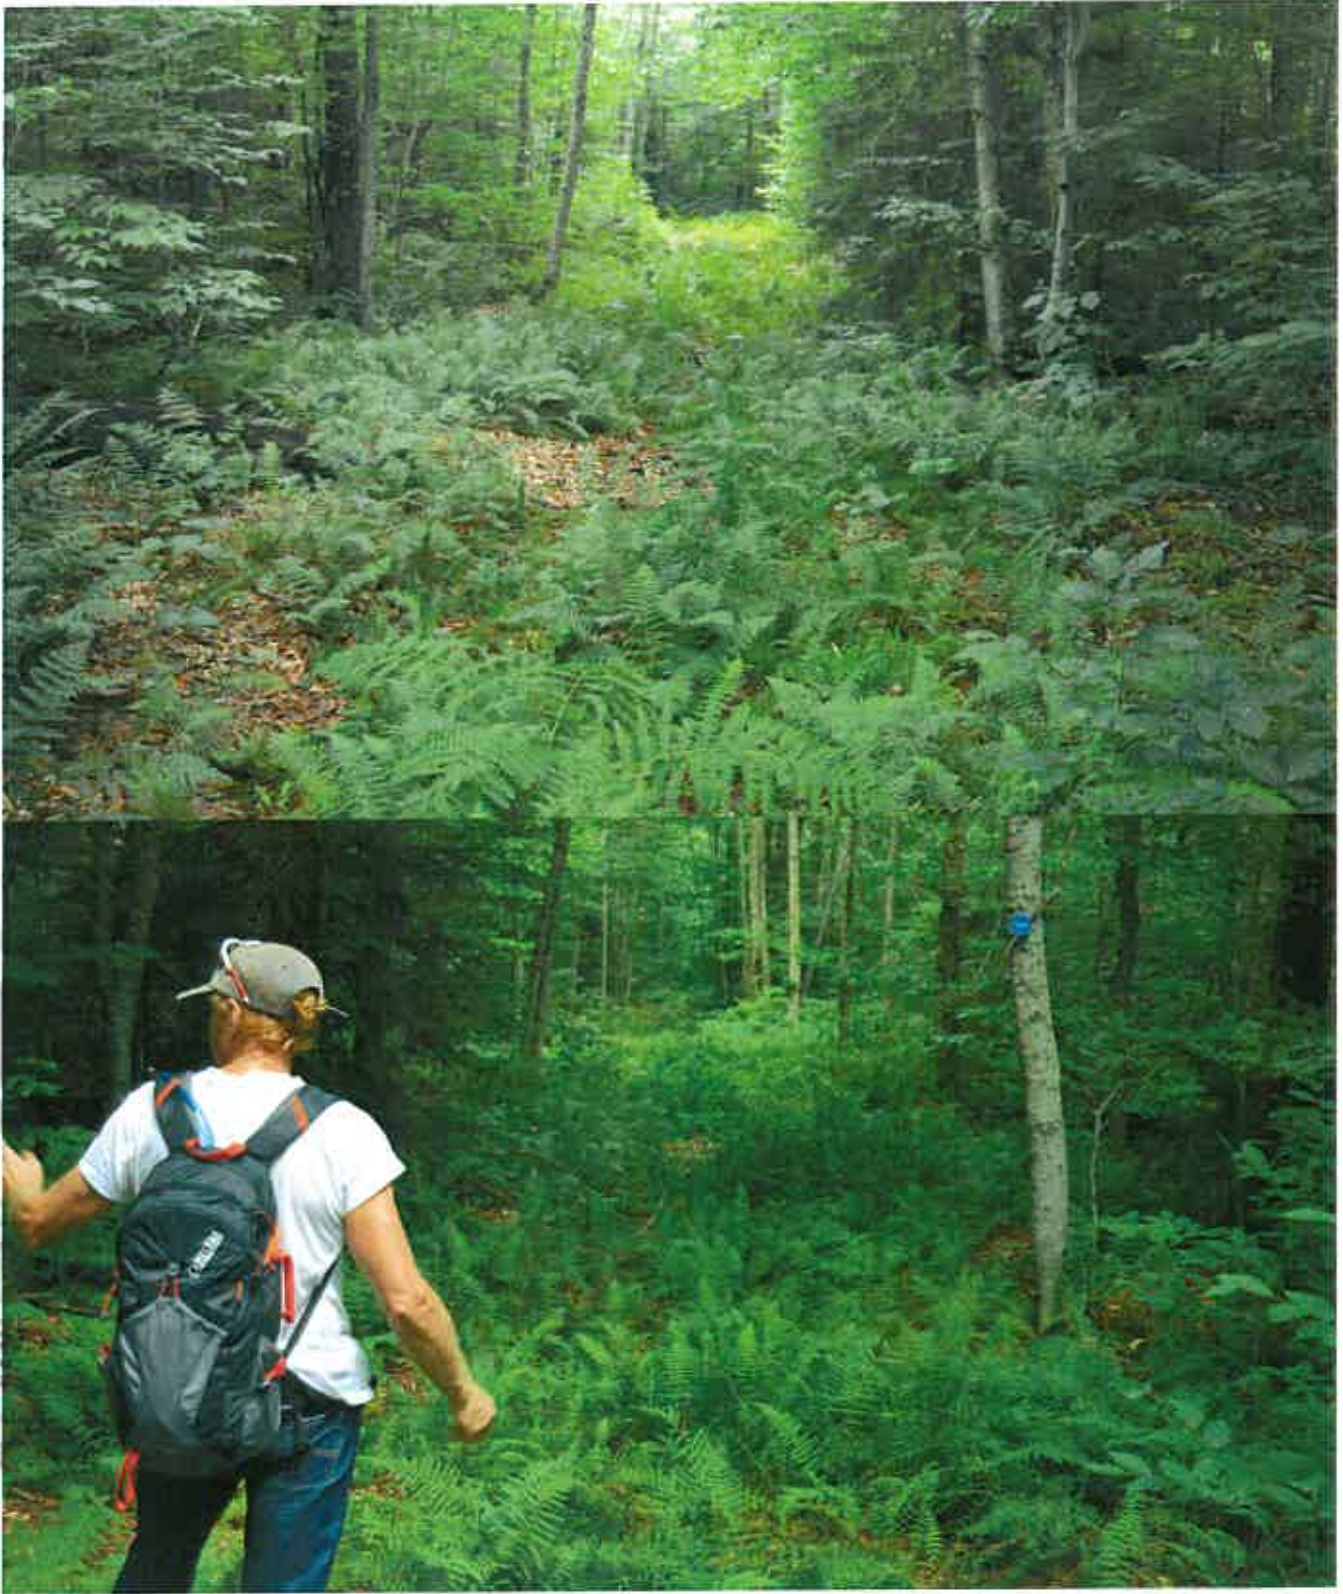
Examples of Fern Field Sections on Seventh Lake Mountain Trail in 2016

The pictures above were taken in the summer of 2016 on the Seventh Lake Mountain Trail, a newly constructed class II community connector snowmobile trail located in the Moose River Plains Wild Forest area, part of the Adirondack Forest Preserve. These pictures show new fern field sections of a highly disturbed trail corridor.

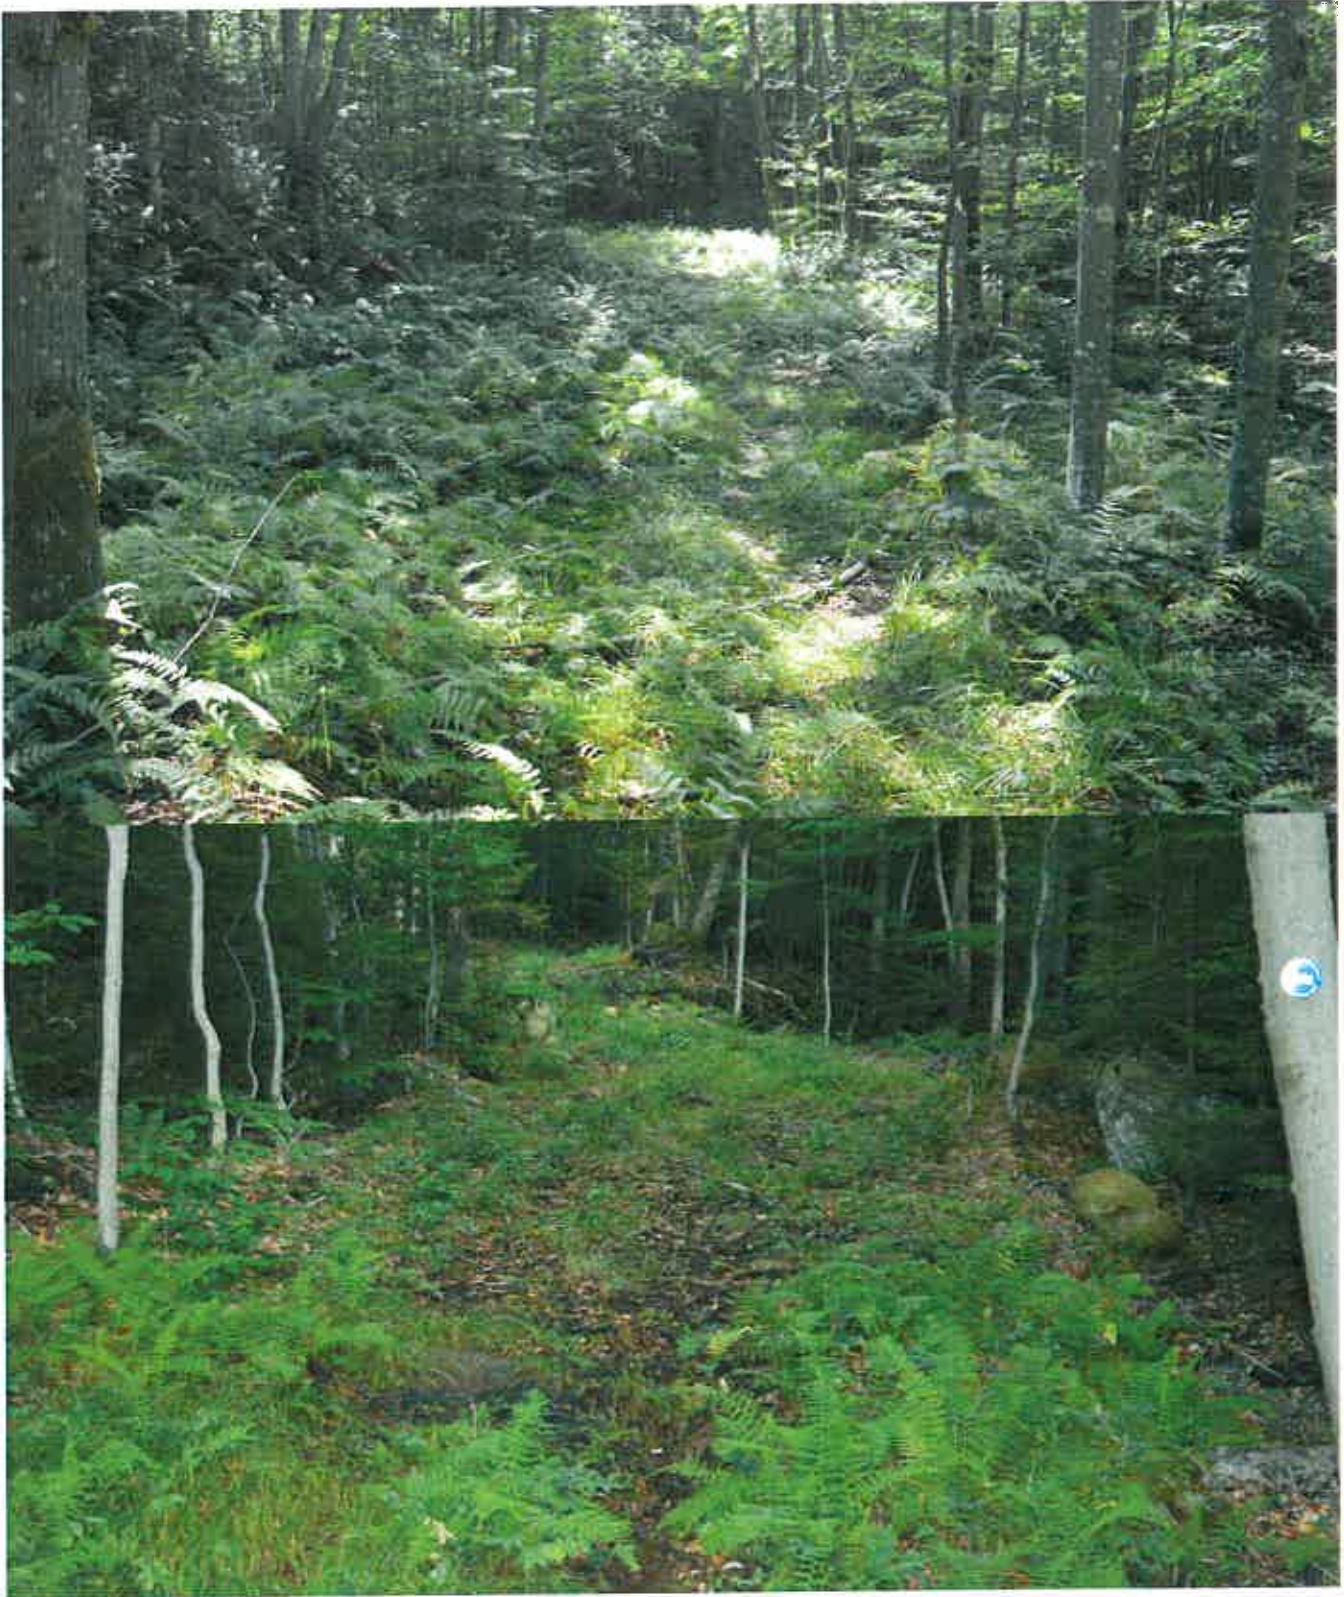
Examples of Fern Field Sections on Seventh Lake Mountain Trail in 2016

The pictures above were taken in the summer of 2016 on the Seventh Lake Mountain Trail, a newly constructed class II community connector snowmobile trail located in the Moose River Plains Wild Forest area, part of the Adirondack Forest Preserve. These pictures show new fern field sections of a highly disturbed trail corridor.

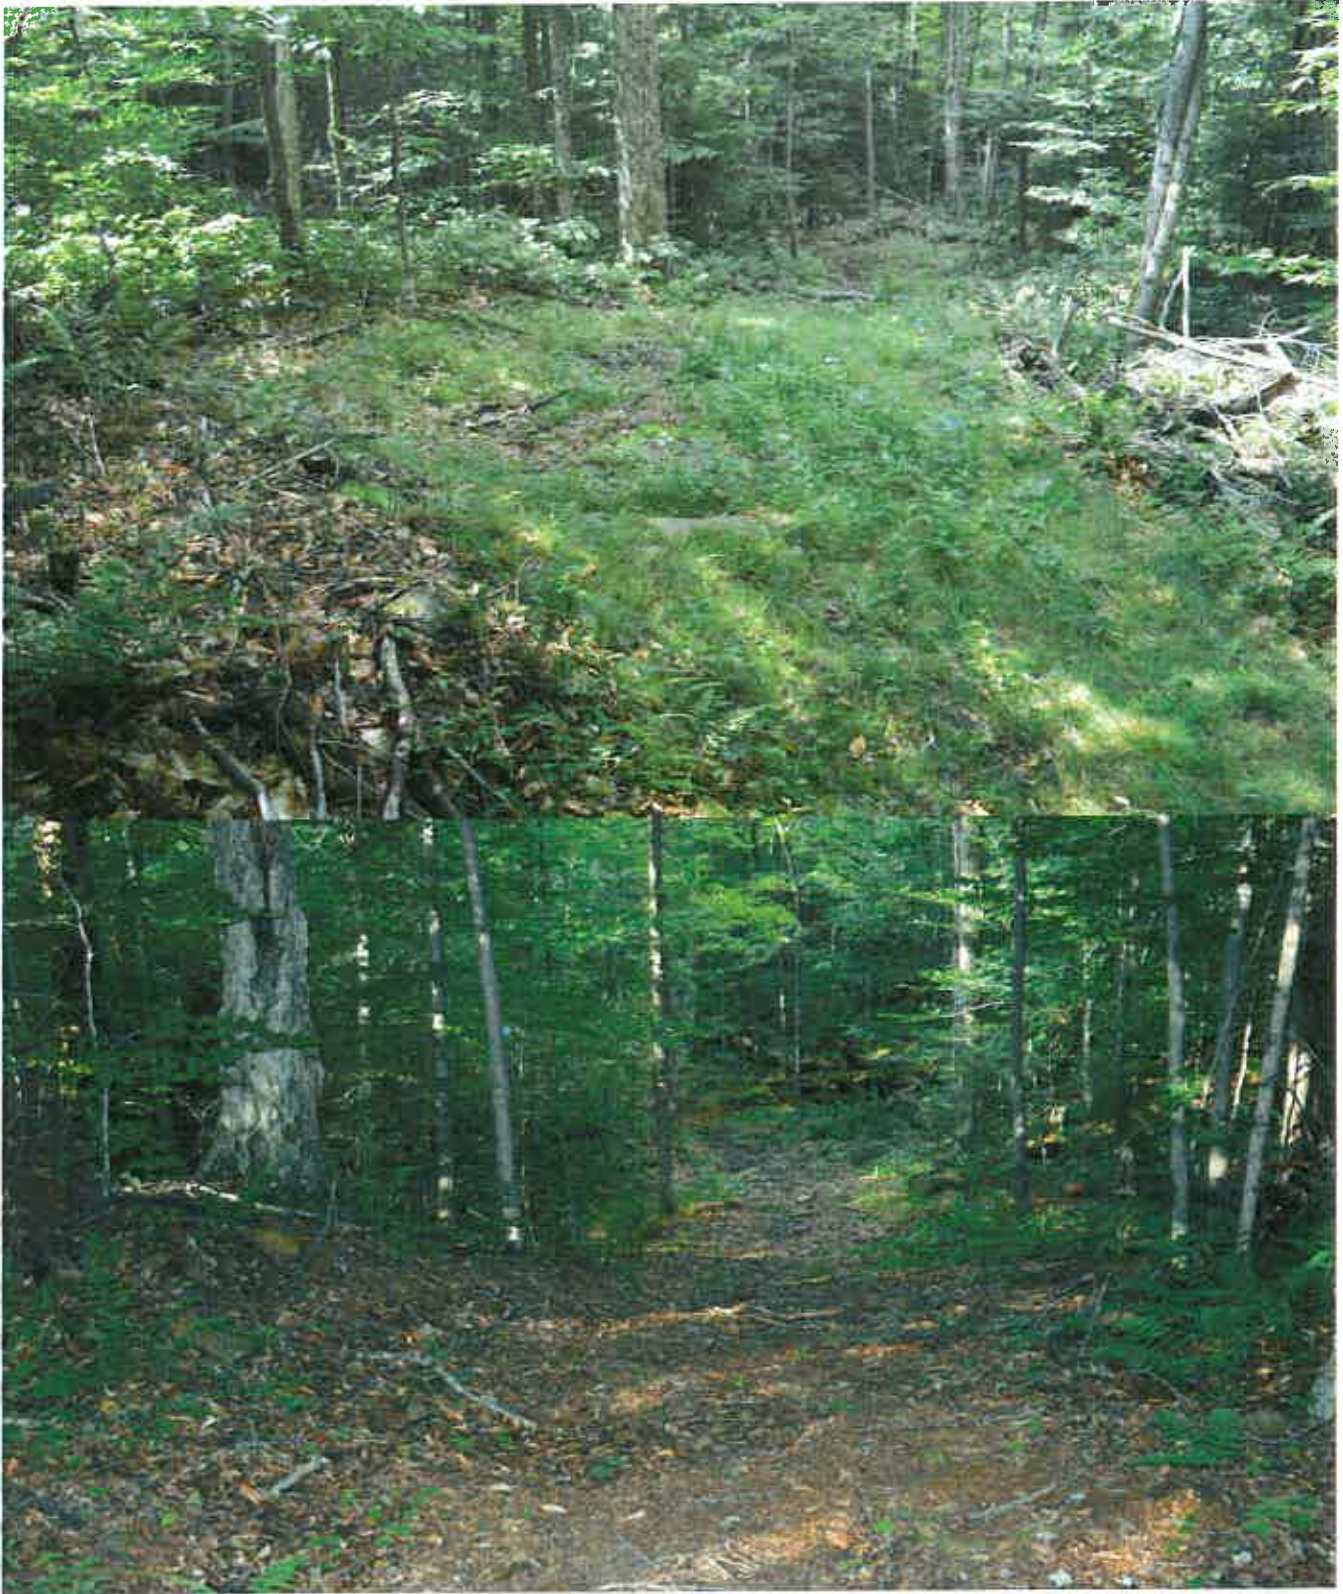
Examples of Stump and Boulder Holes on Seventh Lake Mountain Trail in 2016

The pictures above were taken in the summer of 2016 on the Seventh Lake Mountain Trail, a newly constructed class II community connector snowmobile trail located in the Moose River Plains Wild Forest area, part of the Adirondack Forest Preserve. These pictures show two examples of stump holes that significantly widen the trail.
