Shaker Mountain Wild Forest and Northville Boat Launch

Unit Management Plan Environmental Impact Statement

Examples of Erosion on Seventh Lake Mountain Trail in 2016

The pictures above were taken in the summer of 2016 on the Seventh Lake Mountain Trail, a newly constructed class II community connector snowmobile trail located in the Moose River Plains Wild Forest area, part of the Adirondack Forest Preserve. These pictures show visible trail erosion.

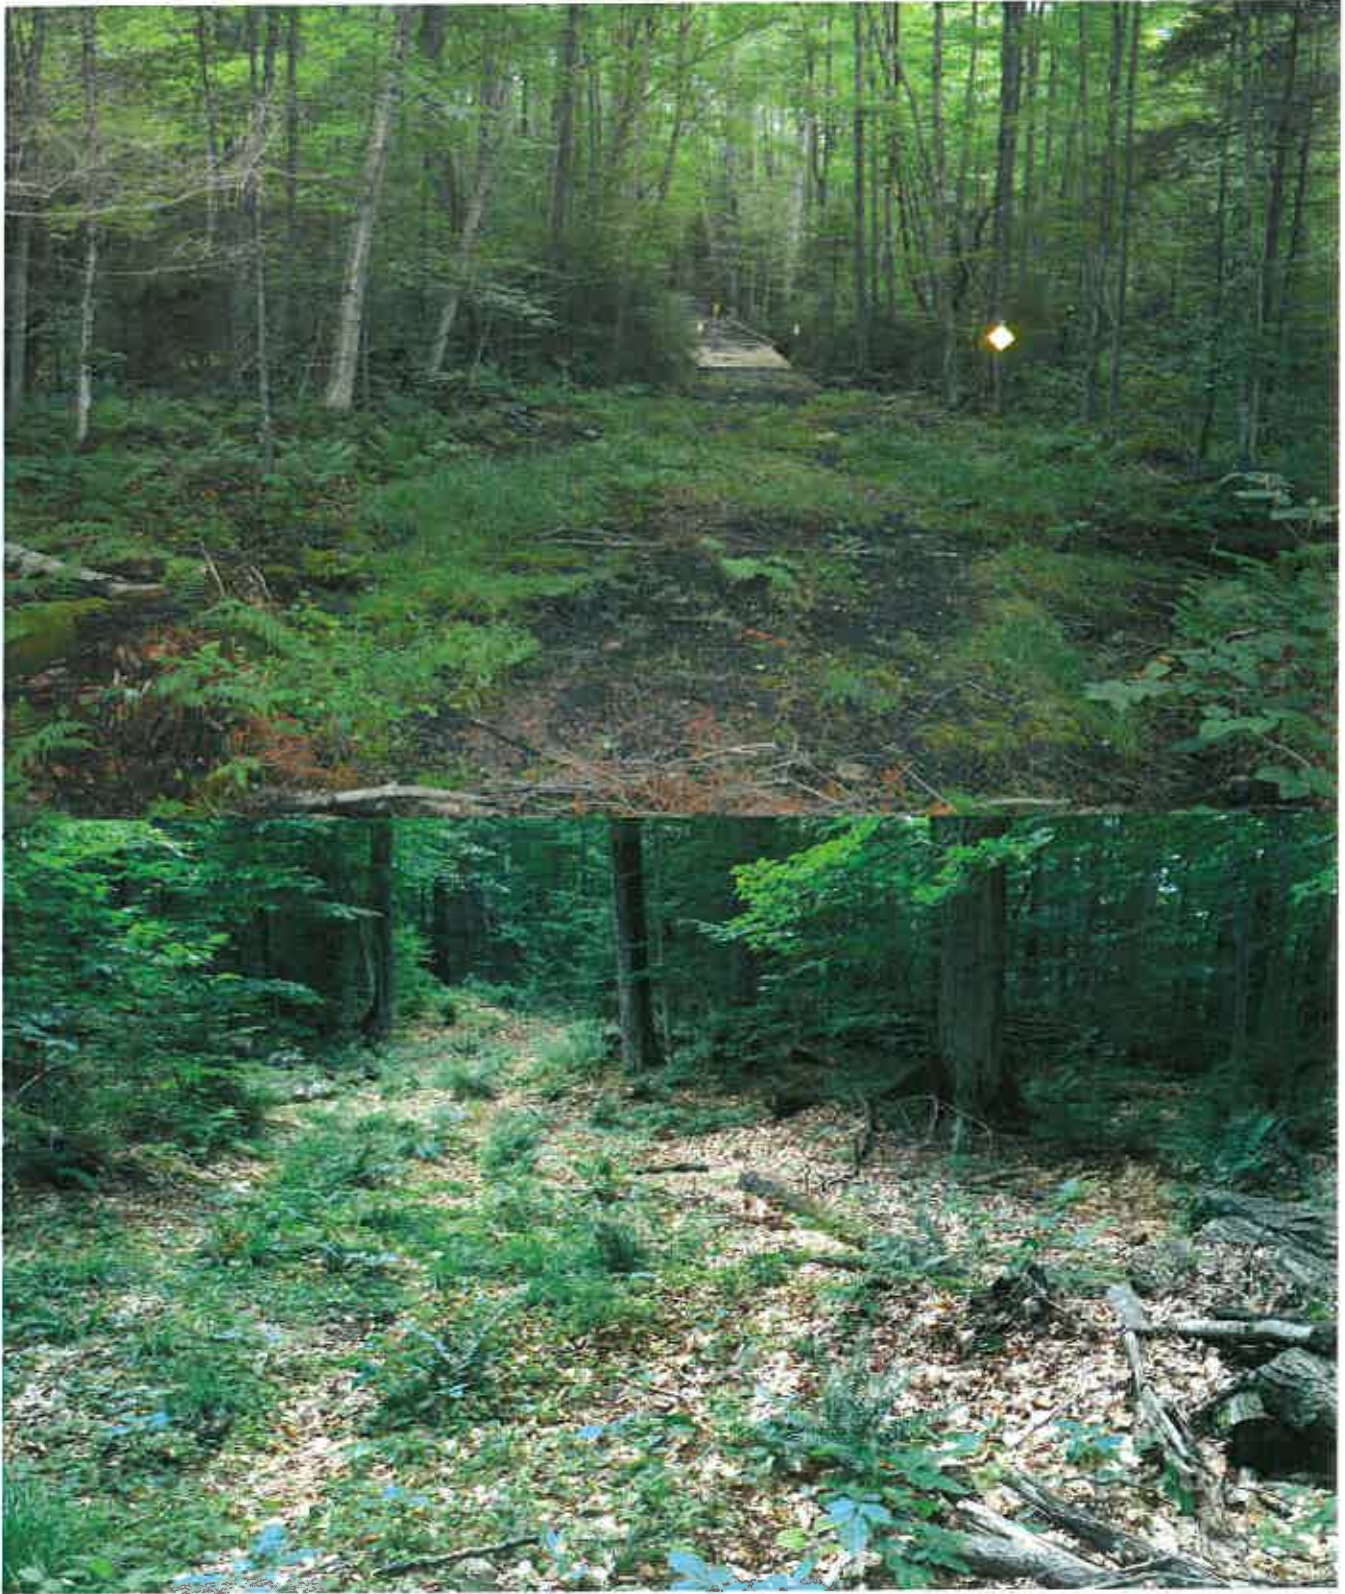
Examples of Wide Trail Sections on Seventh Lake Mountain Trail in 2016

The pictures above were taken in the summer of 2016 on the Seventh Lake Mountain Trail, a newly constructed class II community connector snowmobile trail located in the Moose River Plains Wild Forest area, part of the Adirondack Forest Preserve. These pictures show sections of trail beyond 12 feet in width.

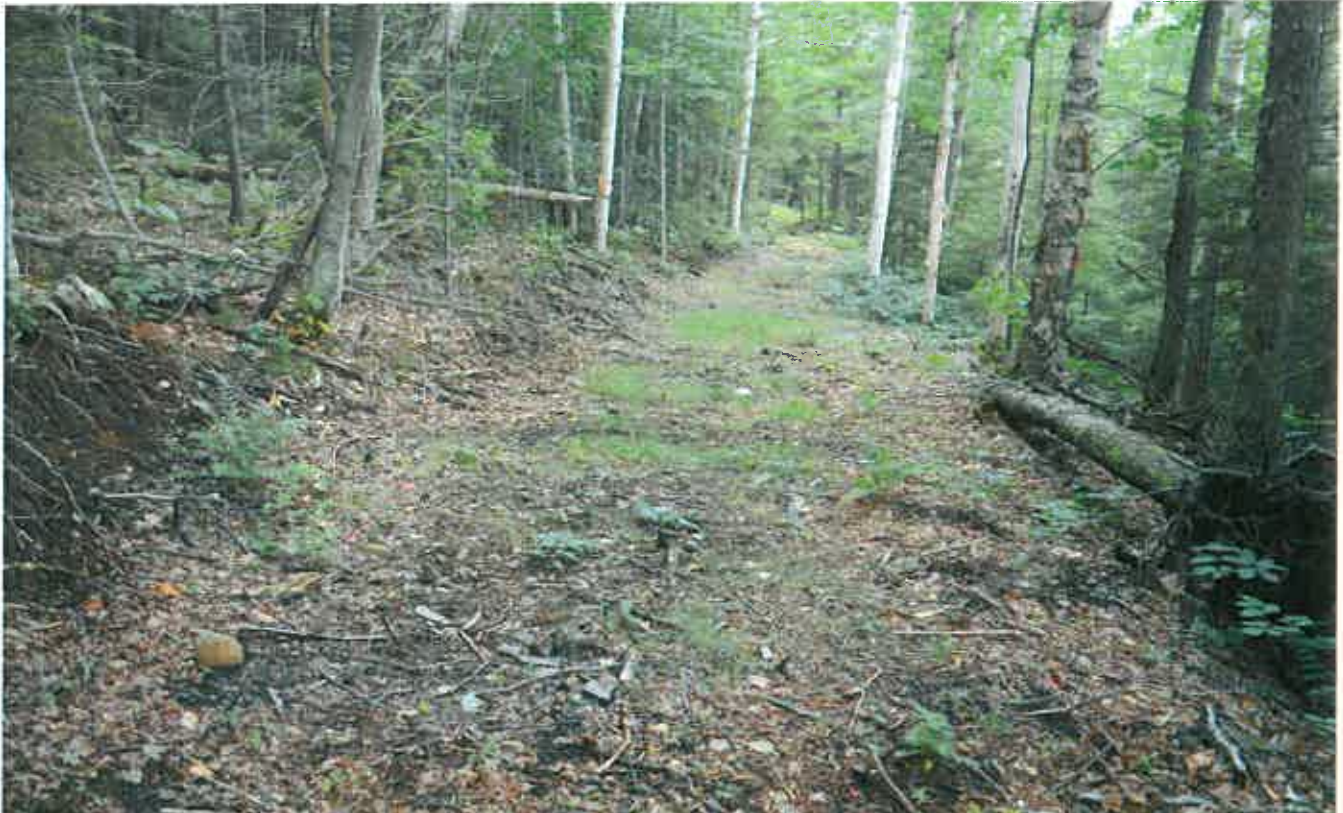
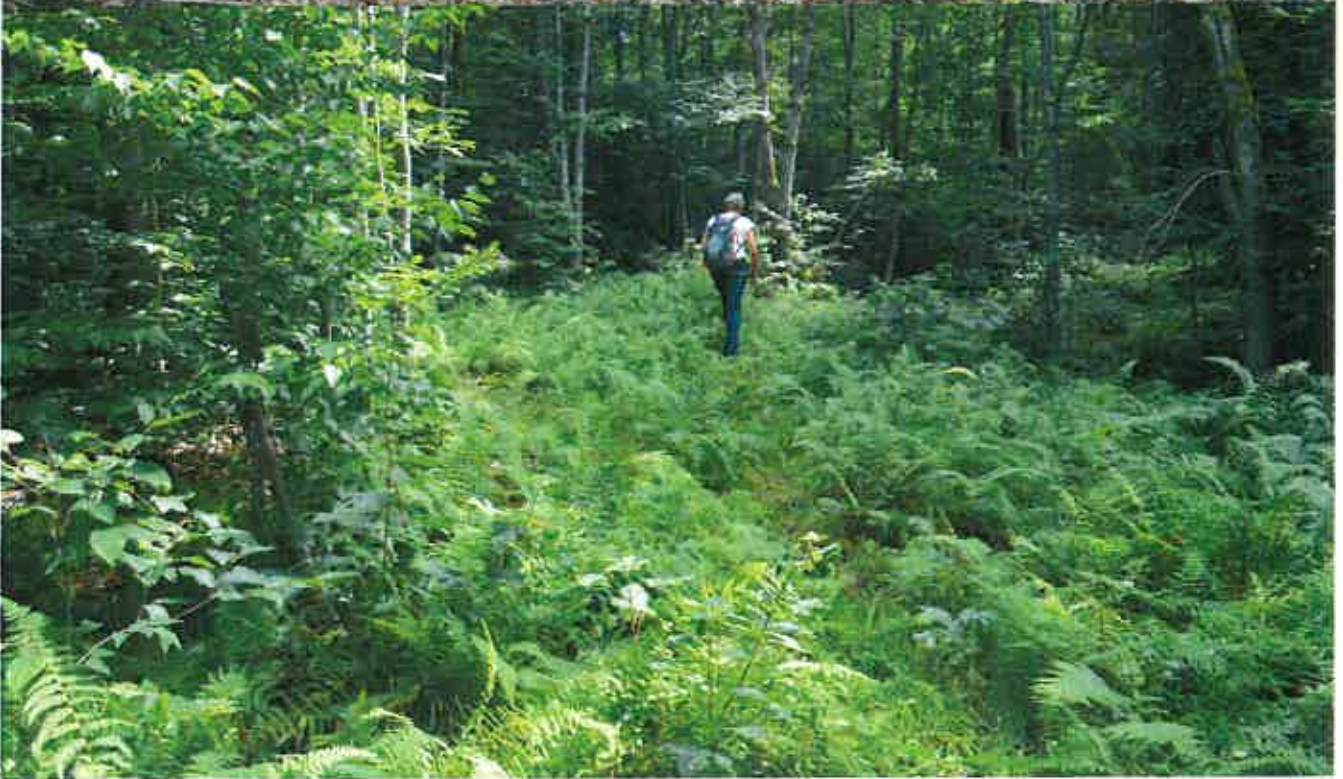
Examples of Wide Trail Sections on Seventh Lake Mountain Trail in 2016

The pictures above were taken in the summer of 2016 on the Seventh Lake Mountain Trail, a newly constructed class II community connector snowmobile trail located in the Moose River Plains Wild Forest area, part of the Adirondack Forest Preserve. These pictures show sections of trail beyond 12 feet in width.

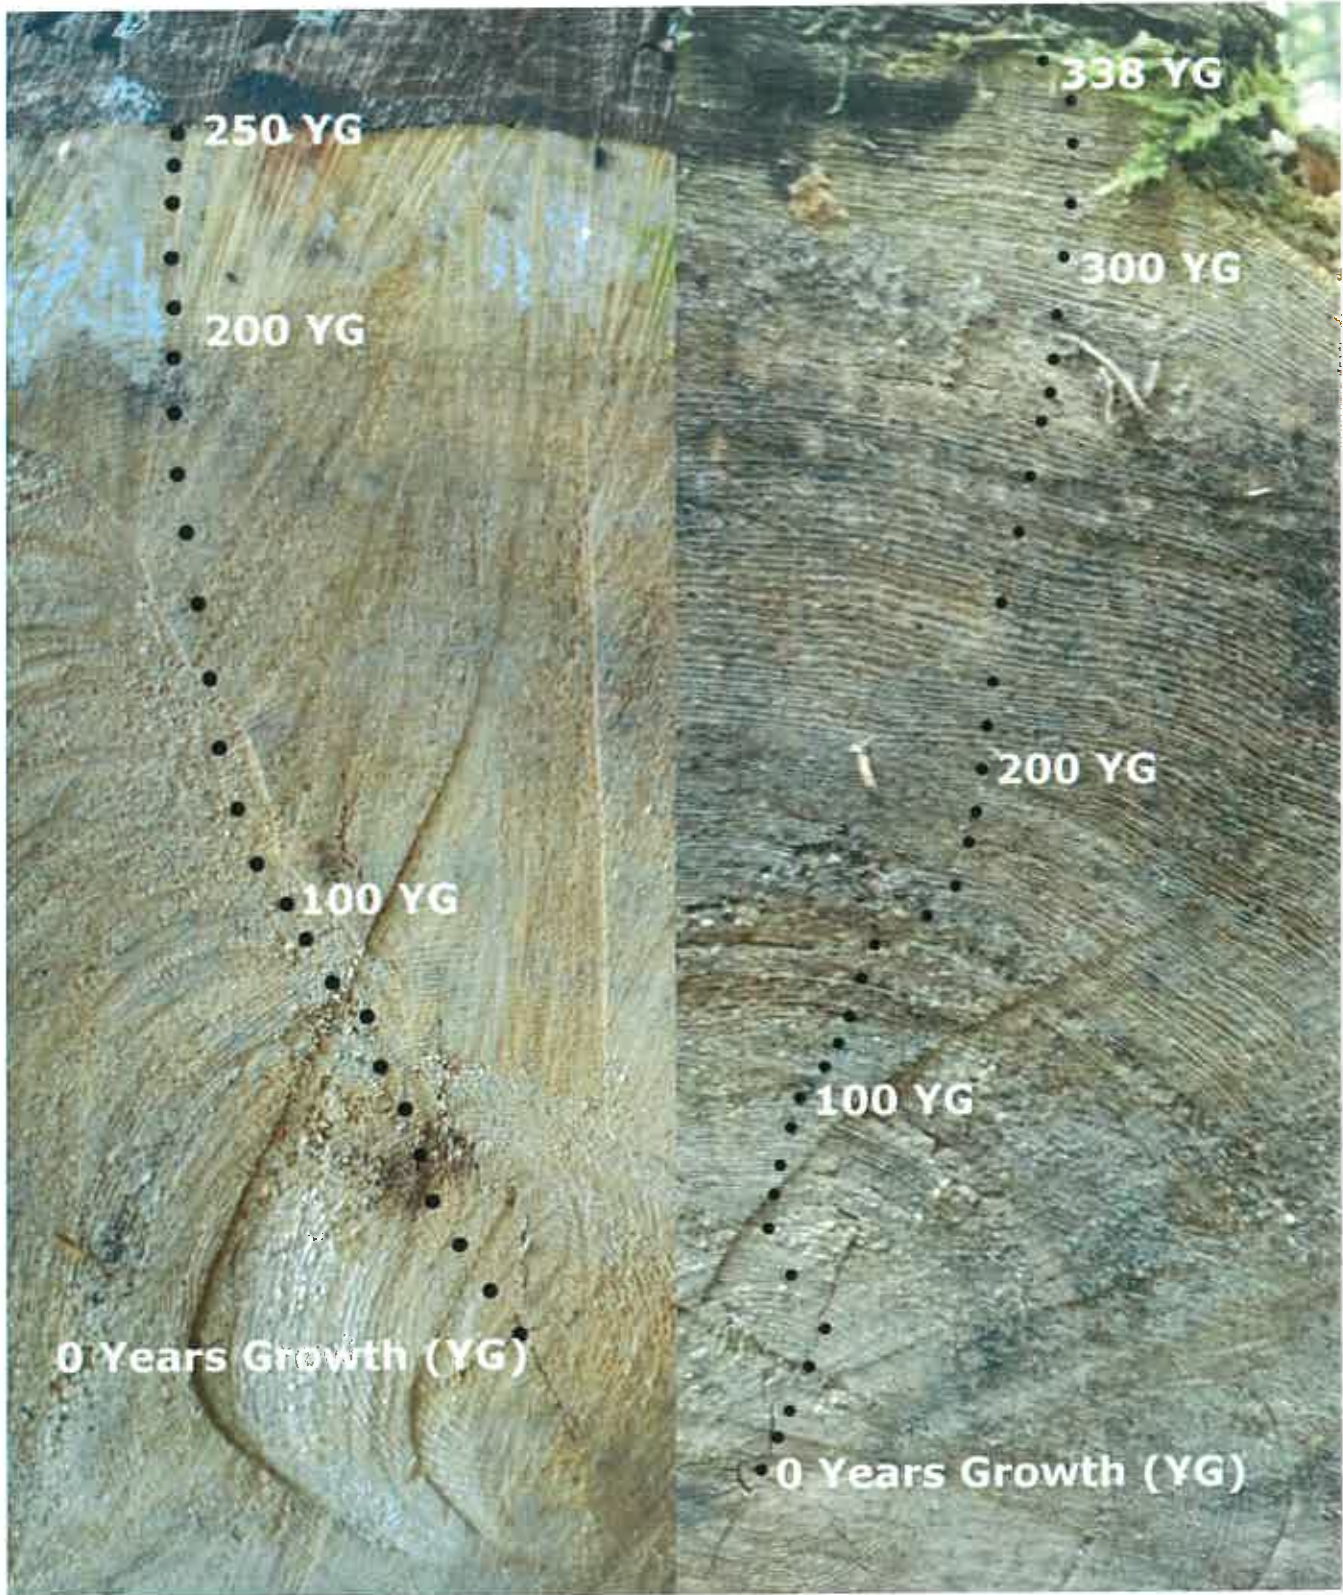
Stumps of Old Growth Trees on the Seventh Lake Mountain Trail

The pictures above were taken in the summer of 2016 on the Seventh Lake Mountain Trail, a newly constructed class II community connector snowmobile trail located in the Moose River Plains Wild Forest area, part of the Adirondack Forest Preserve. These pictures show two trees over 250 years old that were cut down.

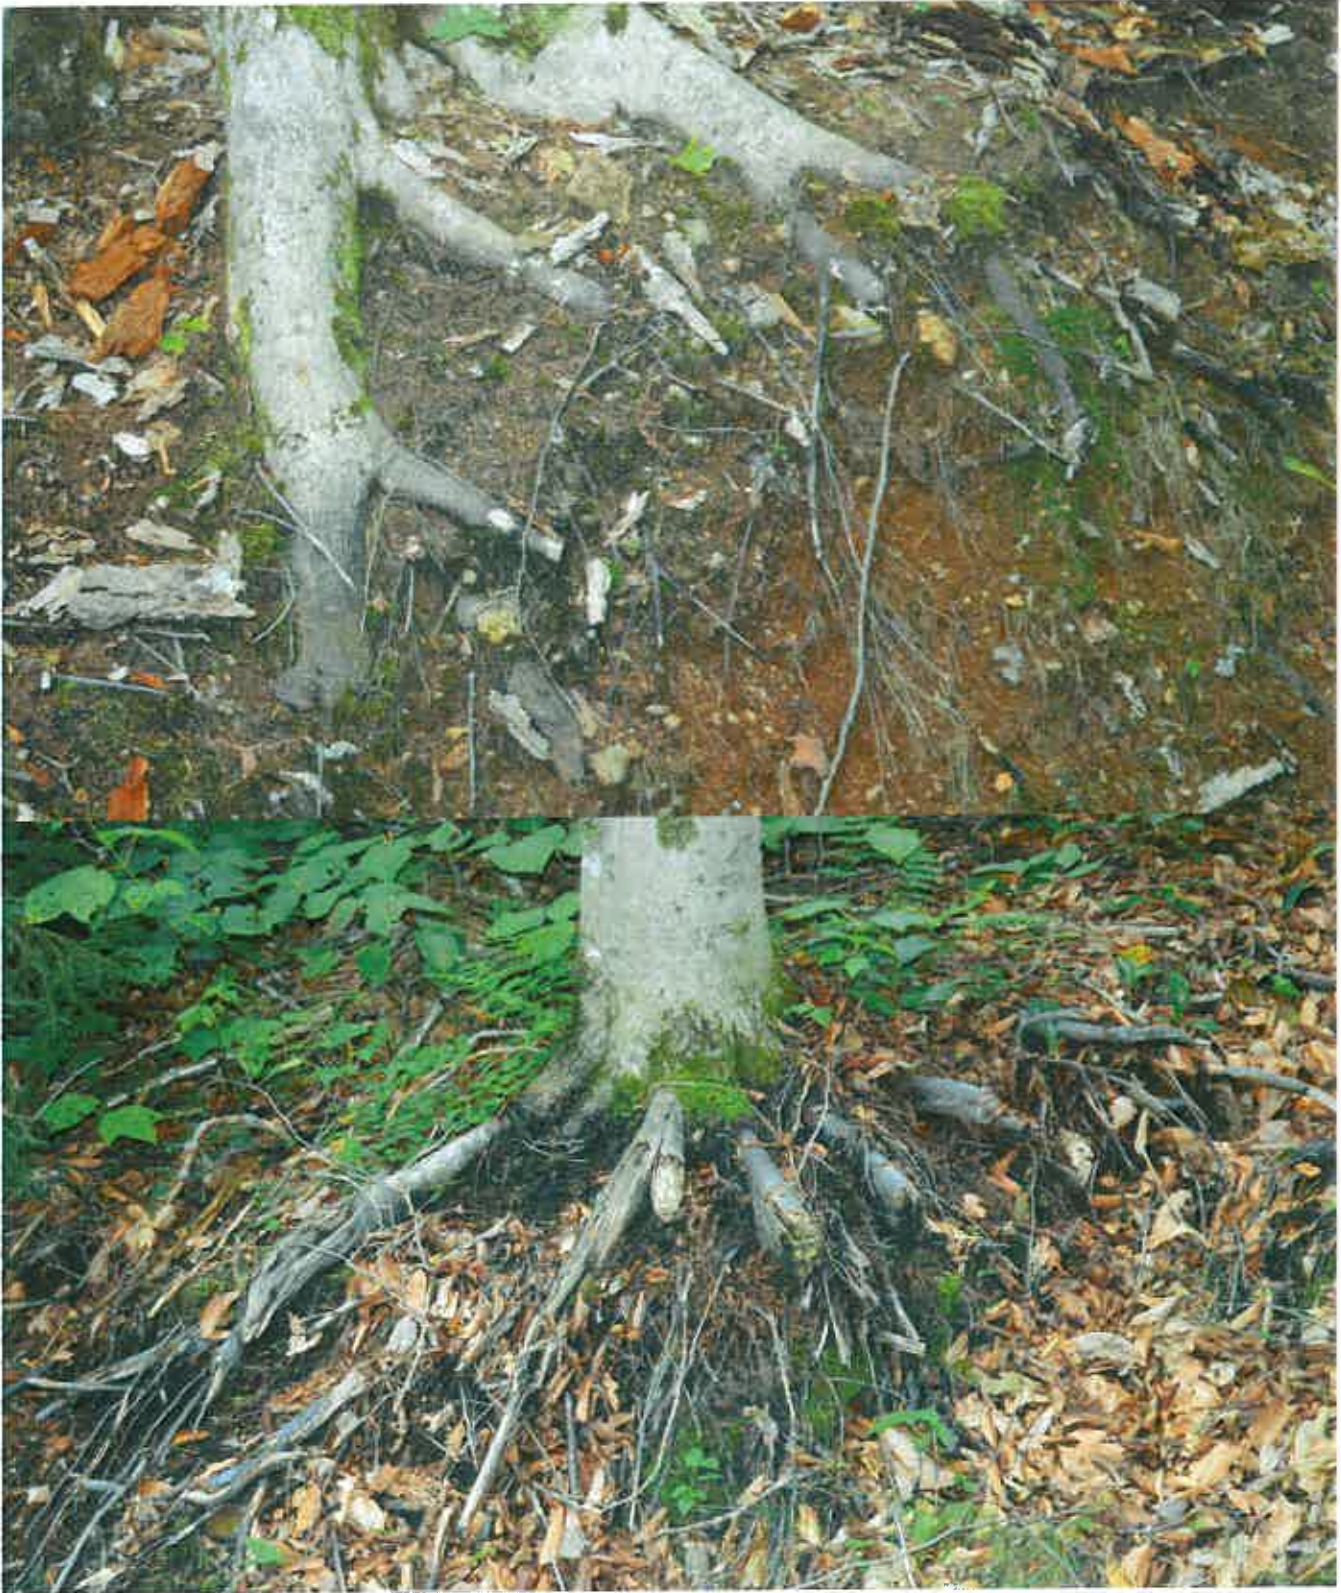
Examples of Root Damage to Trailside Trees on the Seventh Lake Mountain Trail in 2016

The pictures above were taken in the summer of 2016 on the Seventh Lake Mountain Trail, a newly constructed class II community connector snowmobile trail located in the Moose River Plains Wild Forest area, part of the Adirondack Forest Preserve. These pictures show root damage to trailside trees.

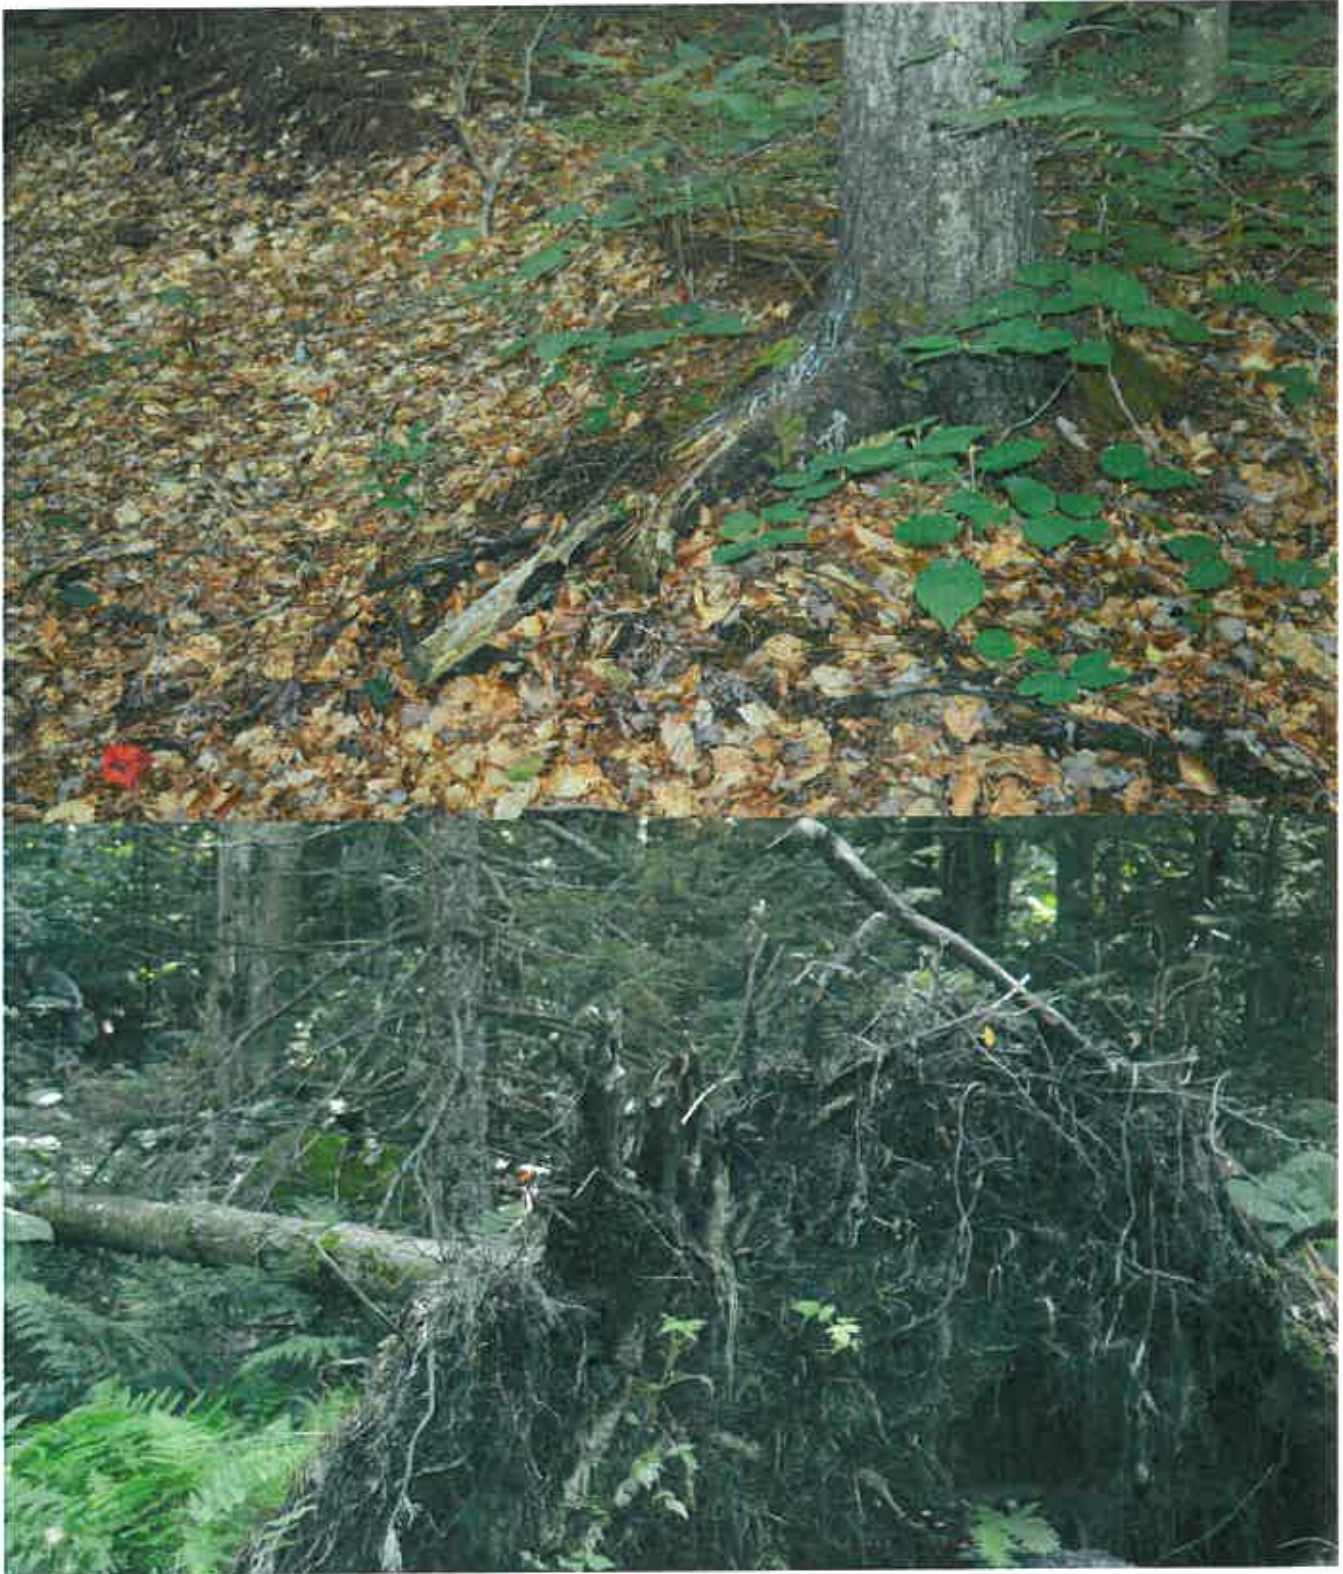
Examples of Root Damage to Trailside Trees on the Seventh Lake Mountain Trail in 2016

The pictures above were taken in the summer of 2016 on the Seventh Lake Mountain Trail, a newly constructed class II community connector snowmobile trail located in the Moose River Plains Wild Forest area, part of the Adirondack Forest Preserve. These pictures show root damage to trailside trees and one damaged tree that toppled over.

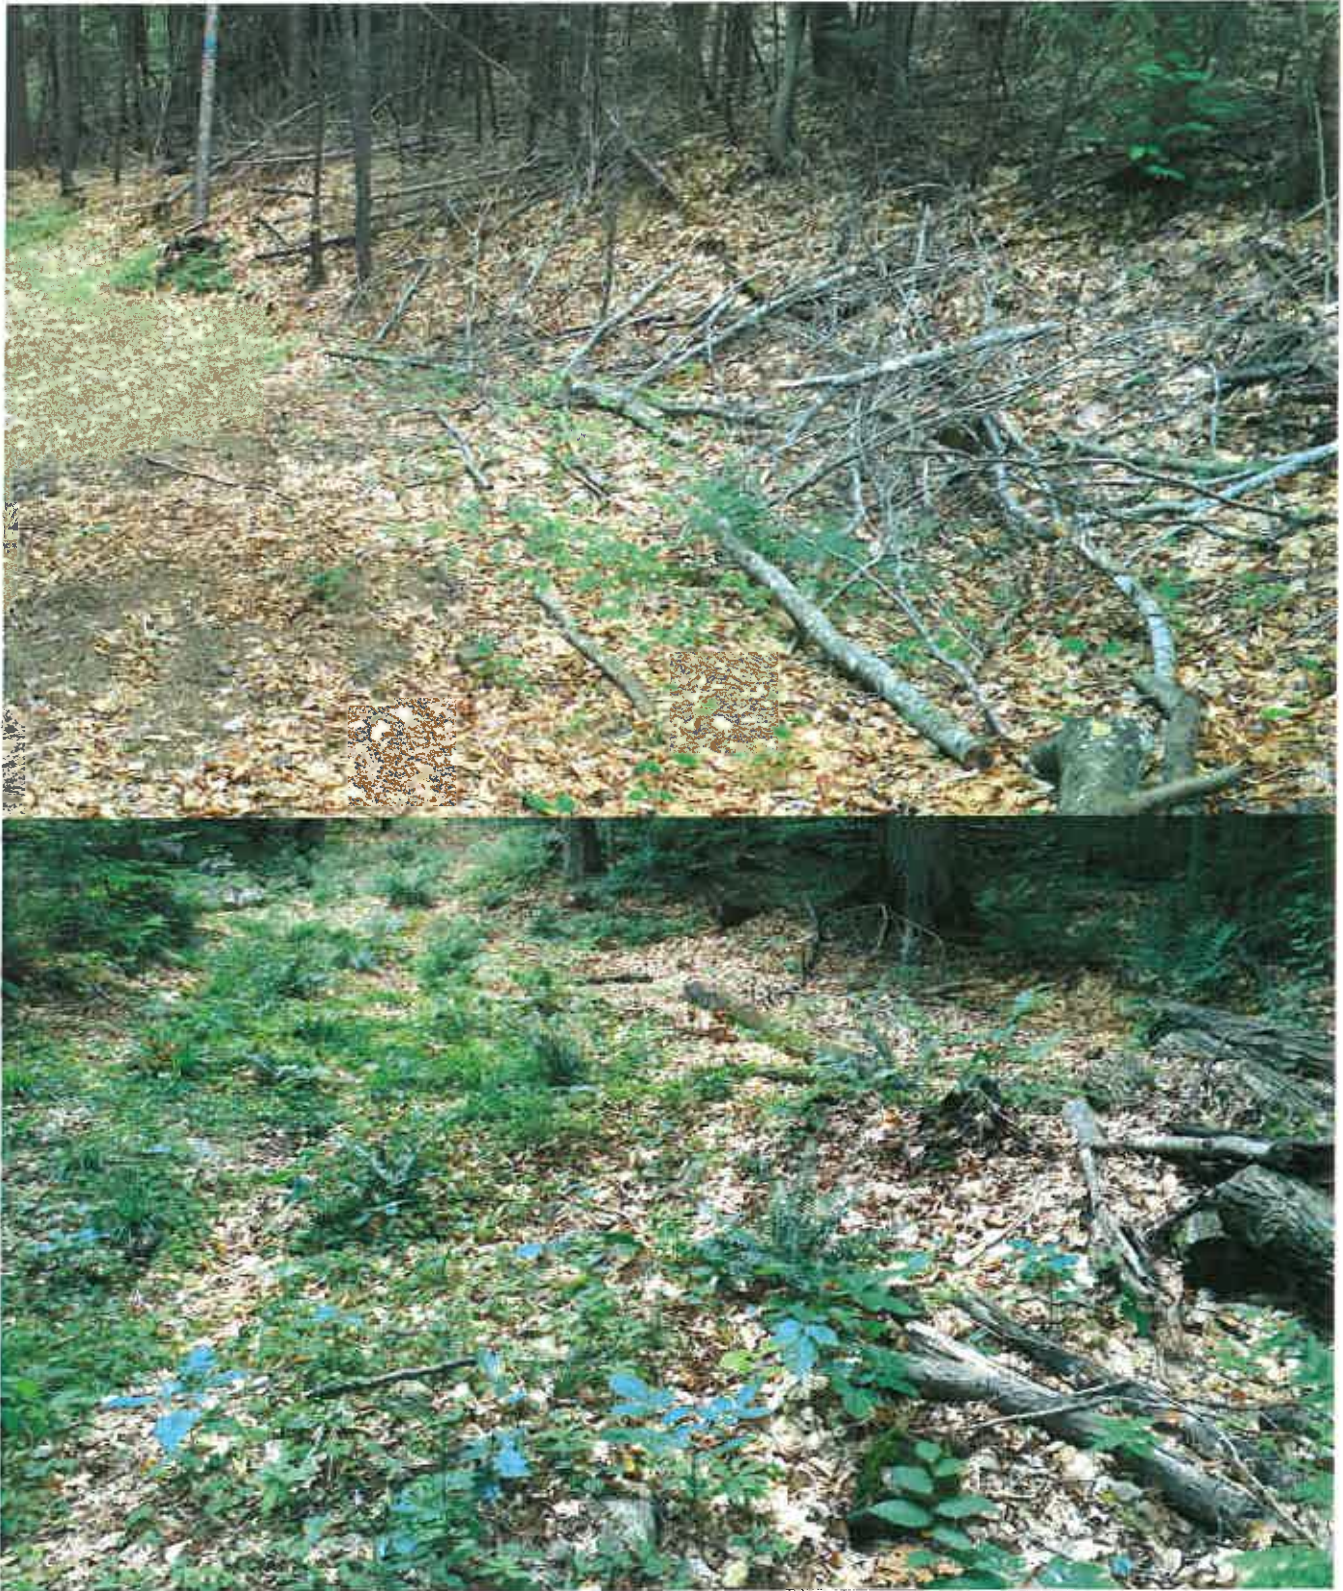
Examples of Trailside Debris Lining the Seventh Lake Mountain Trail in 2016

The pictures above were taken in the summer of 2016 on the Seventh Lake Mountain Trail, a newly constructed class II community connector snowmobile trail located in the Moose River Plains Wild Forest area, part of the Adirondack Forest Preserve. These pictures show trailside debris.

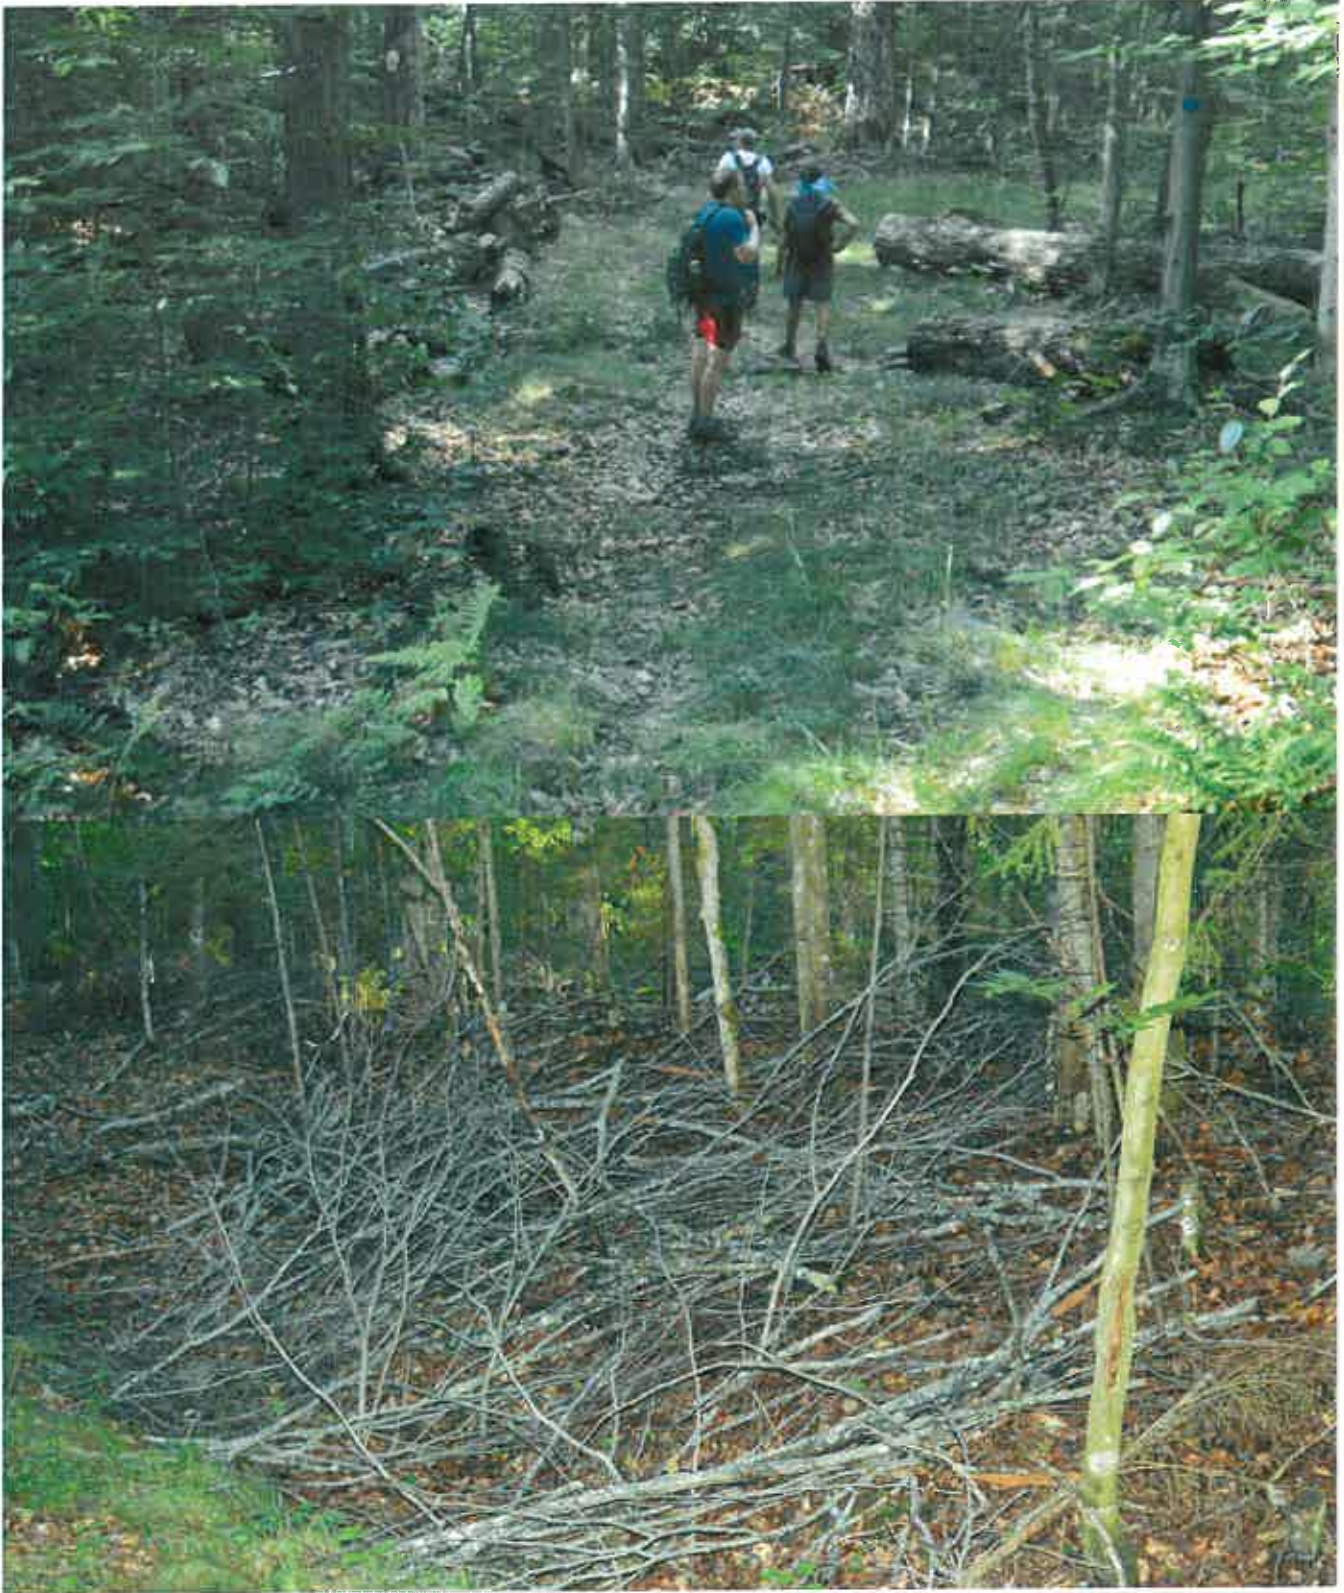
Examples of Trailside Debris Lining the Seventh Lake Mountain Trail in 2016

The pictures above were taken in the summer of 2016 on the Seventh Lake Mountain Trail, a newly constructed class II community connector snowmobile trail located in the Moose River Plains Wild Forest area, part of the Adirondack Forest Preserve. These pictures show trailside debris.

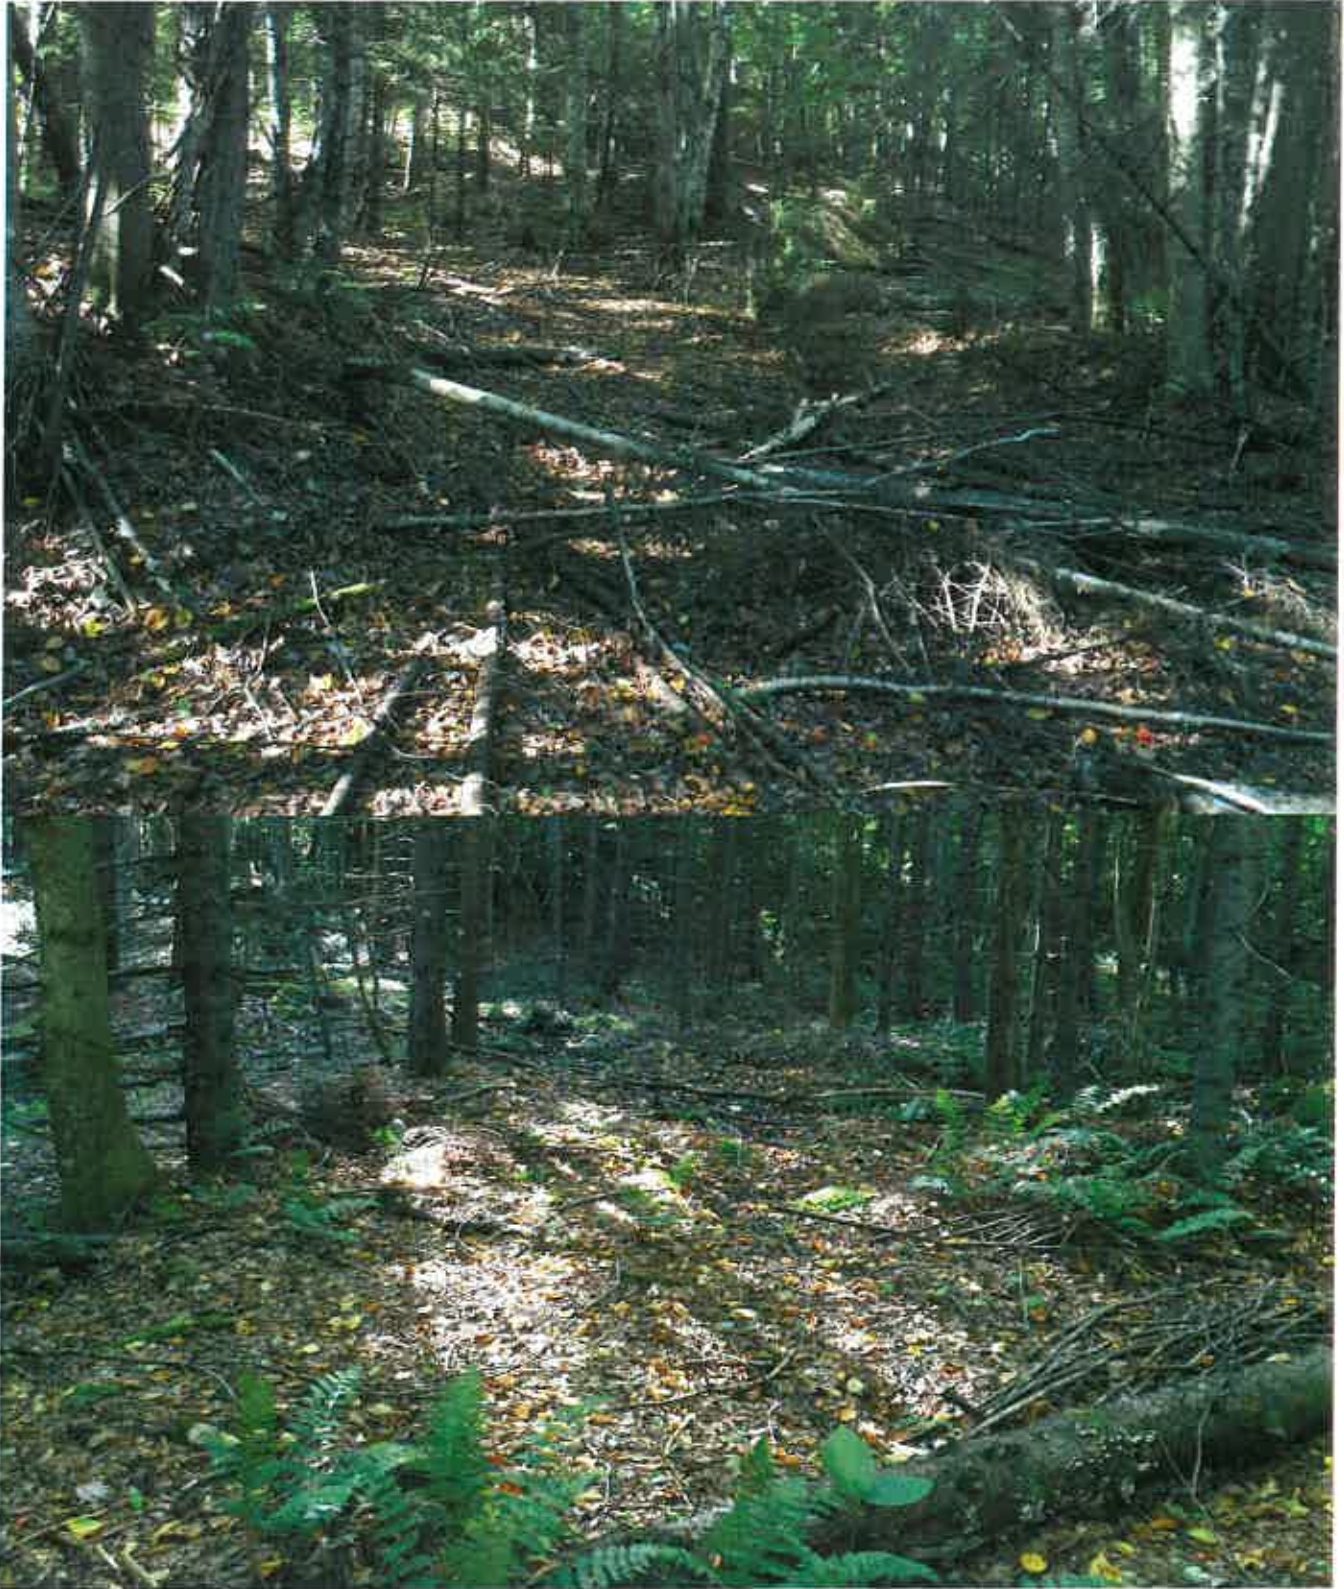
Section of Seventh Lake Mountain Trail Mistakenly Cut, 57 Trees Destroyed

The pictures above were taken in the summer of 2016 on the Seventh Lake Mountain Trail, a newly constructed class II community connector snowmobile trail located in the Moose River Plains Wild Forest area, part of the Adirondack Forest Preserve. These pictures show a section of trail mistakenly cut with 57 trees destroyed.

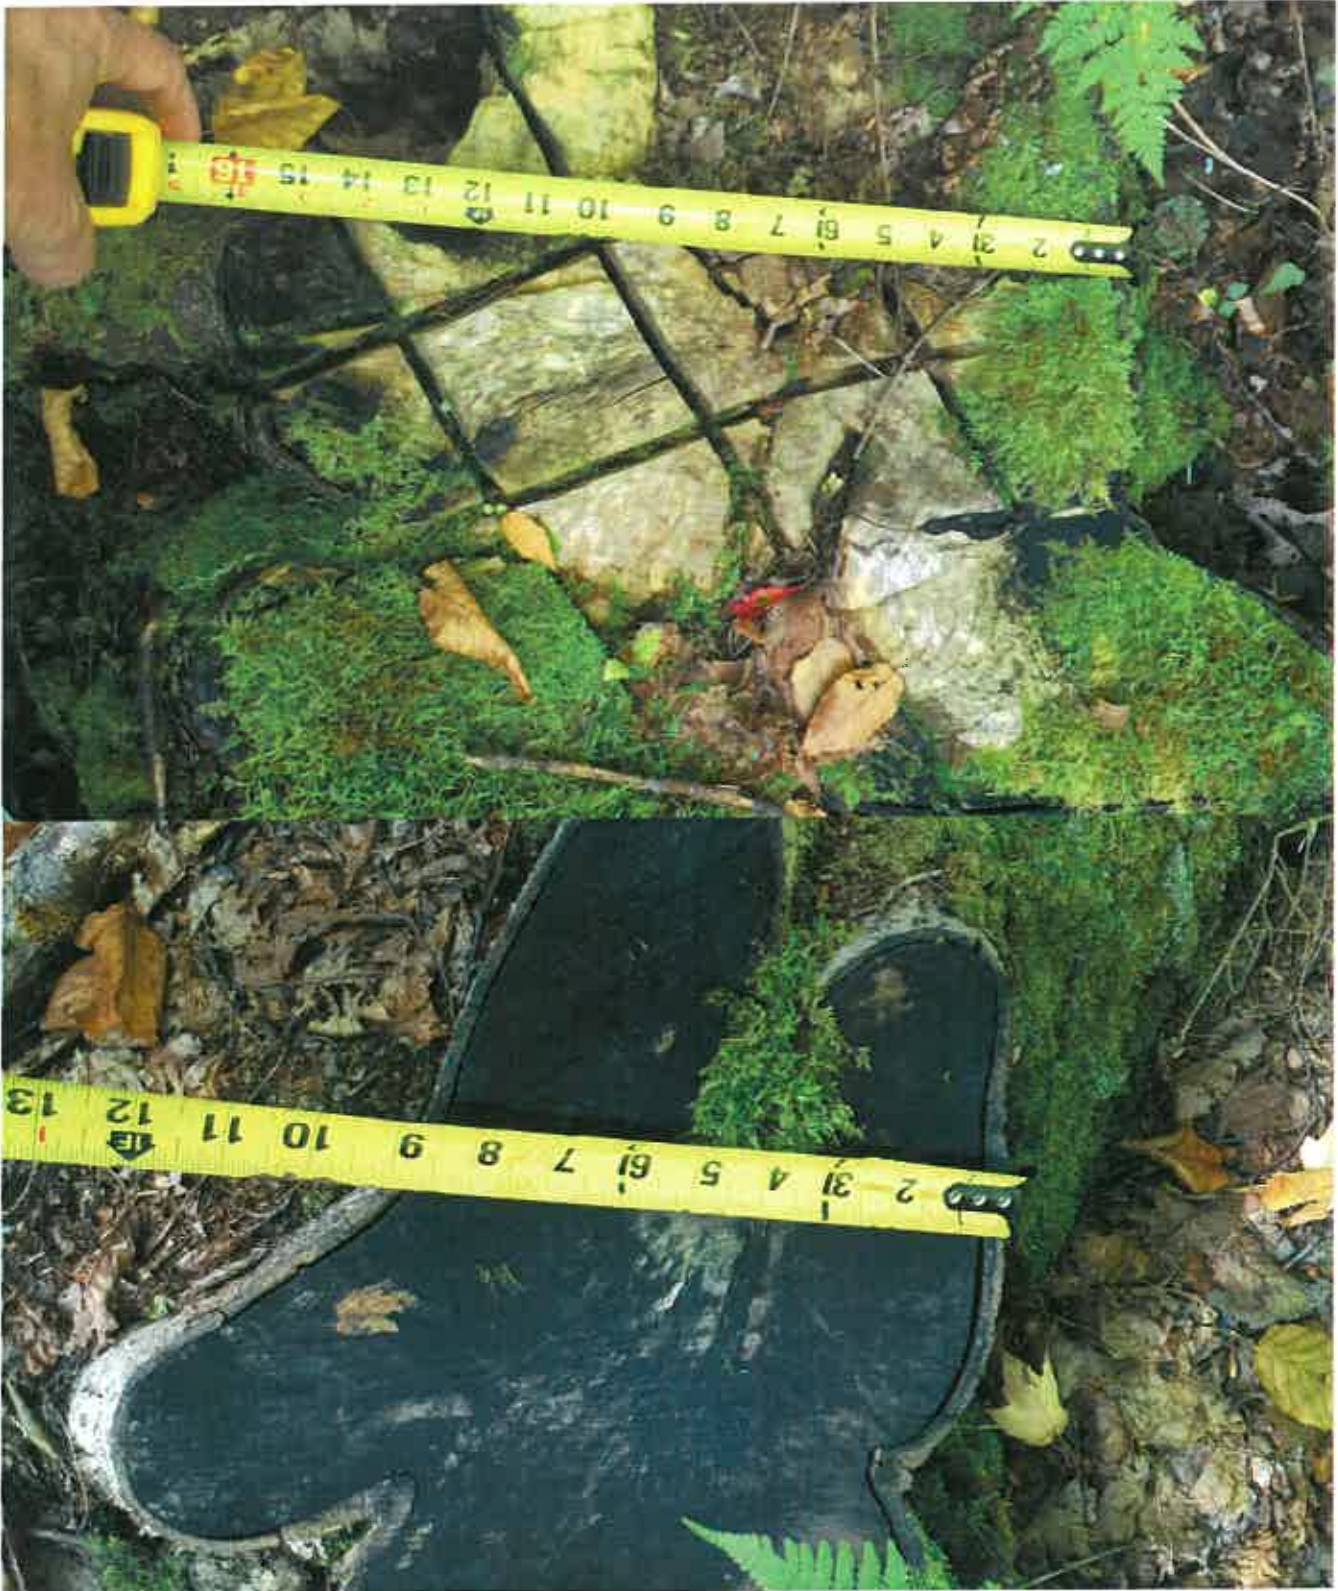
Section of Seventh Lake Mountain Trail Mistakenly Cut, 57 Trees Destroyed

The pictures above were taken in the summer of 2016 on the Seventh Lake Mountain Trail, a newly constructed class II community connector snowmobile trail located in the Moose River Plains Wild Forest area, part of the Adirondack Forest Preserve. These pictures show a two of the 57 trees that were destroyed.

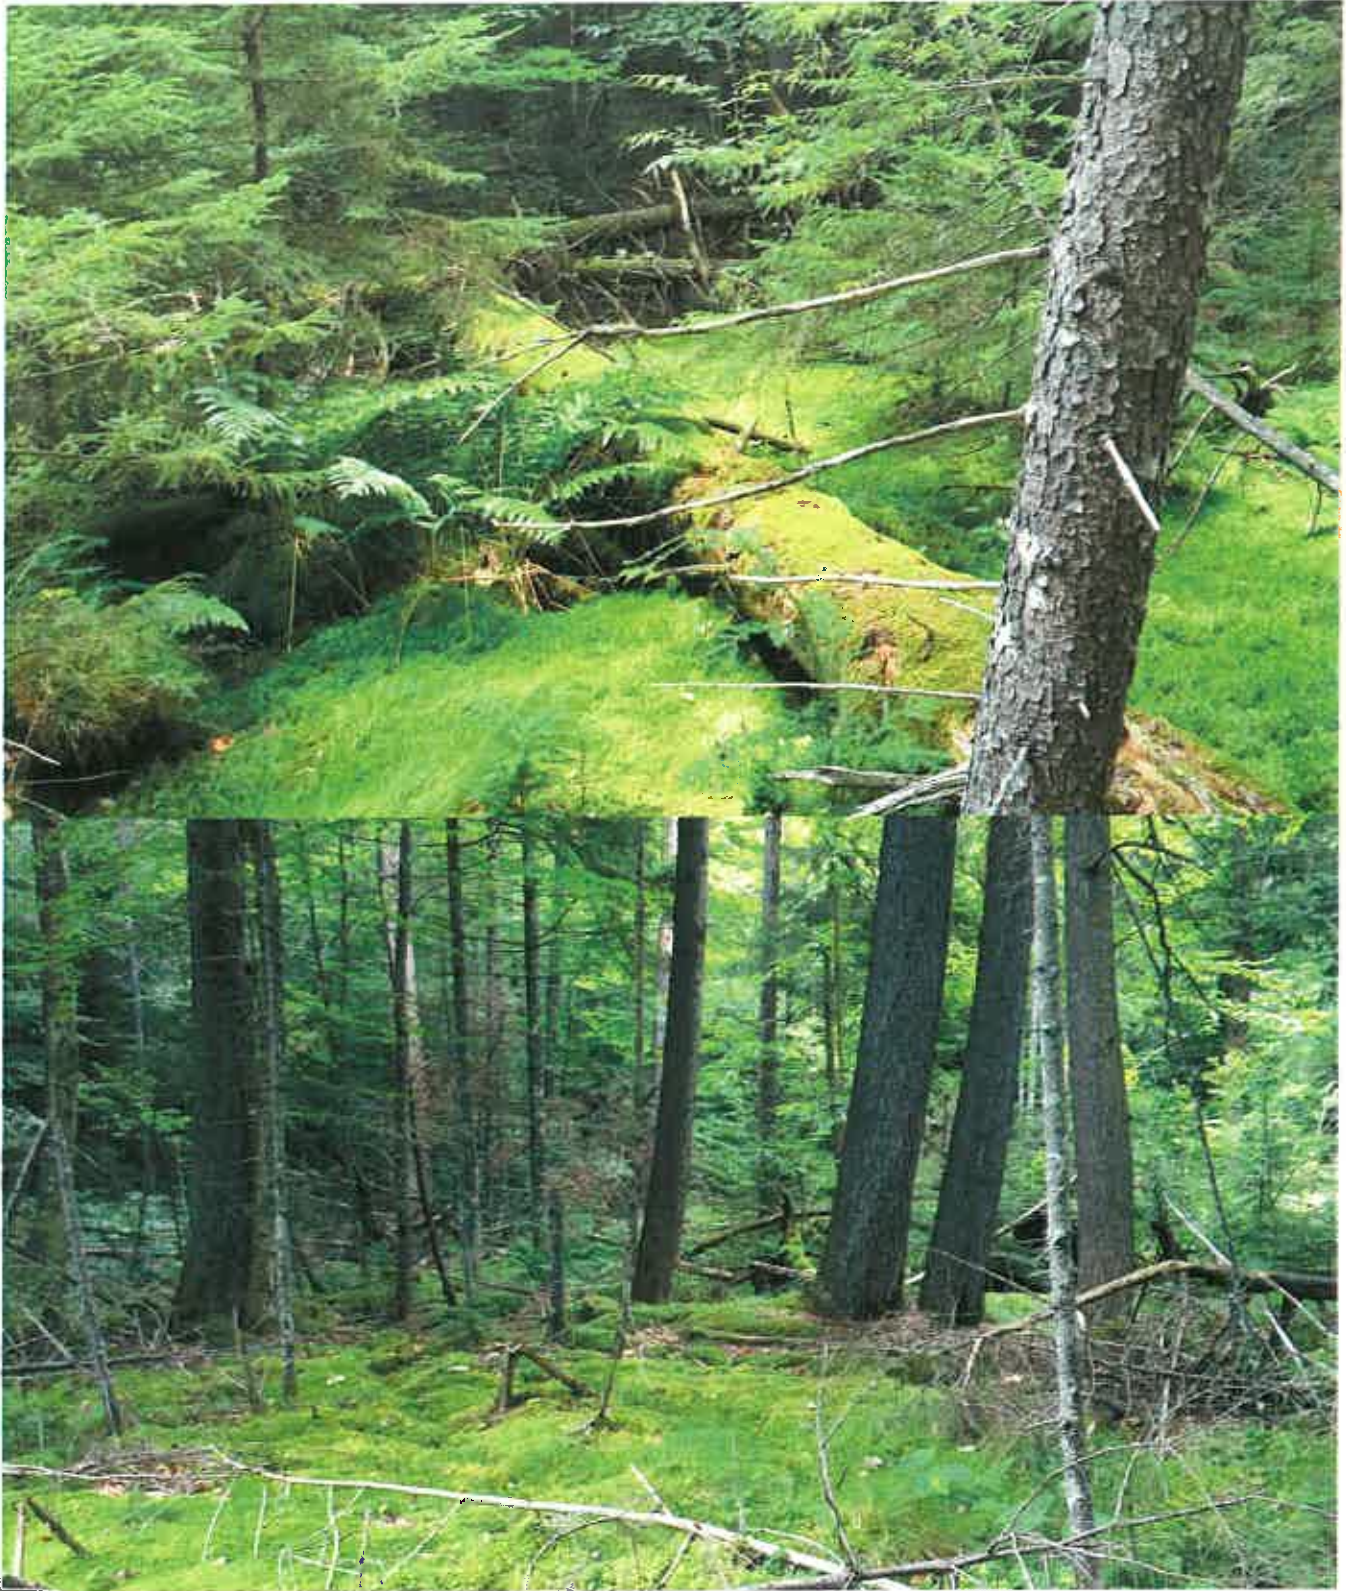
Examples of the Intact Forest Alongside the Seventh Lake Mountain Trail in 2016

The pictures above were taken in the summer of 2016 on the Seventh Lake Mountain Trail, a newly constructed class II community connector snowmobile trail located in the Moose River Plains Wild Forest area, part of the Adirondack Forest Preserve. These pictures show intact forest alongside this trail.
