Shaker Mountain Wild Forest and Northville Boat Launch

Unit Management Plan Environmental Impact Statement

Examples of Erosion on Seventh Lake Mountain Trail in 2016

The pictures above were taken in the summer of 2016 on the Seventh Lake Mountain Trail, a newly constructed class II community connector snowmobile trail located in the Moose River Plains Wild Forest area, part of the Adirondack Forest Preserve. These pictures show visible trail erosion.

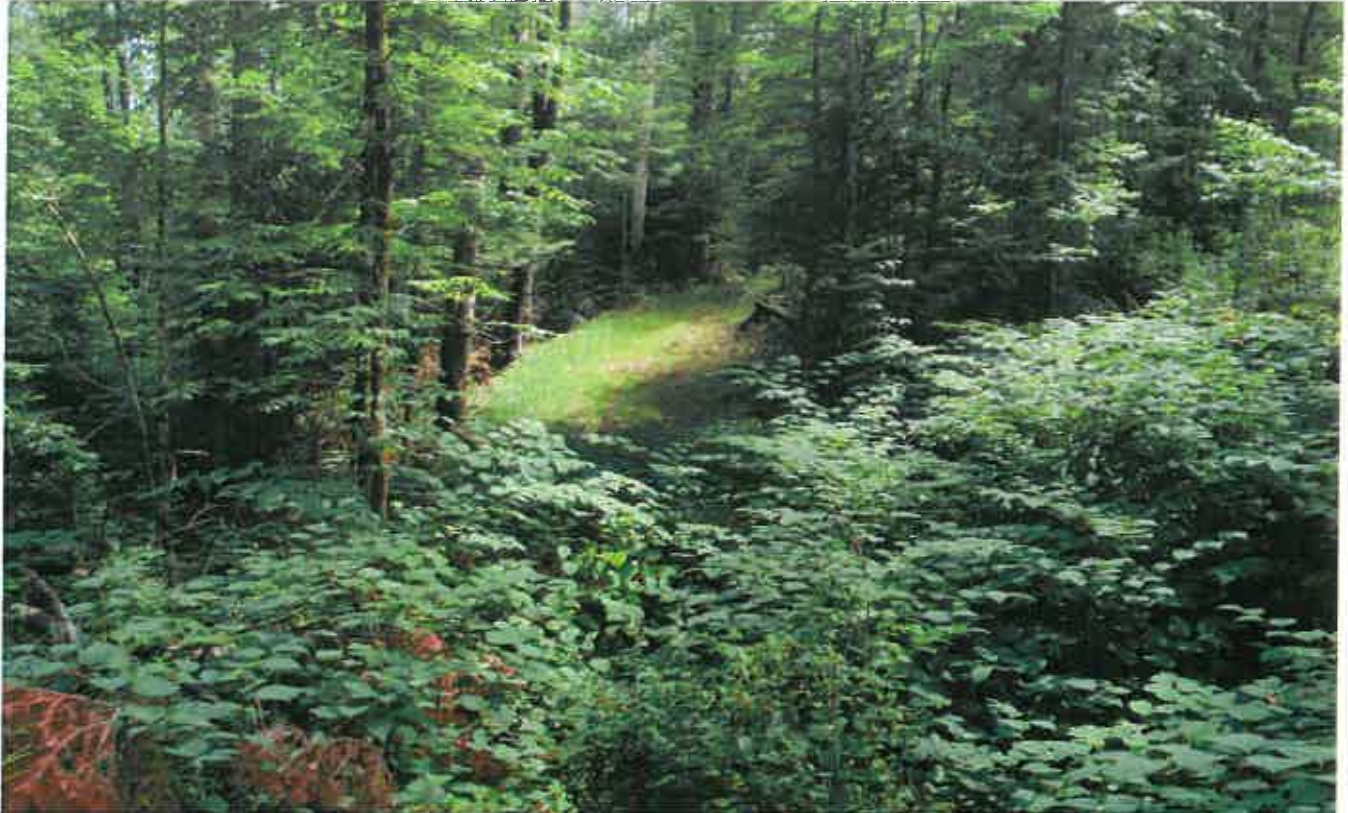
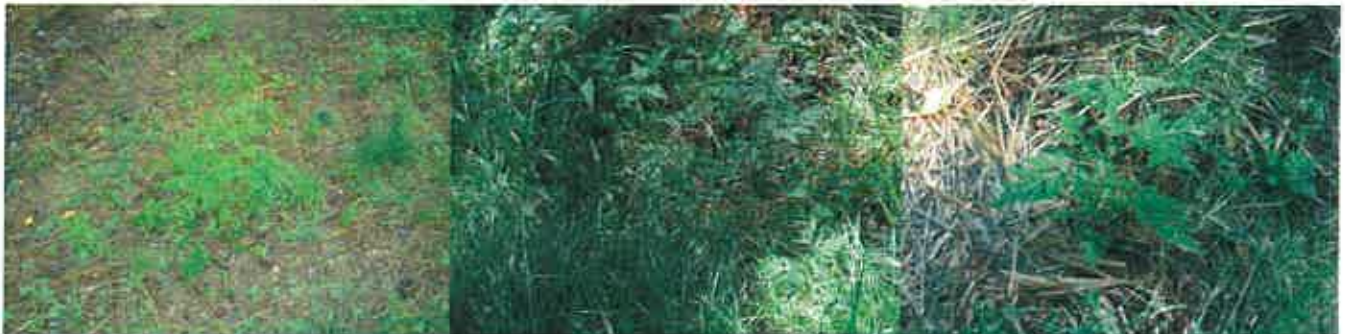
Knotweed and Ragweed Infestation on Newcomb-Minerva-North Hudson Trail

The pictures above were taken in the summer of 2016 on the Newcomb-Minerva Trail, a newly constructed class II community connector snowmobile trail located in the Vanderwhacker Mountain Wild Forest area, part of the Adirondack Forest Preserve. These pictures show infestations of knotweed (top) and ragweed (bottom).
